AA2006-1

**AIRCRAFT ACCIDENT
INVESTIGATION REPORT**

**JAPAN AIRLINES FLIGHT 356
BOEING 747-400D, JA8903
OVER THE SEA 8 NM S.E. OF HAMAMATSU CITY, JAPAN
OCTOBER 21, 2002**

**Aircraft and Railway Accidents Investigation Commission
Ministry of Land, Infrastructure and Transport**

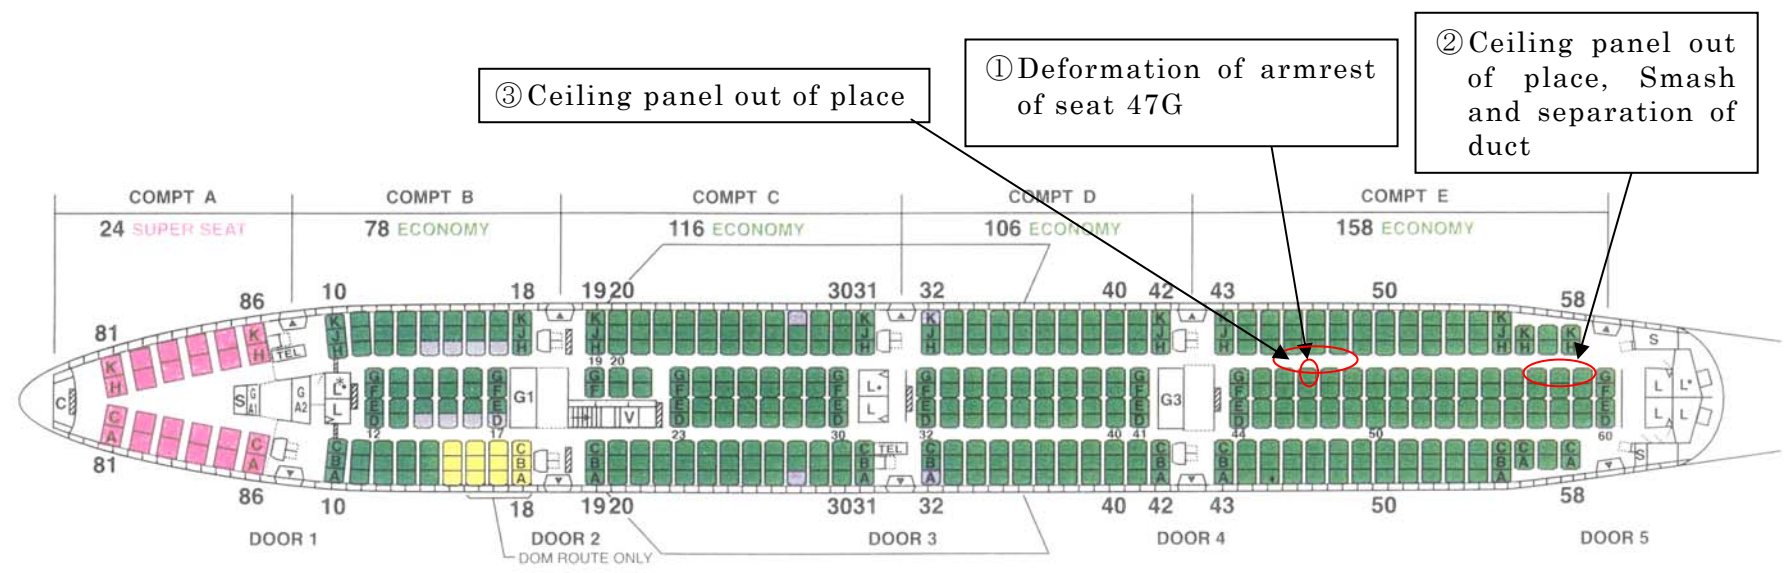
Figure 5 Major damage of cabin

There was minor damage to the interior of the passenger cabin. Details of the damage are as follows. Numbers in parenthesis correspond to the locations indicated in Figure 5. (See Figure 5 and Photos 1, 2 and 3)

A ceiling panel above the right aisle near seat 56G was cracked and displaced from its original position. (②)

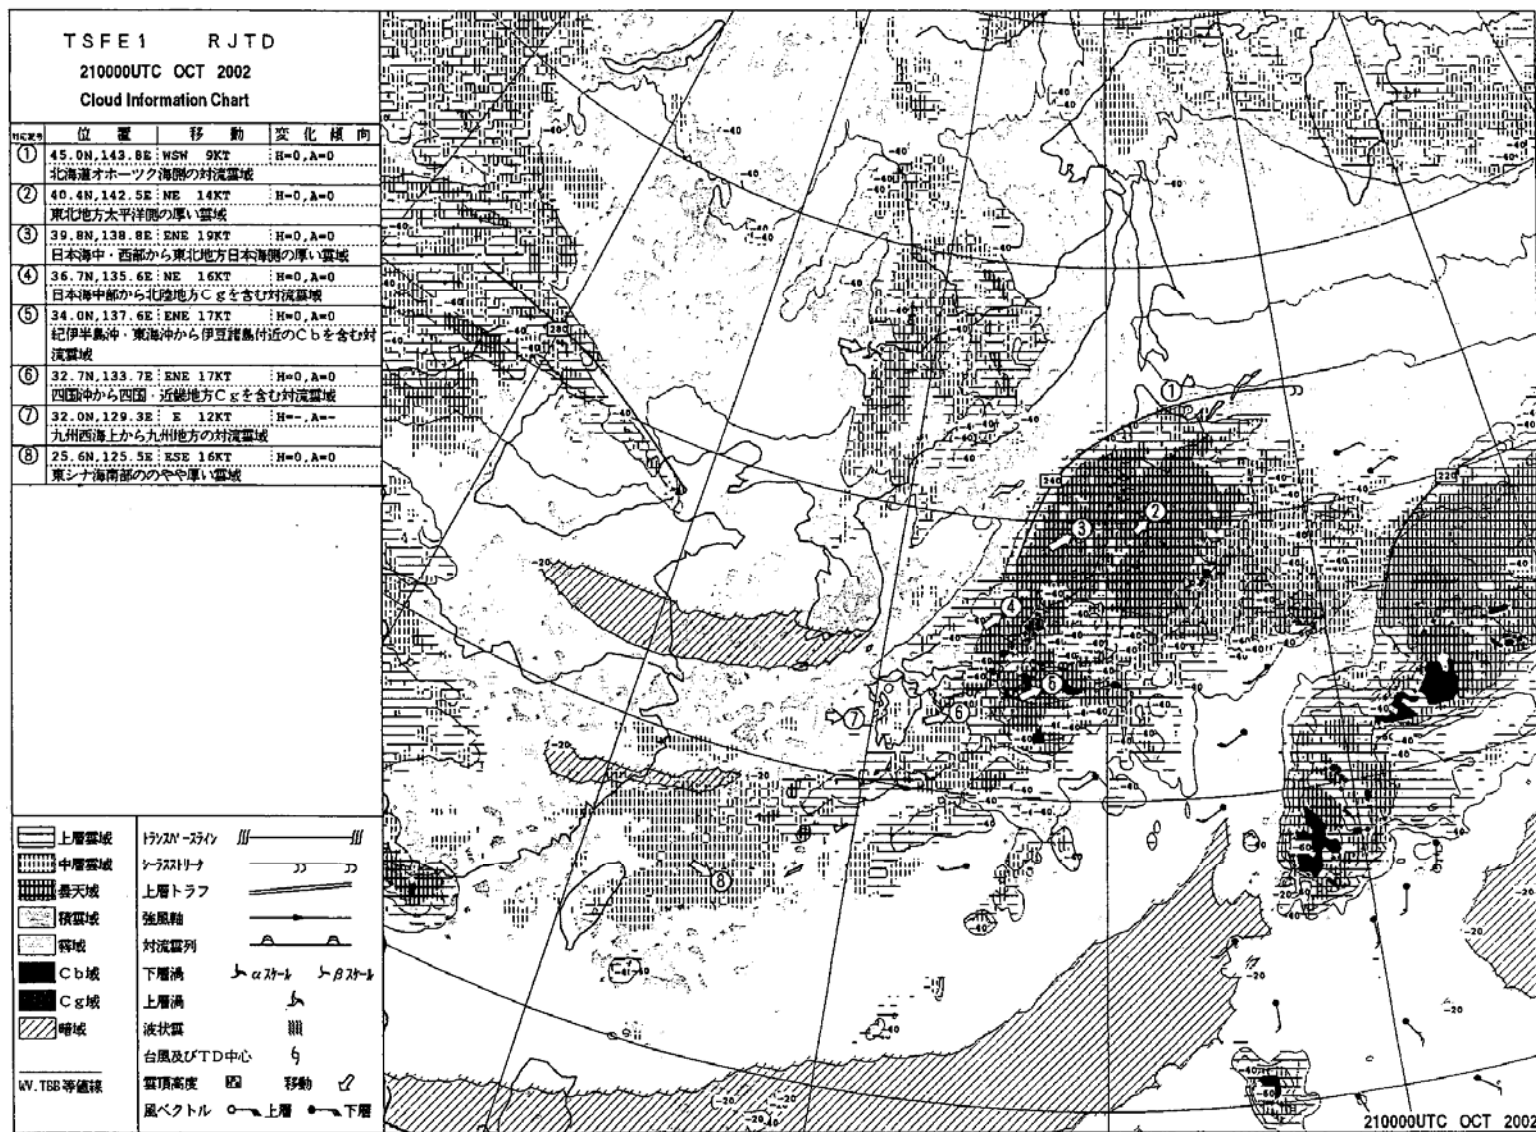
Figure 8 Cloud Information Chart(0900JST, 21 Oct. 2002)

According to the nephanalysis information chart for 09:00 JST on October 21, 2002 in Figure 8, there was a convective cloud zone including cumulonimbus stretching from offshore the Kii peninsula and near Izu Islands through to offshore the Tokai region and proceeding east-northeast. According to the CAPPI chart issued by Meteorological Agency's Nagoya radar at 11:00 JST on October 21, 2002, in figure 9, while echoes were observed at an altitude of 6km, there were no echoes from 8km upwards.

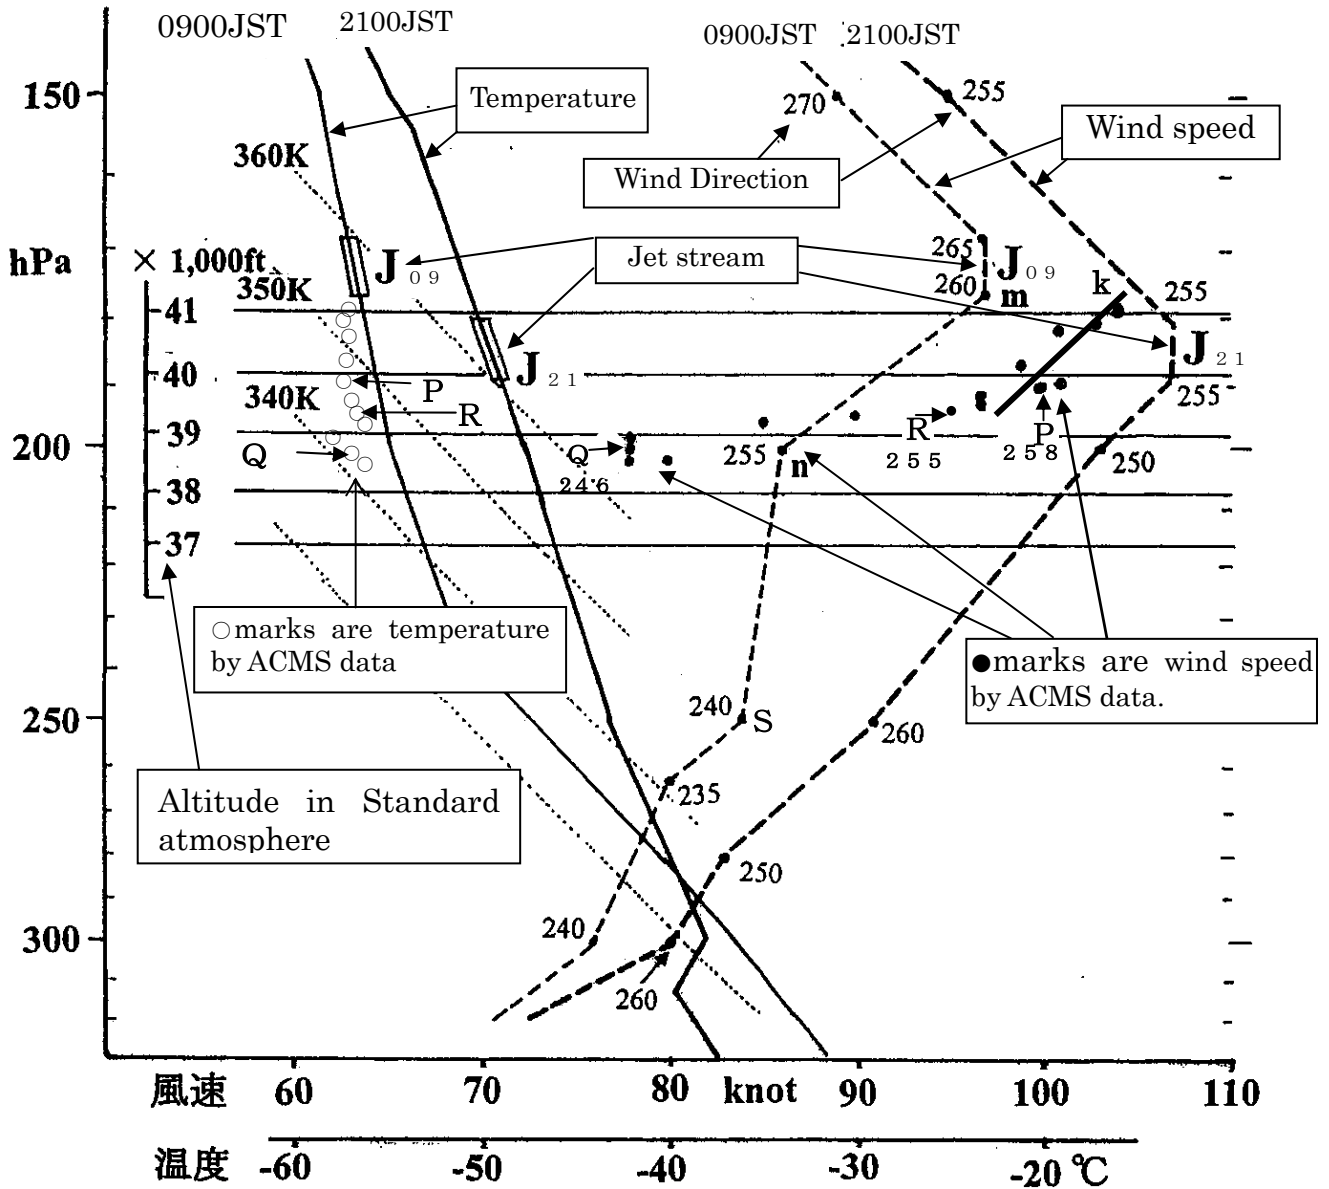
Figure 14 Temperature and Wind speed distribution over Hamamatu (0900 and 2100JST, 21 Oct. 2002)

Figure 14 shows the temperature and the wind speed distribution observed over Hamamatsu at 09:00 and 21:00 on October 21, 2002. According to this chart, the vertical shear (vector) near the altitude at which the accident was the average between point m (altitude 176hPa, wind 260°/97kt) and point n (altitude 200hPa, wind 255°/86kt) and was small at around 5kt/1,000ft at 09:00 on October 21. At 21:00 on October 21, it was around 8kt/1,000ft in the narrow observed altitude band of 189–200hPa below the jet stream.
