**AIRCRAFT SERIOUS INCIDENT
INVESTIGATION REPORT**

**AERO ASAHI CORPORATION
JA9678**

DROPPING OF OBJECT
DURING EXTERNAL CARGO SLING OPERATION
TOTSUGAWA VILLAGE, YOSHINO-GUN
NARA PREFECTURE, JAPAN
AT AROUND 10:23, AUGUST 5, 2016

AERO ASAHI CORPORATION
AÉROSPATIALE AS332L1 (ROTORCRAFT),
JA9678

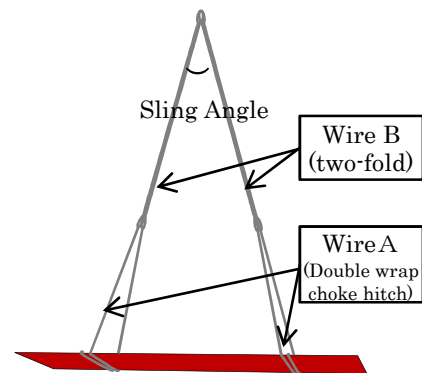
Figure 3 Lashing Status of Steel Plate

As the results of implementing thorough inspection on the packing, the steel plate was slung by two lines of 8 m long wire A for each from two points where wrapping wire twice around the plate to stay in horizontal position, and these two wire were hung at each end by a double folding wire B which was slung from the

remote hook by slinging. Furthermore, a double wrap slinging is the slinging method to wrap a cargo once and the lashing method that tightens the lashing wires with its cargo weight. The sling angle of this slinging was within 60 degrees which meets the regulation required to prevent damages on wires due to an excessive tensile force and a side slip of wires. (See Figure 3.)

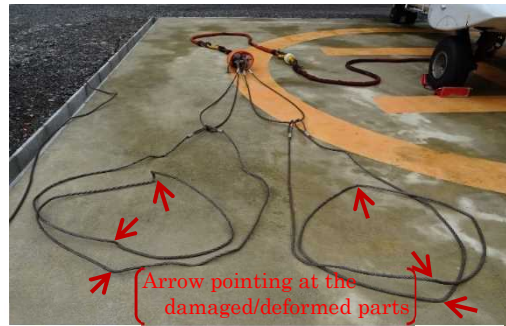
Photo 1 Remote Hook and each wire

After landing at the Helipad, as untying the wires entangled to each other for an inspection, the rotorcraft, remote hook and each wire were connecting as the same style as the time of transporting, and there was no anomaly excluding the two wire A which were tying the steel plate with the double wrap.

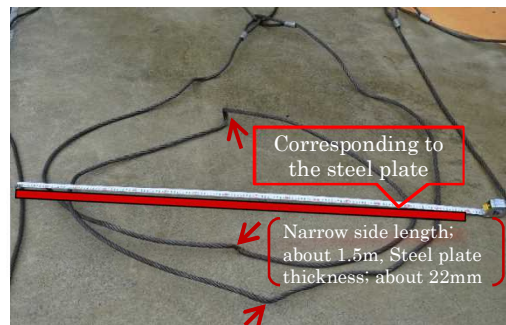
Photo 2 Damages and deformation of the Wire A

Damages and deformations like cut of element wires, abrasions and losing shapes were found on the wire A, at the parts which was near the center of the steel plate, not the parts where had direct contacts with the edges of steel plate in order to sling and keep the plate horizontal. (See Photo 1 and 2)

Because the damages and deformation of the wire A, were found at where the wire was near the center of the steel plate if it was horizontal, the steel plate became the vertical position at the time of dropping, and the edge of the steel plate scratched the damaged and

deformed parts, and dropped. Furthermore, it is probable that because the captain and on-board worker did not see the steel plate in vertical hanging position, the steel plate being held horizontally was turned up vertically in a quite short time and simultaneously dropped.

After the occurrence of this serious incident, the company revised whole of the packing guide to improve the method of packing like the way to attach shackles to holes made in all four corners of steel plate and connect to the wire, as prohibiting the transporting the cargo by lashing with only wire of double wrap regarding the packing to transport a steel plate by slinging. In addition, the company established a standing organization to conduct sufficient technical examination when adopting new transportation method.

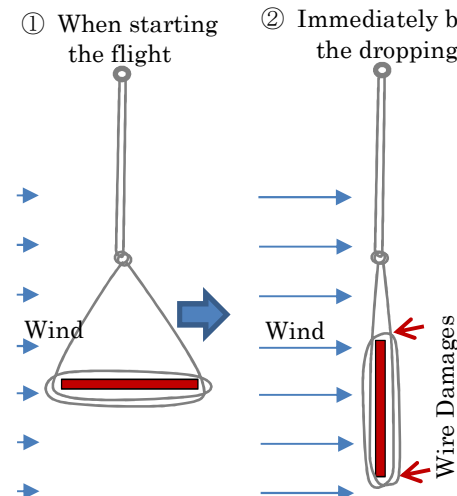
Figure 6 Transition of suspended condition of the steel plate due to an increase of the speed (Viewing the steel plate from the narrow side)

There were no air turbulence prior to dropping, from the situation that it had dropped suddenly from the stable horizontal position which was leaning slightly to back due to 80 kt wind pressure, it is probable that why the steel plate was turned up vertically, turning force caused by wind pressure, acted on the plate, suppressed the tightening force by the weight of steel plate itself and caused the steel plate to turn. It is probable that because the wind pressure onto the steel plate would be increased at once due to turning of the steel plate, the off-balanced steel plate dropped in a flash. In general, a flat board placed parallel to an airflow could generate the lift due to an attitude angel, as the result, since an unexpected motion of the flat board could occur, so it is necessary to pay attention.

| <p>It is probable that the steel plate of being held horizontally was turned up vertically due to effects of wind pressure and others, resulted in the balance loss and dropped.</p> <p>It is probable that the lashing method of this steel plate was adopted because of insufficient technical examination and overlooking the possibility of suspended load collapse.</p> |
