**AIRCRAFT ACCIDENT
INVESTIGATION REPORT**

JAPAN COAST GUARD

J A 9 6 8 A

ROTORCRAFT DAMAGE DURING LANDING JAPAN COAST GUARD AGUSTAWESTLAND AW139 (ROTORCRAFT), JA968A AT AROUND 15:08, AUGUST 9, 2016 AT SHITI-GA-HAMA TOWN, MIYAGI-GUN MIYAGI PREFECTURE, JAPAN

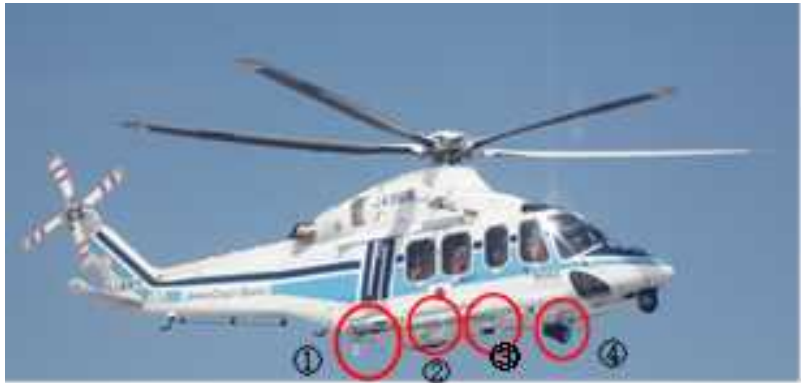
</div> <p style="text-align: center;">Figure 1 Damaged Locations of the Rotorcraft</p>

<p>2.2 Injuries to persons</p>	<p>None</p>
<p>2.3 Damage to Aircraft</p>	<p>Extent of damage to the Rotorcraft: substantial</p> <ul style="list-style-type: none"> ① Deformed outer skin panel, deformed frame at the fuselage bottom and the damaged Heli-Tele antenna ② VHF (No.2) antenna; damaged ③ upper cover parts of the Hoist light device; collapse and, deformed ④ Search light glass; cracked <div style="text-align: center;">

Based on these, it is highly probable that the Rotorcraft landed without lowering the landing gear and suffered damages to its fuselage bottom surface.

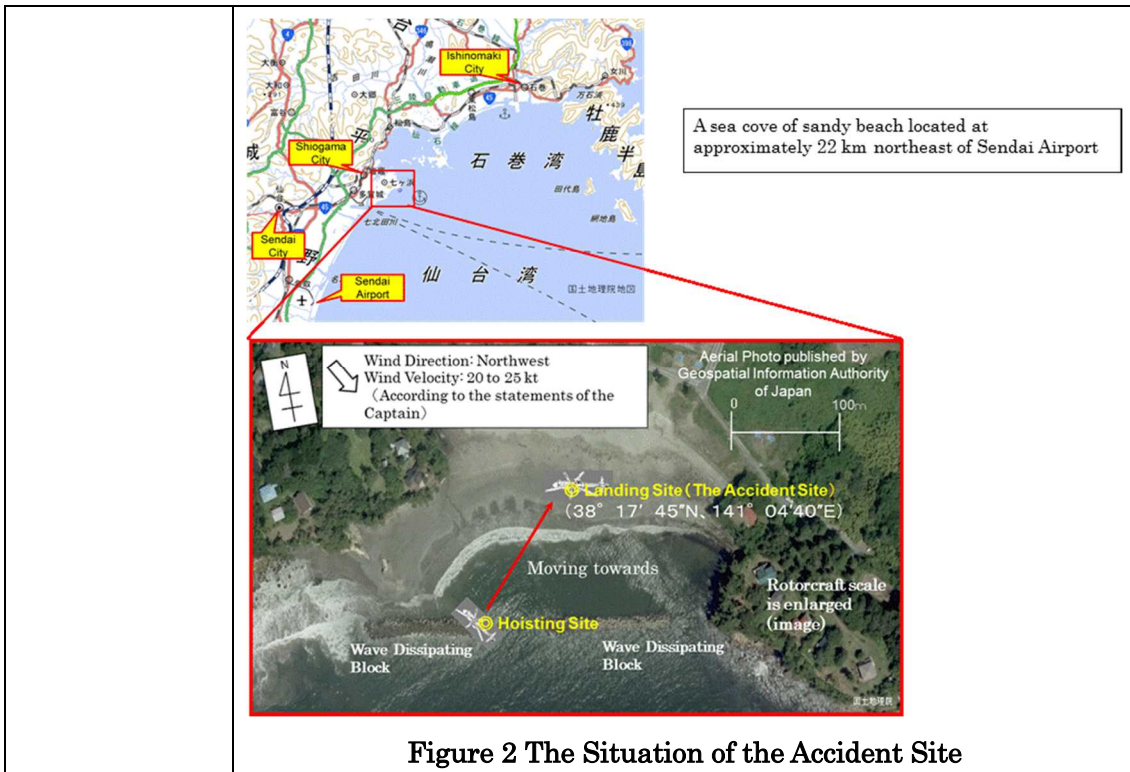
Figure 2 The Situation of the Accident Site

2.7 Accident Site	<p>The accident site was an inlet of sandy beach, which had a sea shore at the south side and sheer hills at both sides of the inlet.</p>
