# AIRCRAFT ACCIDENT INVESTIGATION REPORT

Northwest Airlines  
Boeing 747-400, N663US  
New Tokyo International Airport  
September 19, 1991

Aircraft Accident Investigation Commission  
Ministry of Transport

September 24, 1993

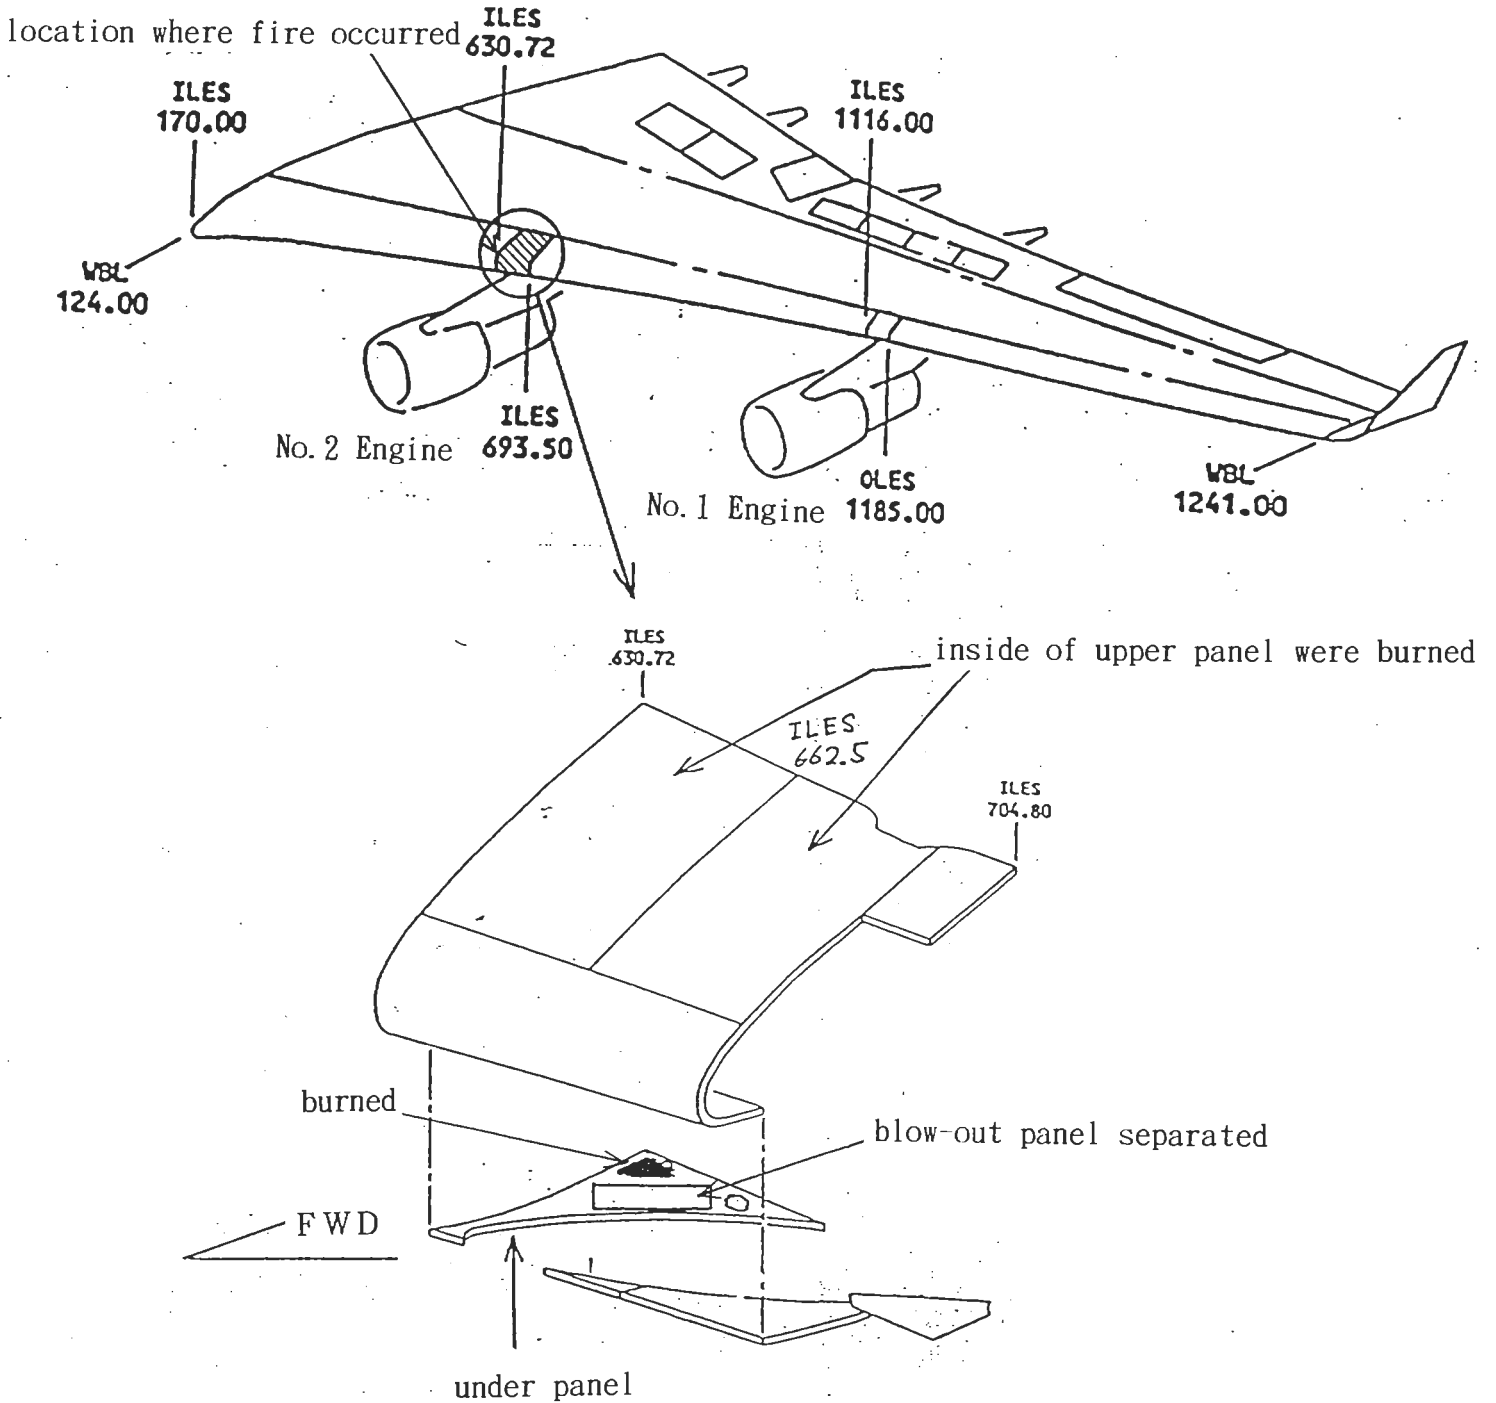
Attached Fig. 5 Location where fire occurred within Left Wing Leading Edge

- \* Access panel(No.511BB) on the wings undersurface inboard of No.2 engine pylon strut: burned, and the blowout panel: separated (the said blowout panel is designed to separate by a differential pressure of 2.5 psi)

- \* Access panel (No.511CT) on wing's upper surface as well as the inside of the fixed panel adjacent thereto: burned

- \* No. 2 engine pylon strut fairing panel (inside): burned

- \* Left and right skate angle of No.2 engine pylon strut: deformed by heat
- \* Web stiffener of No.2 engine pylon strut: deformed by heat
- \* Wing leading edge rib at inboard leading edge station (ILES)662.5: burned

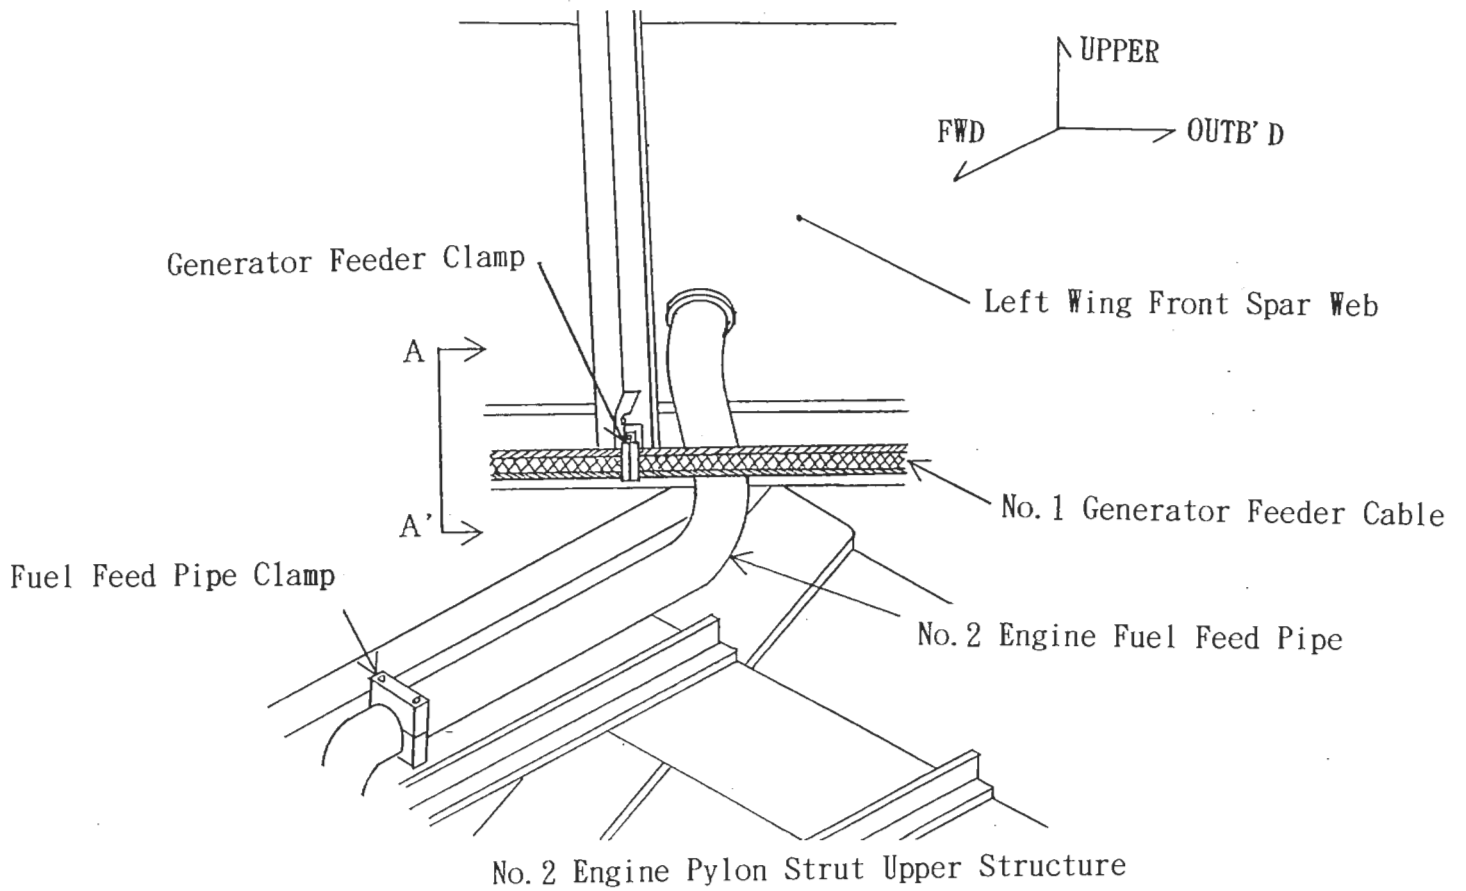
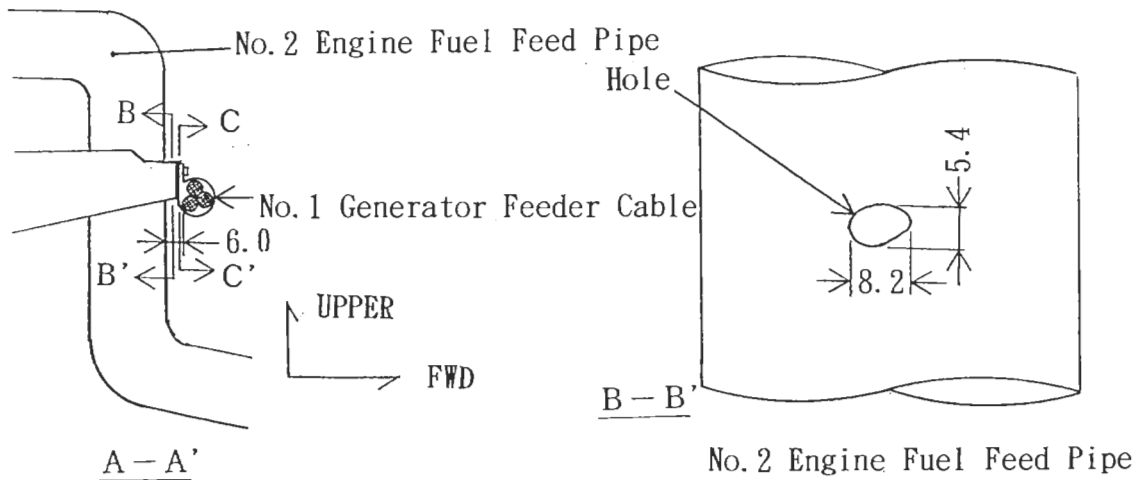
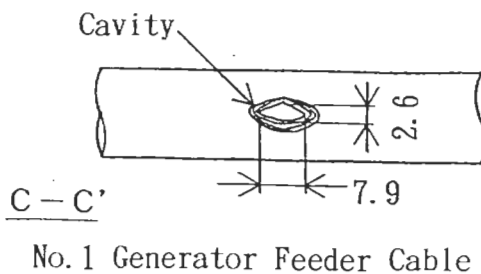
Attached Fig. 6 Damage to No.1 Generator Feeder Cable and No.2 Engine Fuel Feed Pipe

On the fuel feed pipe of the aircraft at a location aft of the generator feeder cable crossing, there was found a hole of 8.2 mm in long diameter and 5.4 mm in short diameter. And the portion in defect (hole area x pipe thickness) of the pipe was approximately 28 mm<sup>3</sup>. The anticorrosive coating in the peripheral of the hole was chafed off with such traces remaining. The chafed portion was 9.9 mm in long diameter and 7.1 mm in short diameter. On the identification tape (material:glass fibre) pasted on the location of the fuel feed pipe where the hole was created, there was found a hole too of almost the same size as the hole on the pipe.

Size of the opening of the cavity in No.1 generator feeder cable is 7.9 mm in long diameter and 2.6 mm in short diameter and the abraded area of the insulation coating was 13.3 mm in long diameter and 6.9 mm in short diameter. The cavity caused by melting of the conductor was about 136 mm<sup>3</sup> in volume. (see Attached Fig. 6 and Photos. 1, 5 and 6)

(1) The insulation coating was damaged by chafing between No.1 generator feeder cable and No.2 fuel feed pipe, and thereby both were electrically shorted.

(4) Due to chafing as well as arcing resulting therefrom, a hole was opened on No.2 fuel feed pipe, from where fuel spouted, and the fuel was ignited by the arc to cause fire at the area.

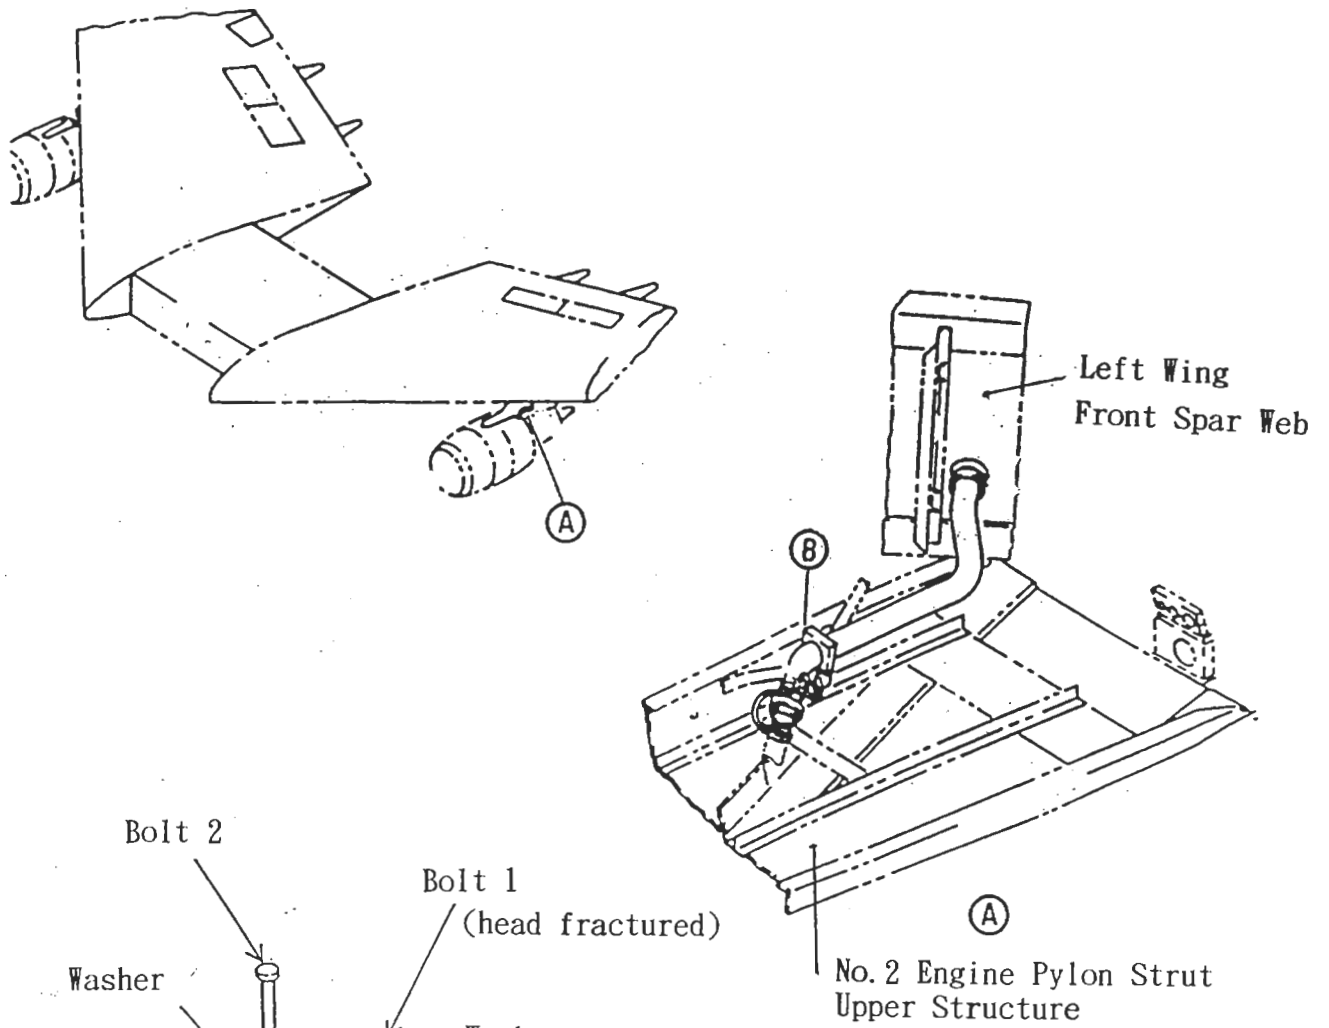
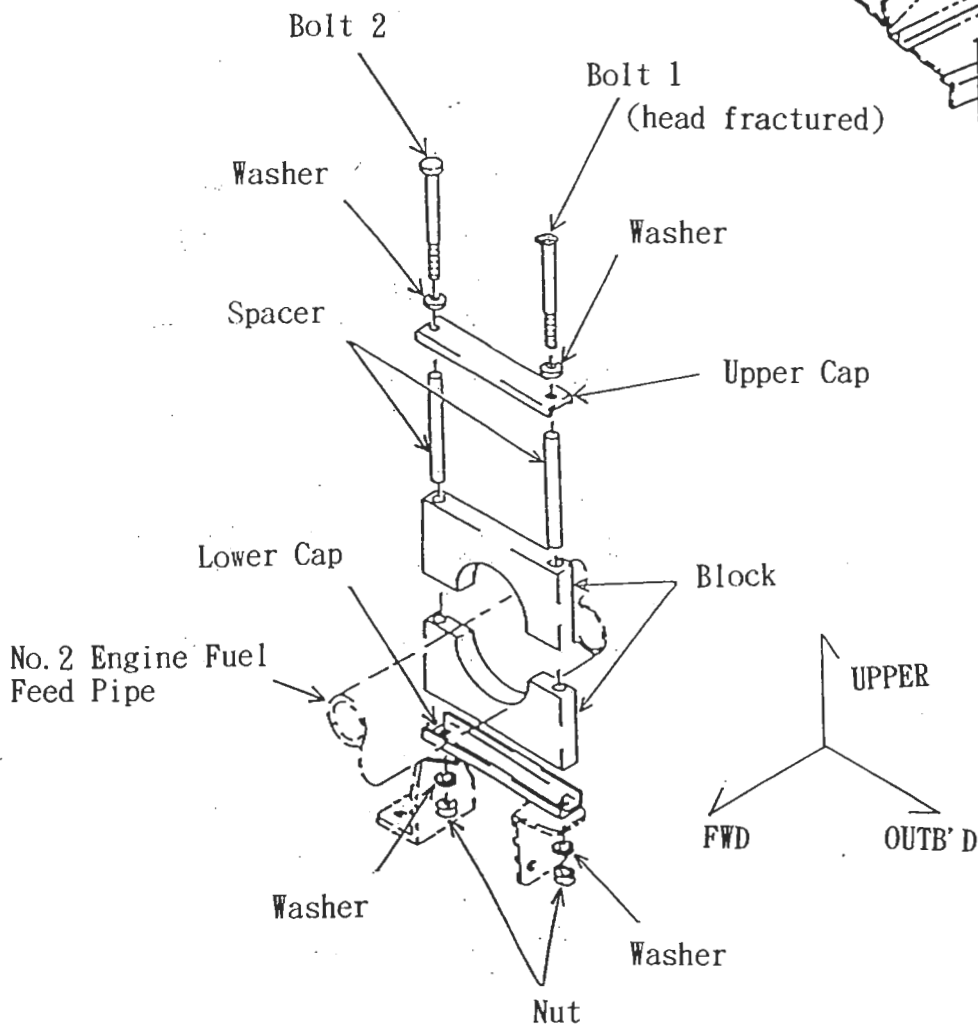
Attached Fig. 7 No. 2 Engine Fuel Feed Pipe Clamp

No.2 engine fuel feed pipe is fixed to structure of the upper portion of the pylon strut by a clamp just before it enters No.2 engine pylon. The clamp is composed of caps (of an aluminum), spacers (of an aluminum), bolts (of a steel), blocks (rubber), etc. (see Attached Figs. 6 and 7.) The outside bolt head of the clamp was fractured. Results of inspection on parts of the clamp made visually as well as by a scanning electron microscope (SEM) and others were as follows:

It was fractured at its head, and at the center of the fractured surface there was a rhombus-shaped plane of approximately 1.5 mm x 1.5 mm and surrounded by a rough surface. The diameter of the grip of the bolt (NAS1801-3-52) was within the specification.

No damage was recognized except that the plating of the grip was expanded by heat.

No damage was recognized on caps, spacers and self-lock nuts.

Block were burned.

The overall fractured surface was covered with cadmium, about 1/3 of which was spherical. The spherical cadmium was concentrated in the perimeter of the rhombus-shaped plane located in the center.

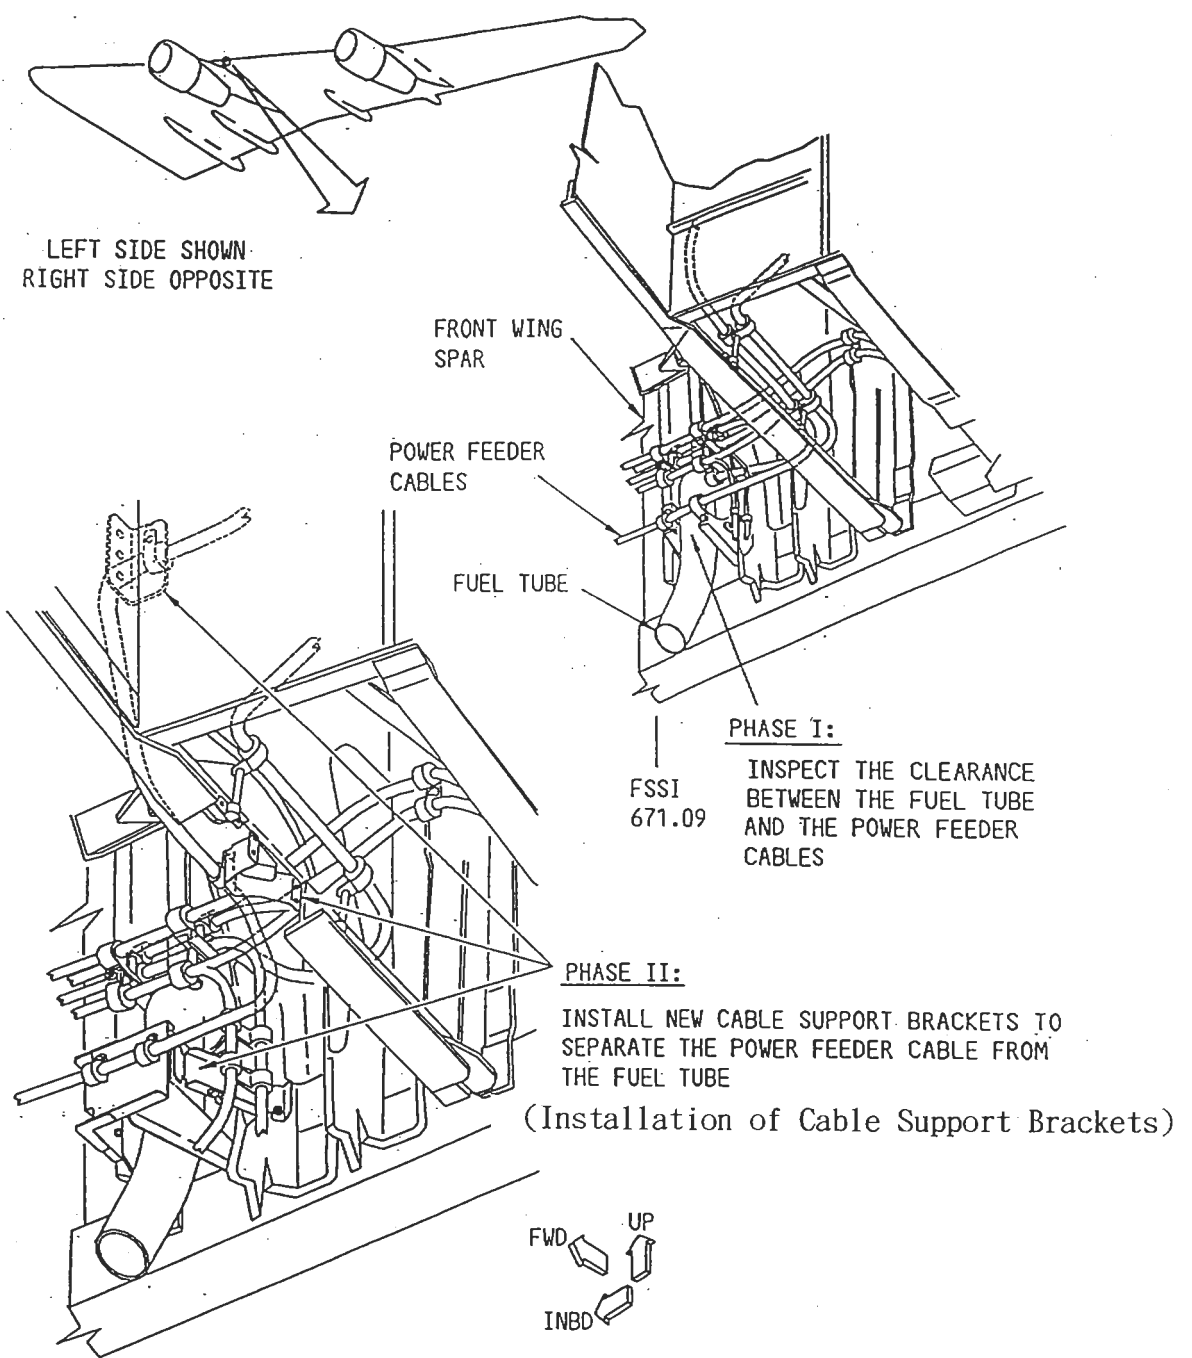
Attached Fig.10 Modification by Boeing SB of installation of  
No.1 Generator Feeder Cable Support Brackets

This Service Letter, applicable to Boeing 747-400 airplanes, recommends to prevent the clamps from being flexed or fractured by reinstalling the clamp in a "lobed down", instead of "lobed up", position through a support plate, taking into consideration instances reported in which the generator feeder cable clamps were fractured between the inboard engine and the outboard engine, and thereby the feeder cable and structural parts contacted each other, causing abrasion of insulation coating of the feeder cable, and leading to arcing as well as trip-off of the generator.

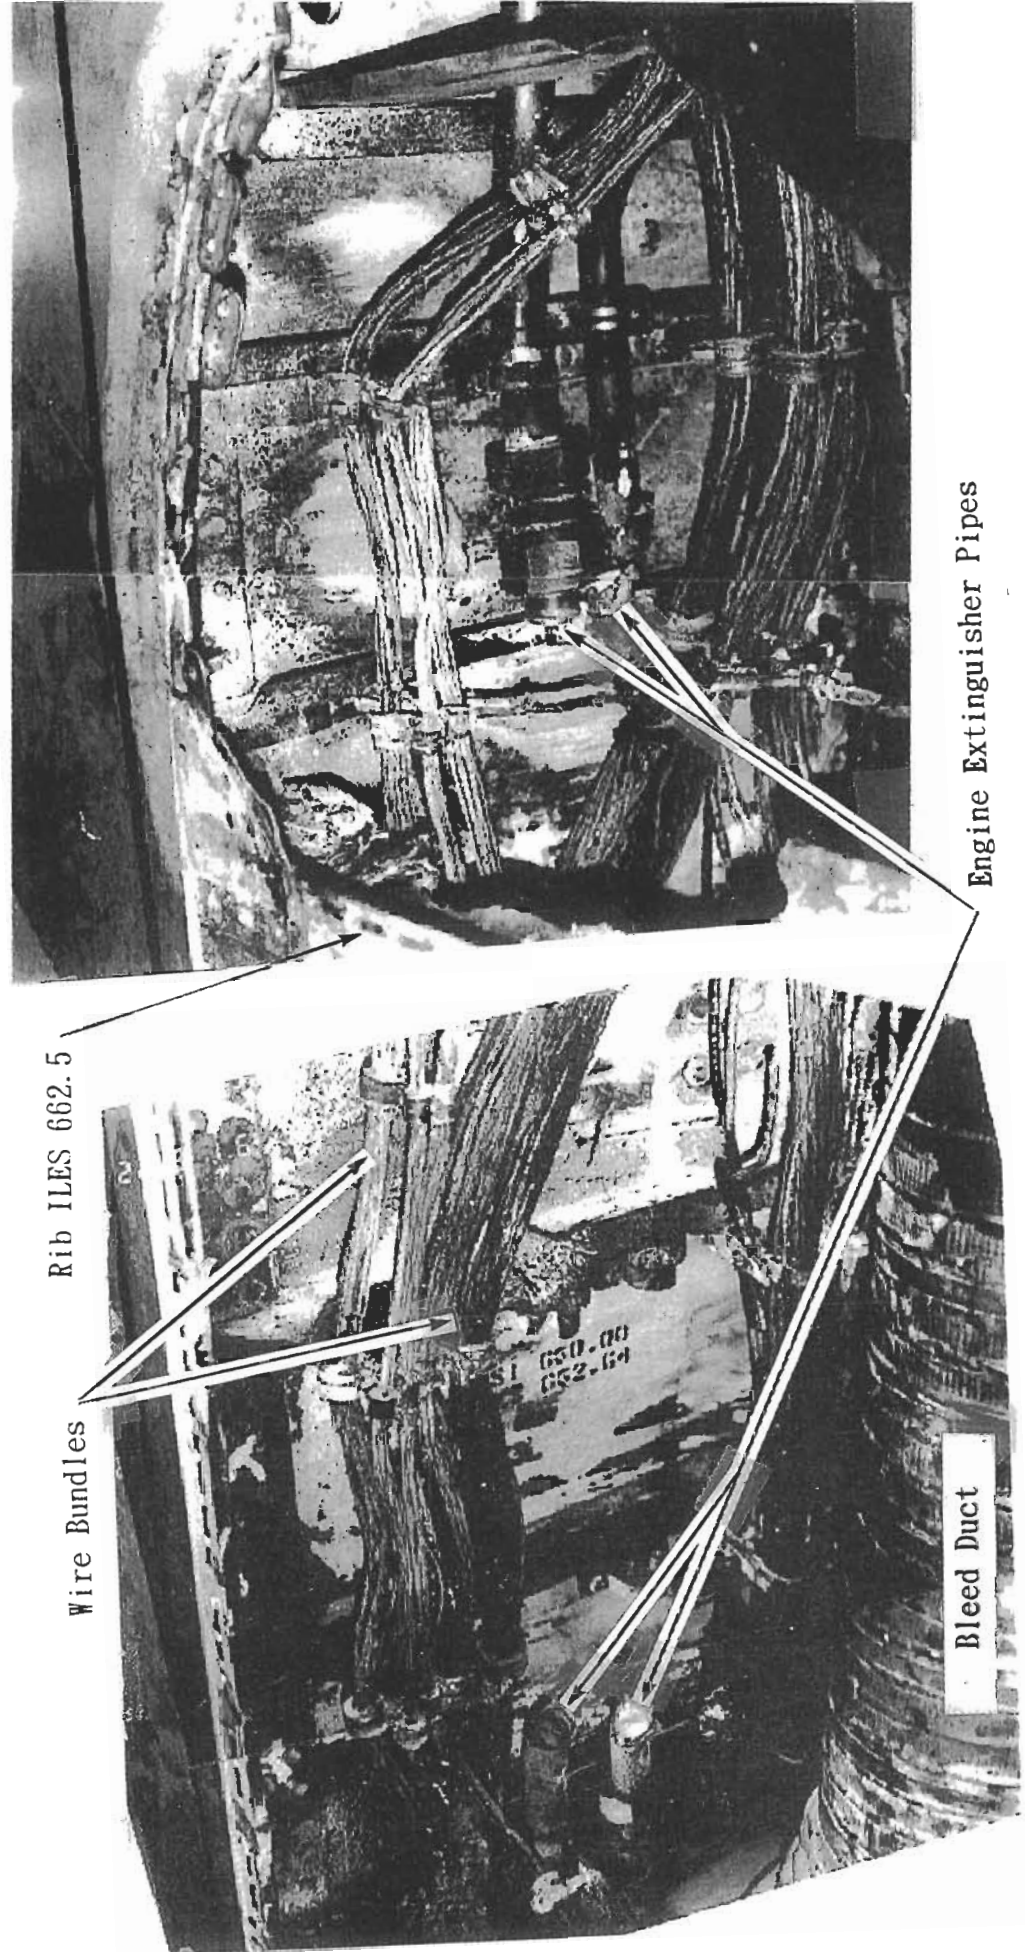
Photo. 2 Wire Bundles and Extinguisher Pipes burned within Left Wing Leading Edge

- \* No.2 engine fuel feed pipe: damaged (hole)
- \* No.1 generator feeder cable: damaged (cavity)
- \* No.2 engine fuel feed pipe  
clamp bolt: fractured,  
block: burned
- \* Wire bundles: burned
- \* Piping for fire extinguisher for No.1 and No.2 Engine: melted
- \* Wires of electric motor for driving leading edge flaps: burned

Ten systems of wire bundles, out of the wire bundles in the said area, were significantly burned, and within some bundles short-circuit was found among wiring.

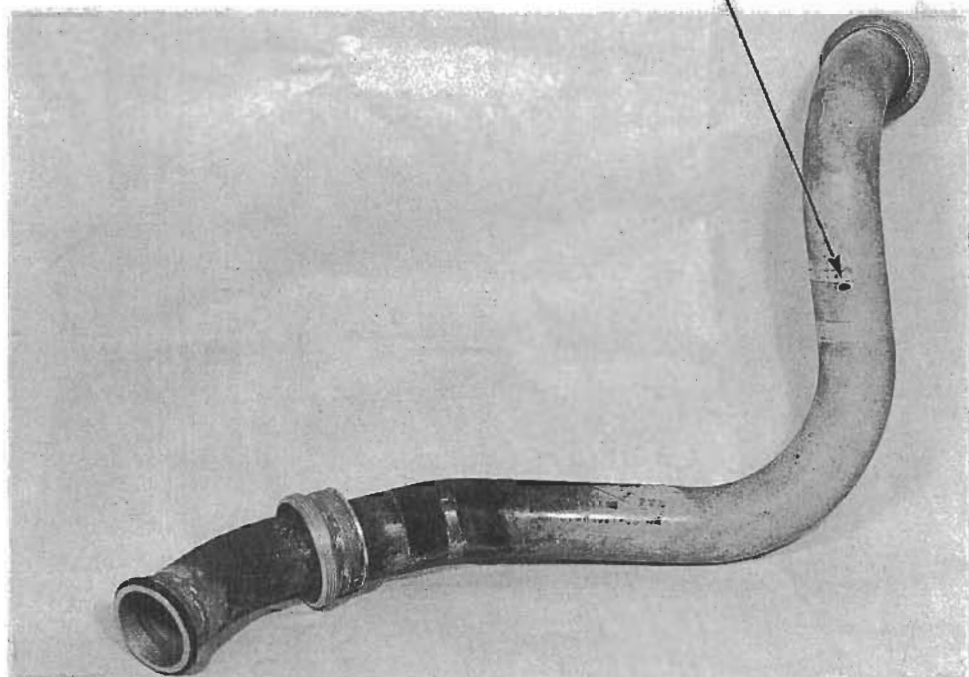
Photo. 3 No. 2 Engine Fuel Feed Pipe

Damaged Portion of No. 2 Engine Fuel Feed Pipe (Hole)
