**MARINE ACCIDENT
INVESTIGATION REPORT**

Vessel type and name: Vehicles Carrier PYXIS

Accident type: Fire

Date and time: About 0948 hrs (JST), October 14, 2008

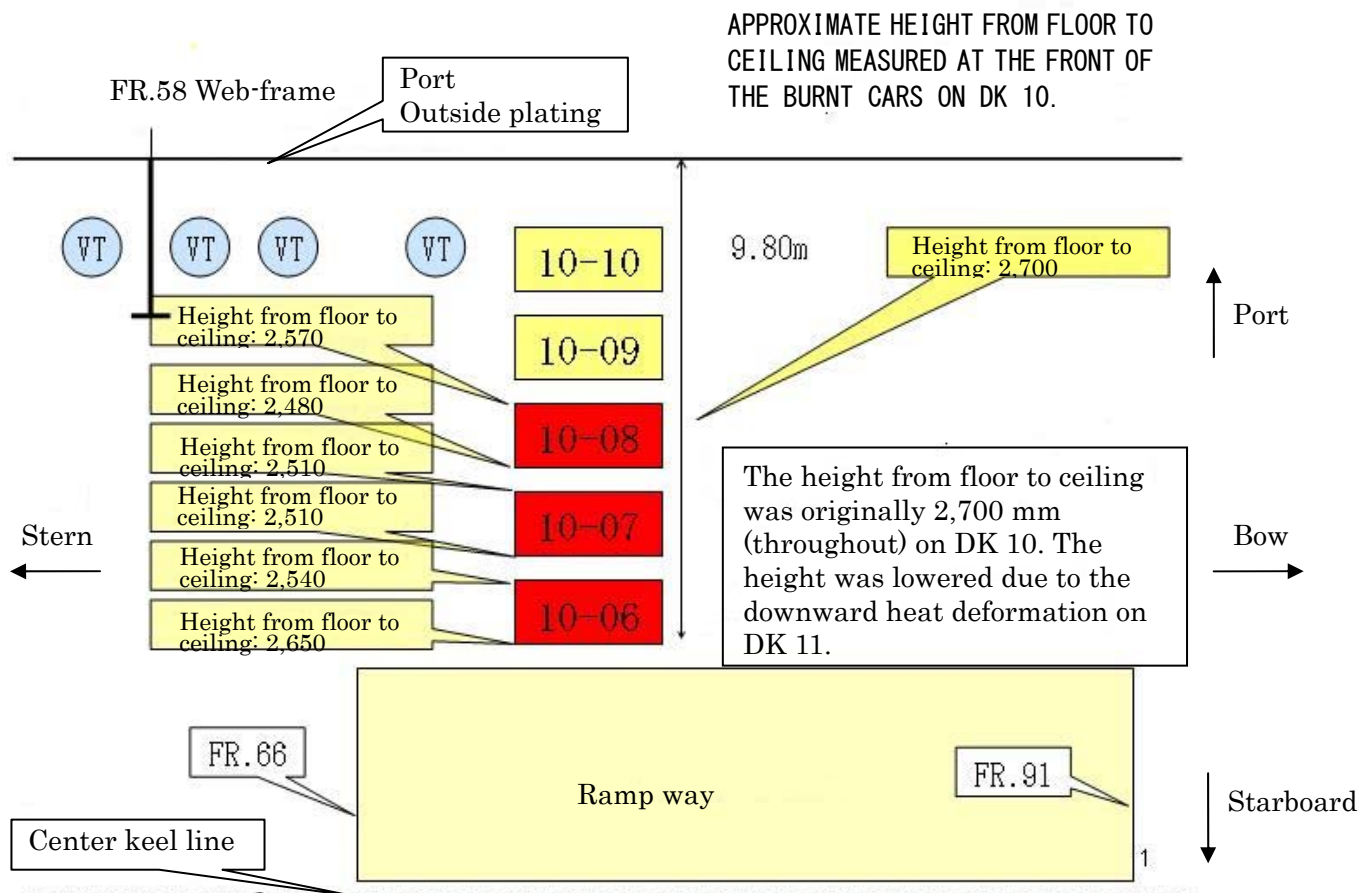
A strip of paint on the surface, about 10 m wide and about 21 m long, from the port outside plating of HLD 3 to the Center keel line was burnt away, and the structural materials in beam frame No. 70, supporting DK 11, were melted down to about 220 mm at most due to heat.

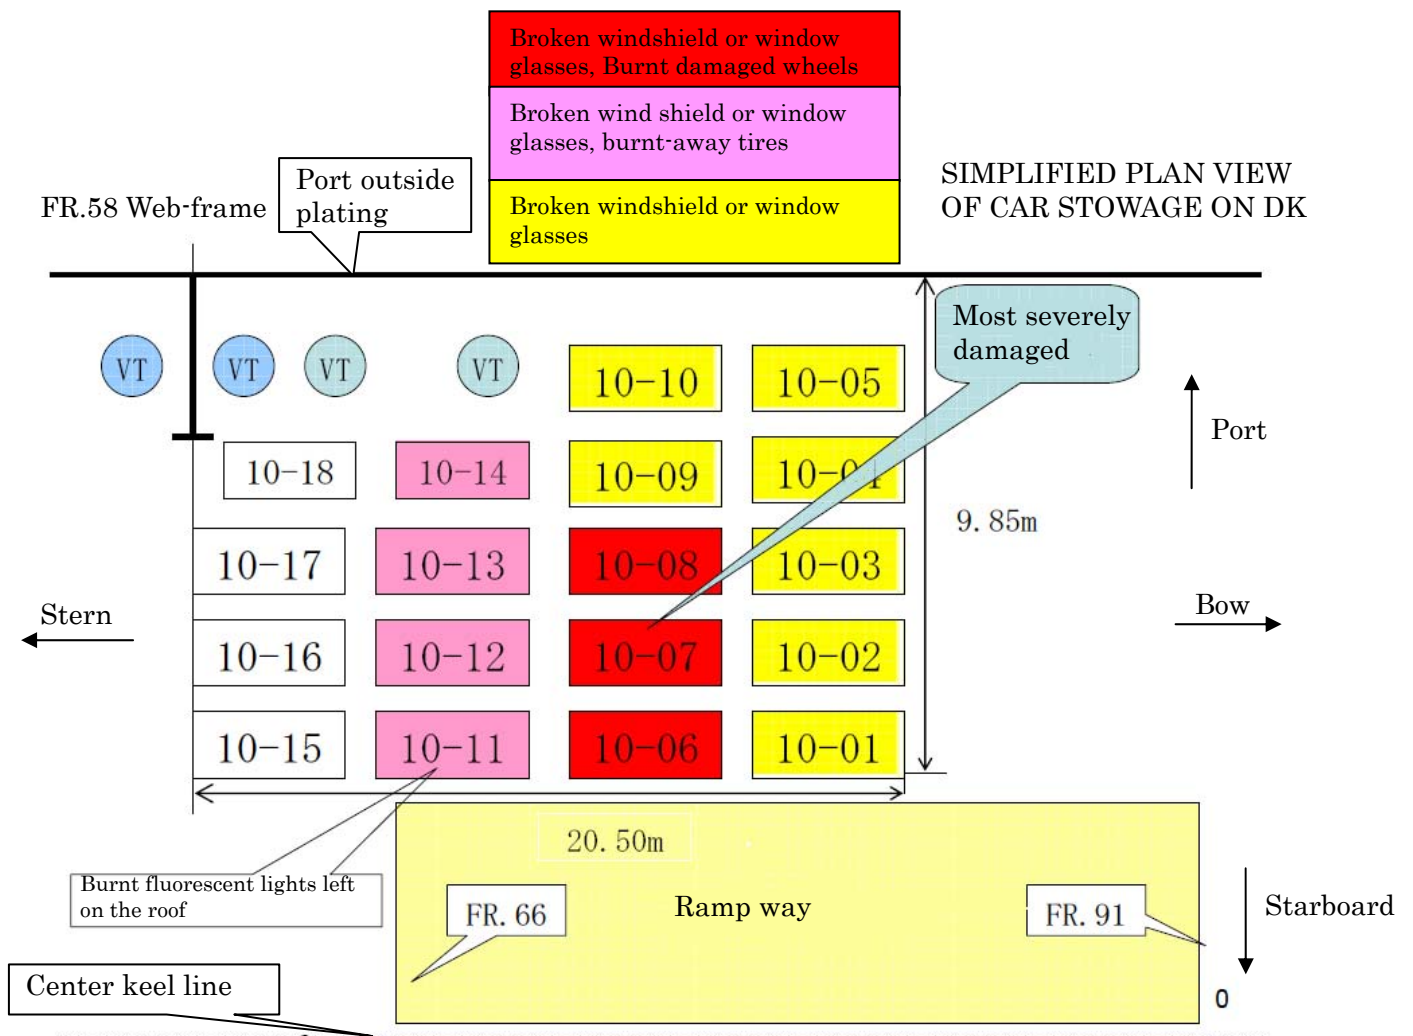
Of the cars loaded on the port side of the ramp way and facing the stern direction in frames 66 to 91, 14 cars received severe burnt damage.

Car 10-06, car 10-07 and car 10-08 received very severe damage, but the most severely damaged car was car 10-07. This car was burnt inside the engine bay, and all the paint on both sides of the body was burnt away. Also, signs that fire had spread to the fuel intake of the fuel tank and to the rear trunk were found.

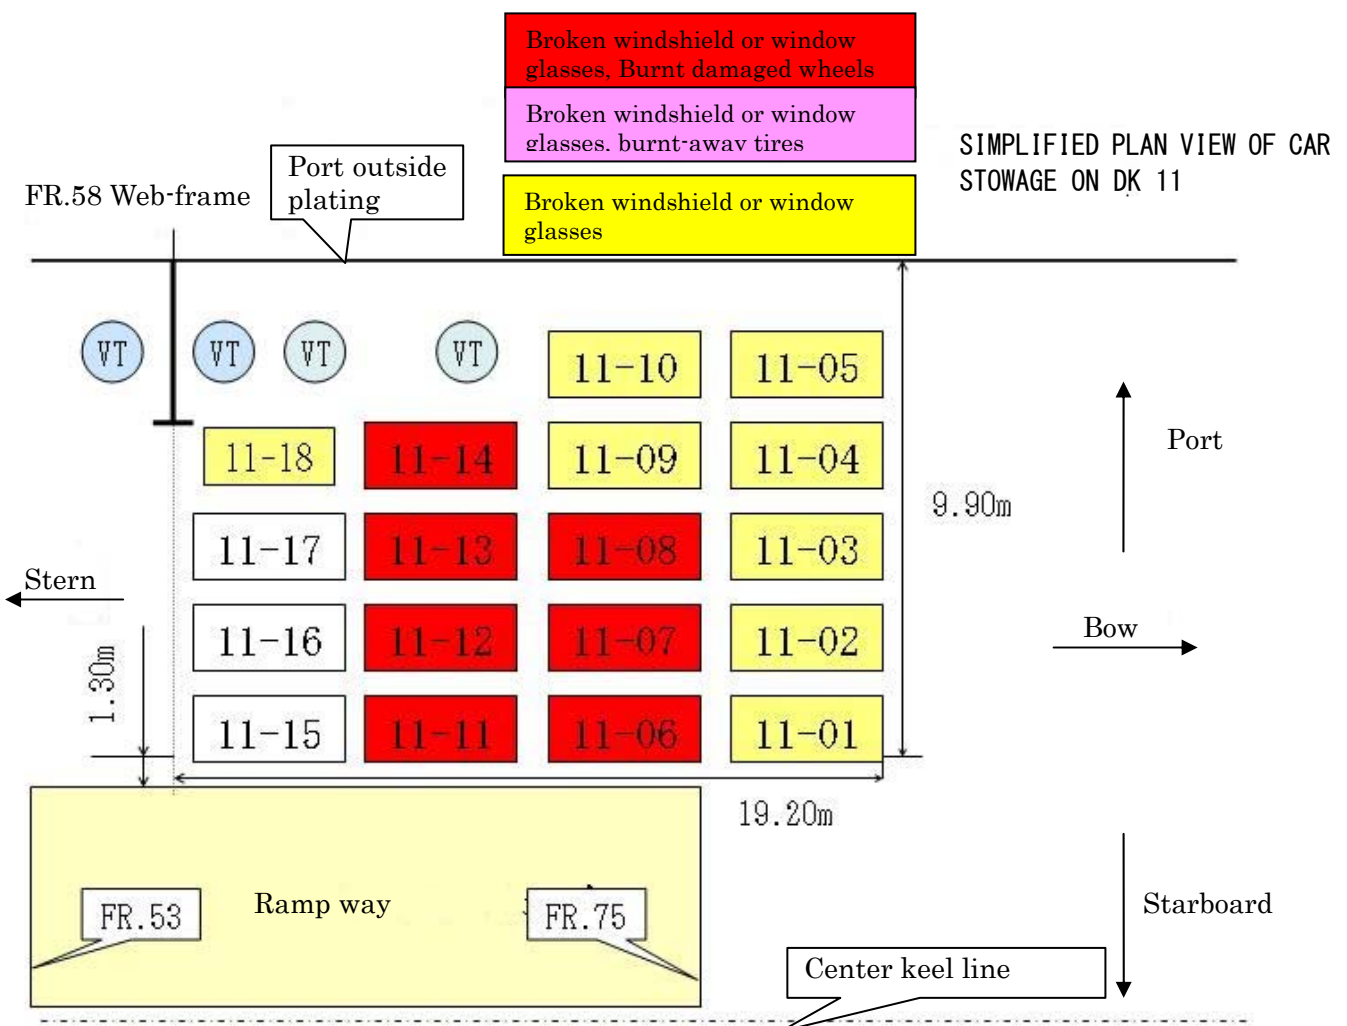
Of the cars loaded facing the stern direction on the port side of the ramp way on DK 11, the 15 cars that were placed approximately directly above the burnt car on DK 10 received severe damage.

The damage appeared to be caused by the heat coming from the lower layer through the holes for lashing clasps in the deck floor. The situation of the melting or burning away was less severe than the burnt cars on DK 10 but severer than the burnt cars on DK 12.

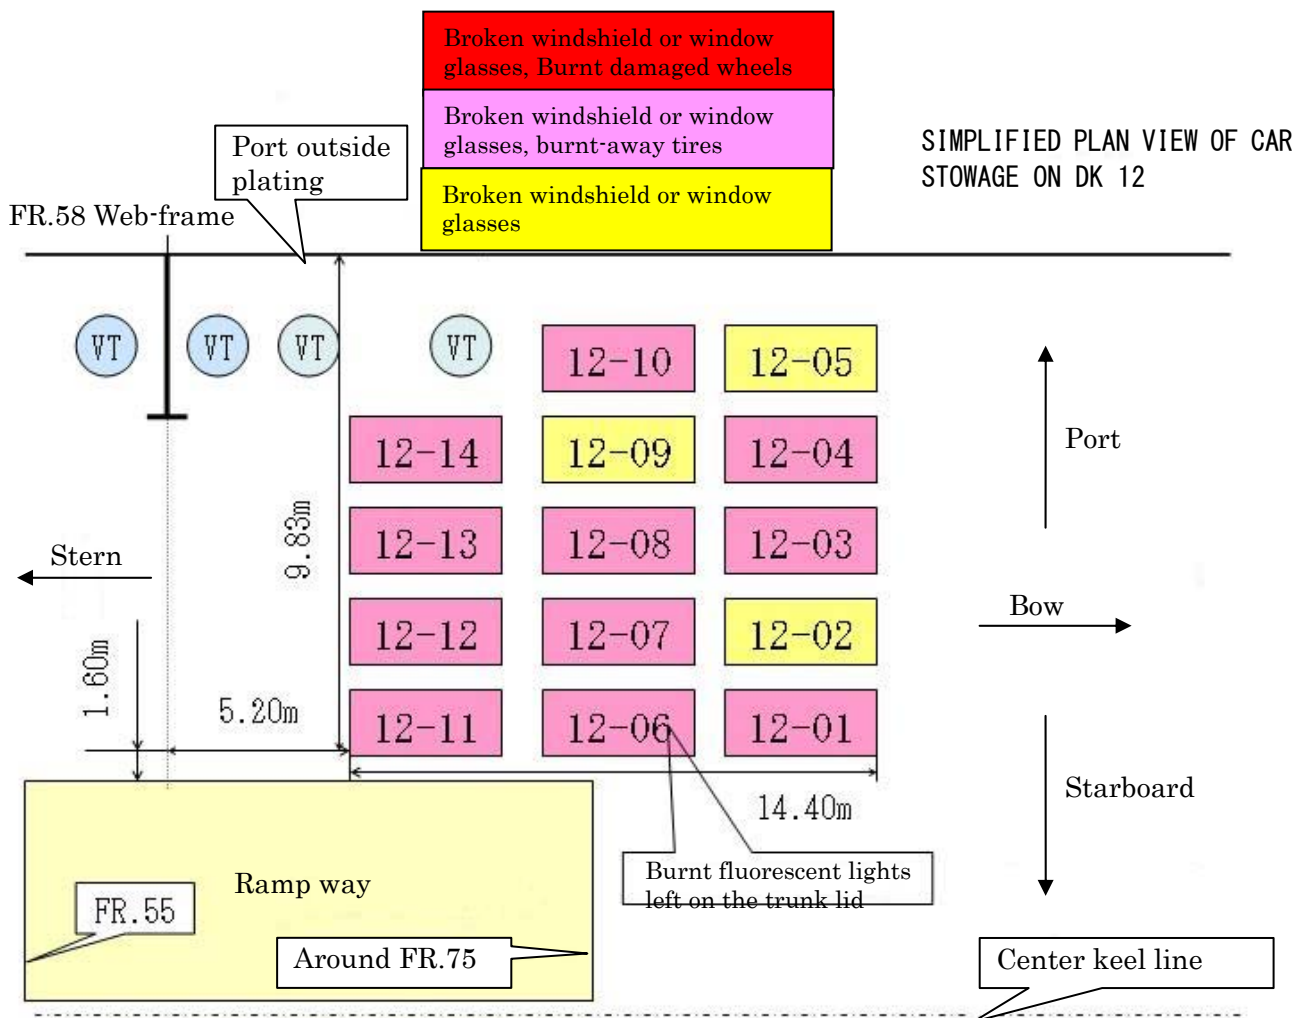
Of the cars placed facing the stern direction on the port side of the ramp way on DK 12, the 14 of the same type, which were placed almost directly above the burnt cars on DK 11, received the most severe damage.

Like the burnt cars on DK 11, the cars on DK 12 appeared to be burnt at first on the bottom by the heat coming through the openings on the deck.

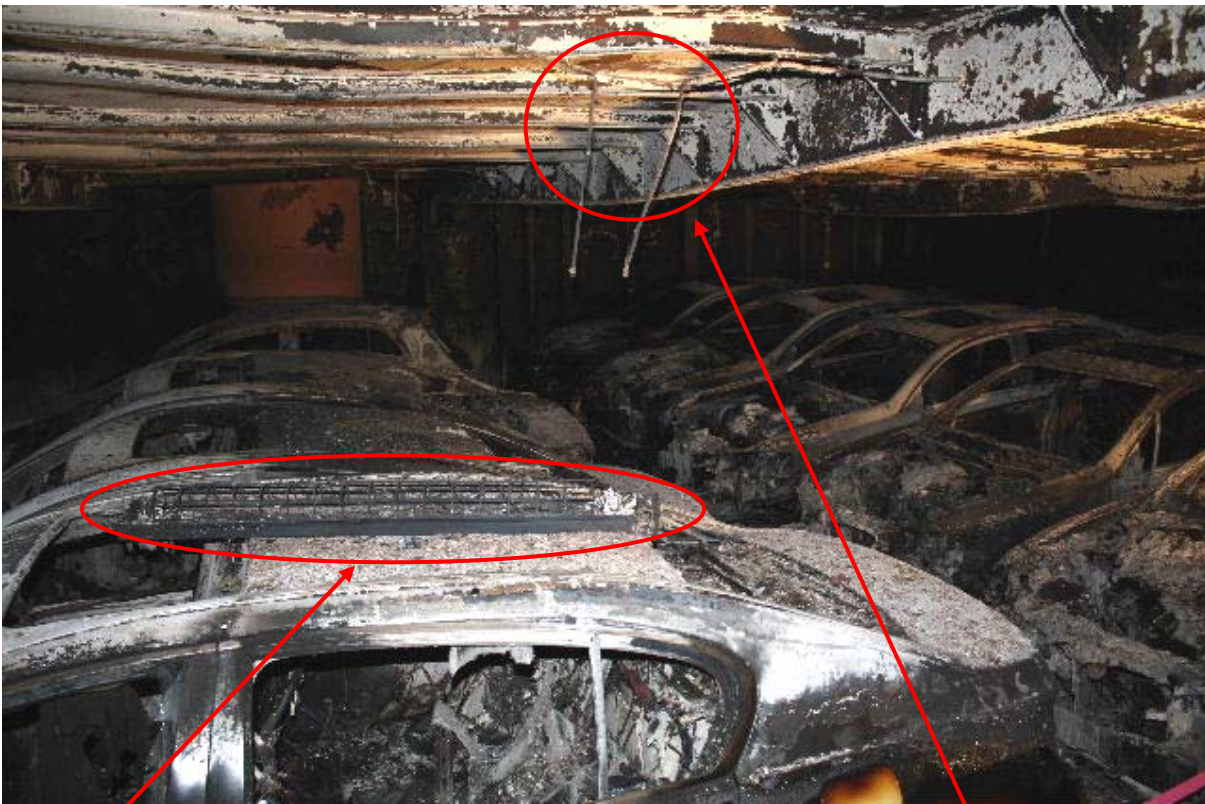
Photo 2: Fire Damage Situation of DK 10 Ceiling

Paint was burnt away

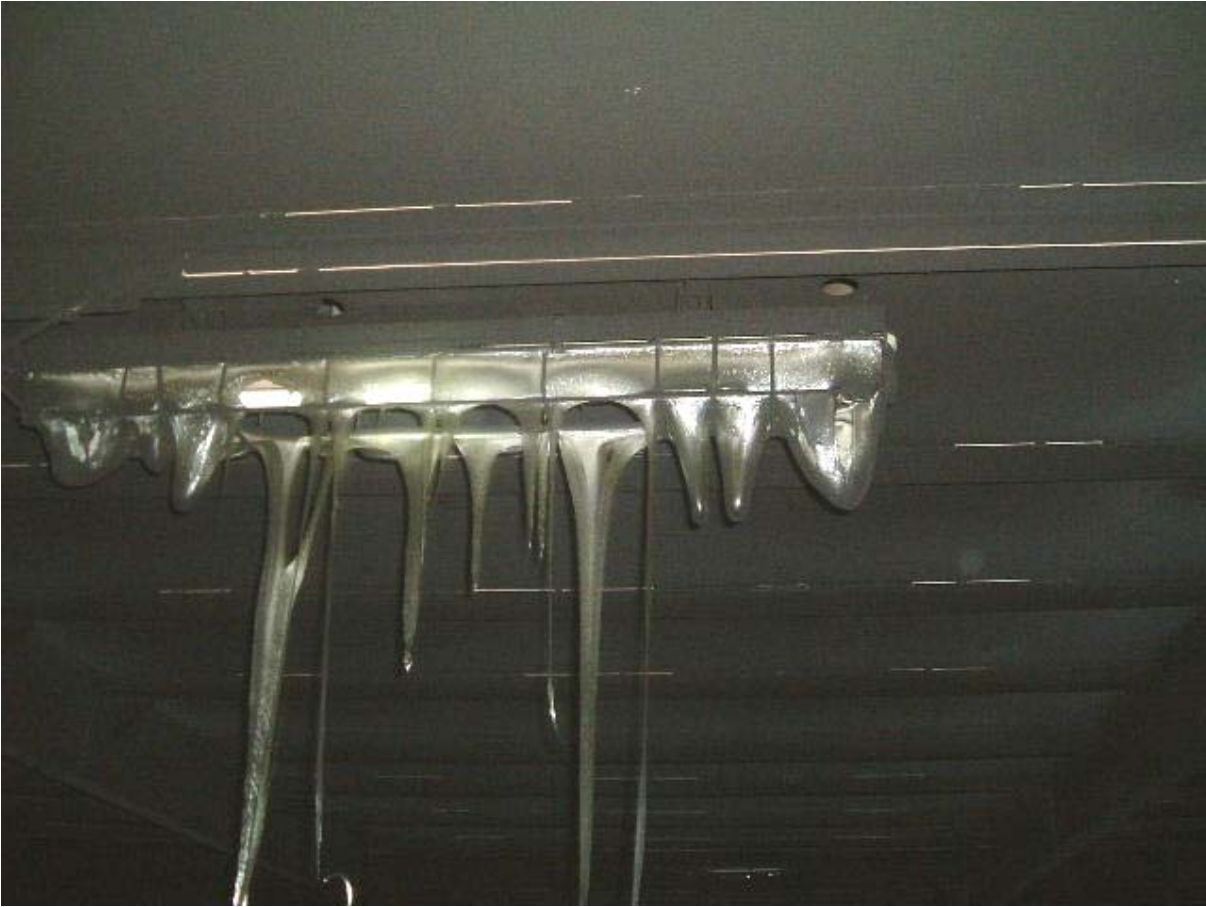
Photo 3: Fire Damage Situation of Fluorescent Lights

On DK 10 to DK 13, the plastic covers of some of the fluorescent lights on the ceilings melted, and the fluorescent bulbs were broken or some of the lights were down on the floor due to coming off the mounting equipment.

On DK 10 and DK 12, one fluorescent light in each deck had fallen due to the mounting gear being burnt up. The installation location of those fallen lights was not above the most severely

A fluorescent light was found to have fallen here

The light had been attached

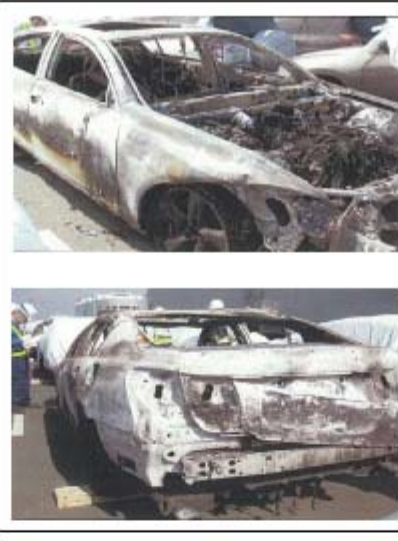
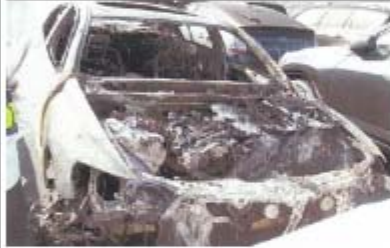
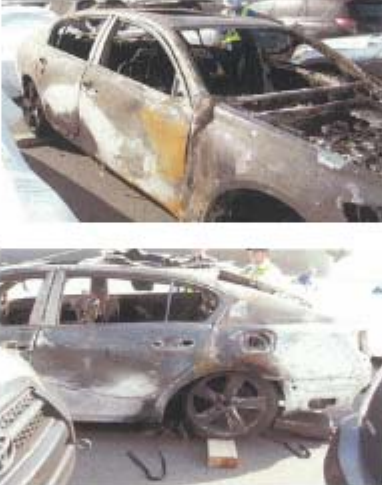
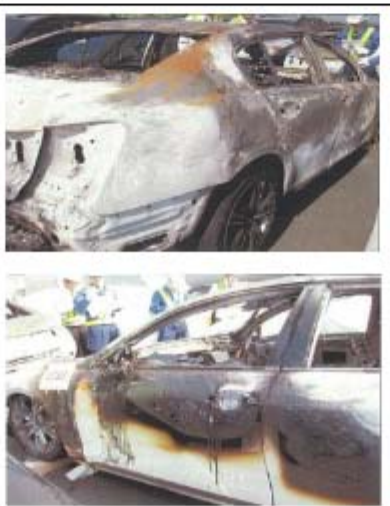
Photo 4: Fire Damage Situations of Cars on DK 10

Cars next car 10-07, such as car 10-06 on the starboard side, car 10-08 on the port side, car 10-02 on the bow side and car 10-12 on the stern side, received severe damage on their bodies, and tires and aluminum wheels nearest car 10-07, and received damage partially on their bodies on the opposite side of car 10-07.

(a) As for electric circuit systems, in the three most severely damaged of the 14 cars, no fuses were found to have melted, while in the other 11 cars, the fuses were found to have melted and were identified later as the results of secondary short circuit¹⁷ of the electric cables or between the cables and the body due to cable coating being melted or burnt away.

(b) As for fuel systems, although the fuel tanks of the three most severely damaged cars were found to have received burnt damage, no burnt damage was found inside of those tanks, and some of fuel was vaporized, some remained. As for the other 11 cars, in 2 cars, similar situations were found.

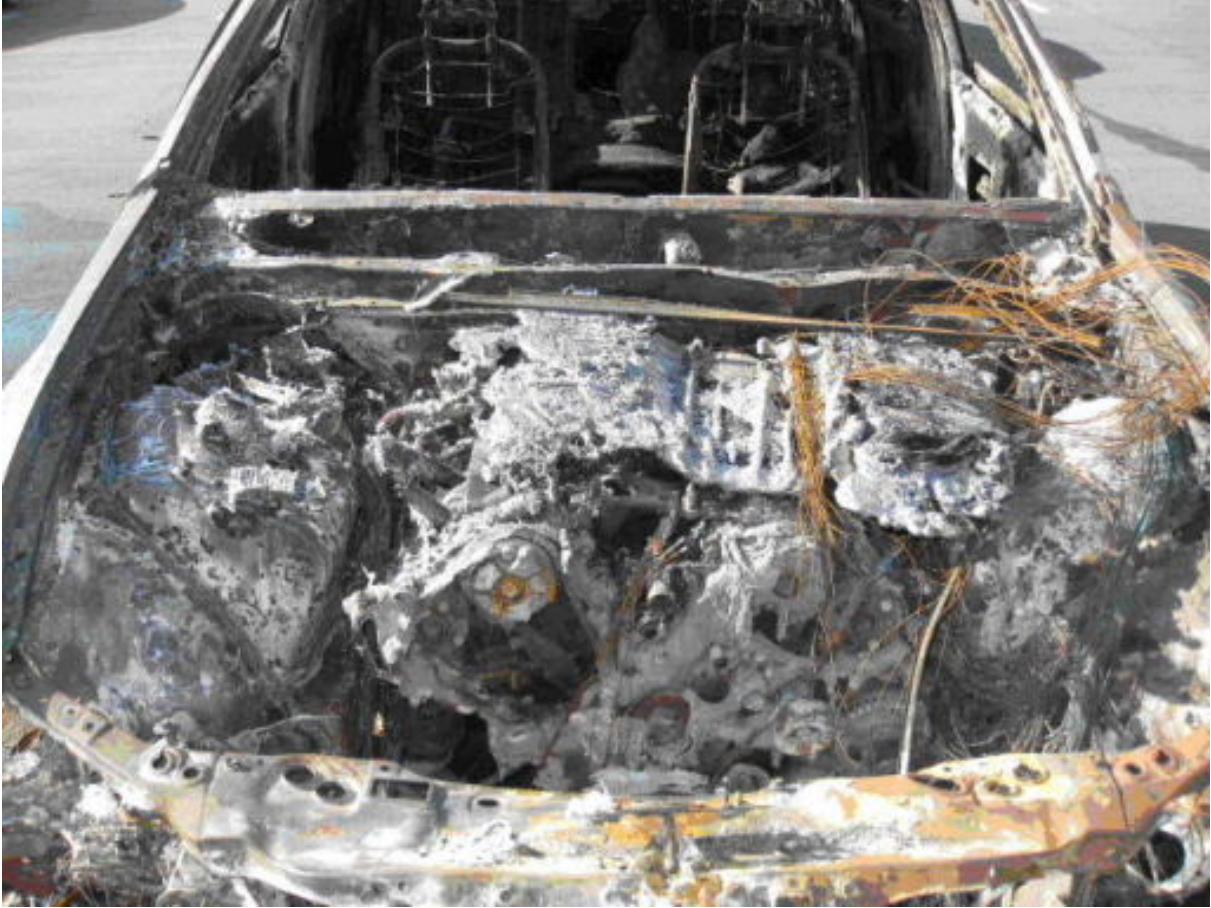
Photo 16: Fire Damage Situations of Car 10-07 Engine Bay

Although the cause of fire in the engine bay of the car remains unidentified, the possibility that it was the electric equipment in the ship or the handling of fire such as smoking, or that the electric system of the car was involved cannot be completely denied. Therefore, it is desirable that Company A should motivate crew members to be more sensitive to fire protection, execute stricter controls on fire-handling, inspect electric equipment in cargo holds more strictly; and the automobile manufacturing company should give more consideration to fire protection starting from cars in transportation.
