MA2011-6

**MARINE ACCIDENT
INVESTIGATION REPORT**

Vessel type and name: Cargo ship RICKMERS JAKARTA

Type of accident: Accident with workers injuries and a fatality

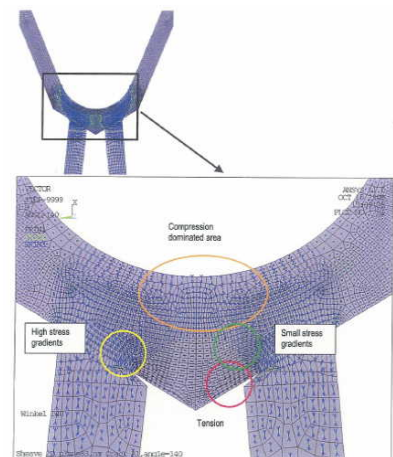
FEM Vector plot of principal Stress (without crack)

High stress gradients were obtained close to the welded parts of the rim and the web. The crack started not at the welding part.

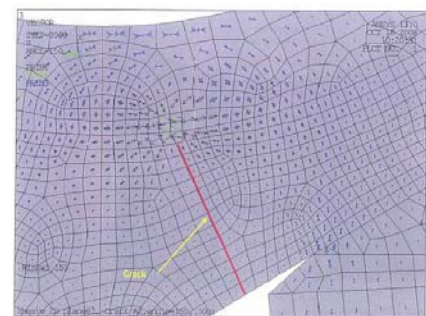
FEM Vector plot of principal Stress (8 mm crack)

The results as vector plots of the principal stress (8mm crack) shown that highest stress gradients occurred at the end point of the crack.

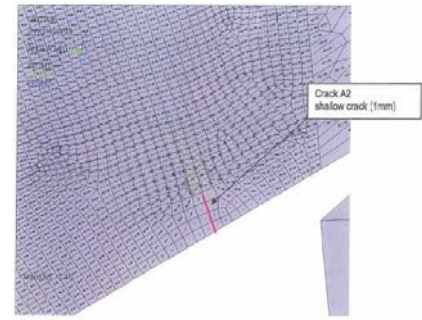
FEM Vector plot of principal Stress (1 mm depth crack)

The results as vector plots of the principal stress (1mm crack) shown that highest stress gradients occurred at the end-point of the crack.

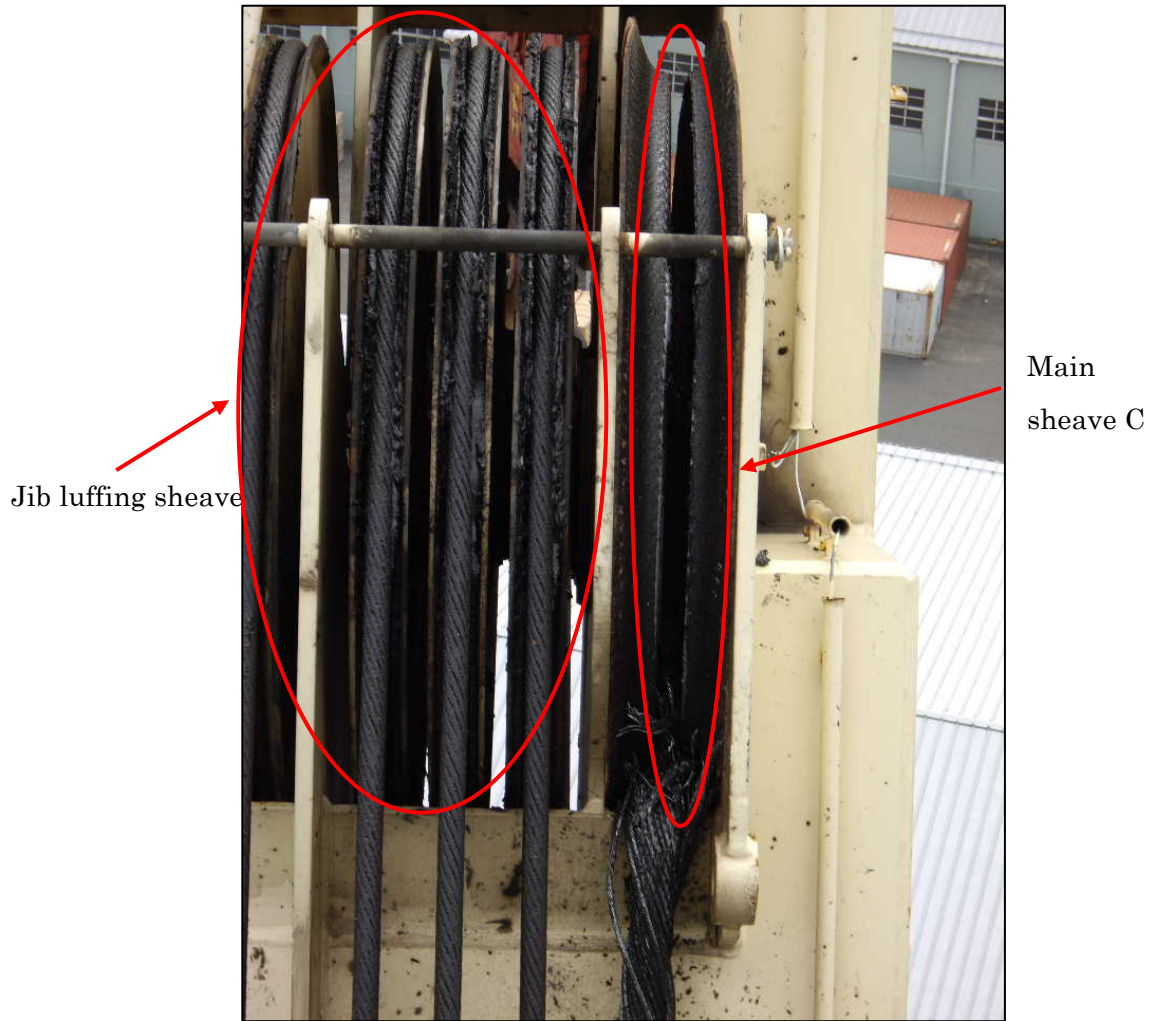
Picture 3—Sheaves at the end of Jib (Crane No.3)

According to the pictures taken immediately after the accident, the rim of Main Sheave C was fractured, and rust was observed on the rim's fractured surface on the backside of the wire guide surface.

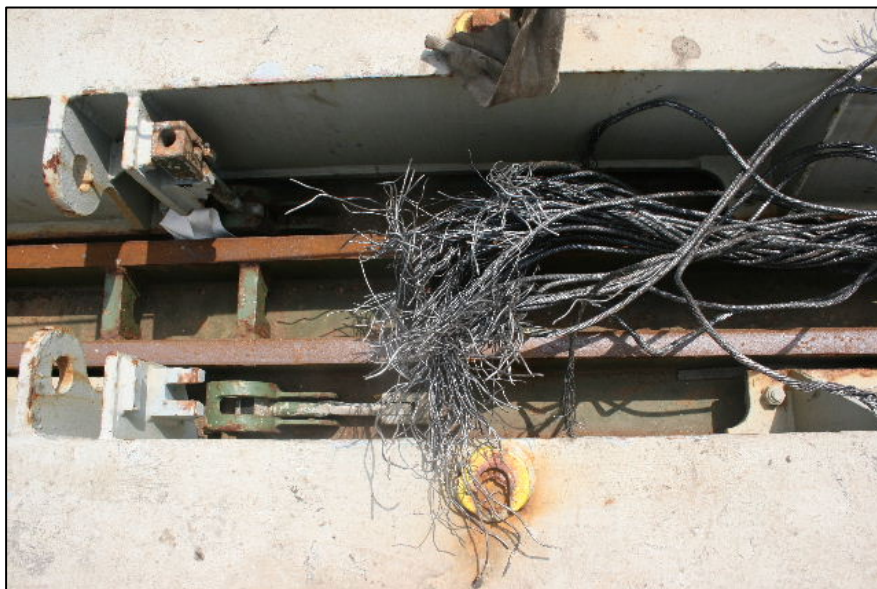
Picture 6—the Main Wire at its Break Point

But then at the broken part and in its vicinity, the plastic coating covering the core strands

were destroyed, and found damages of the outer wires and strands.

From the findings described above, it could be concluded that the broken Main Wire neither had defects in terms of strength nor any problems in terms of quality. The accident was the result of secondary damage by the impact load.

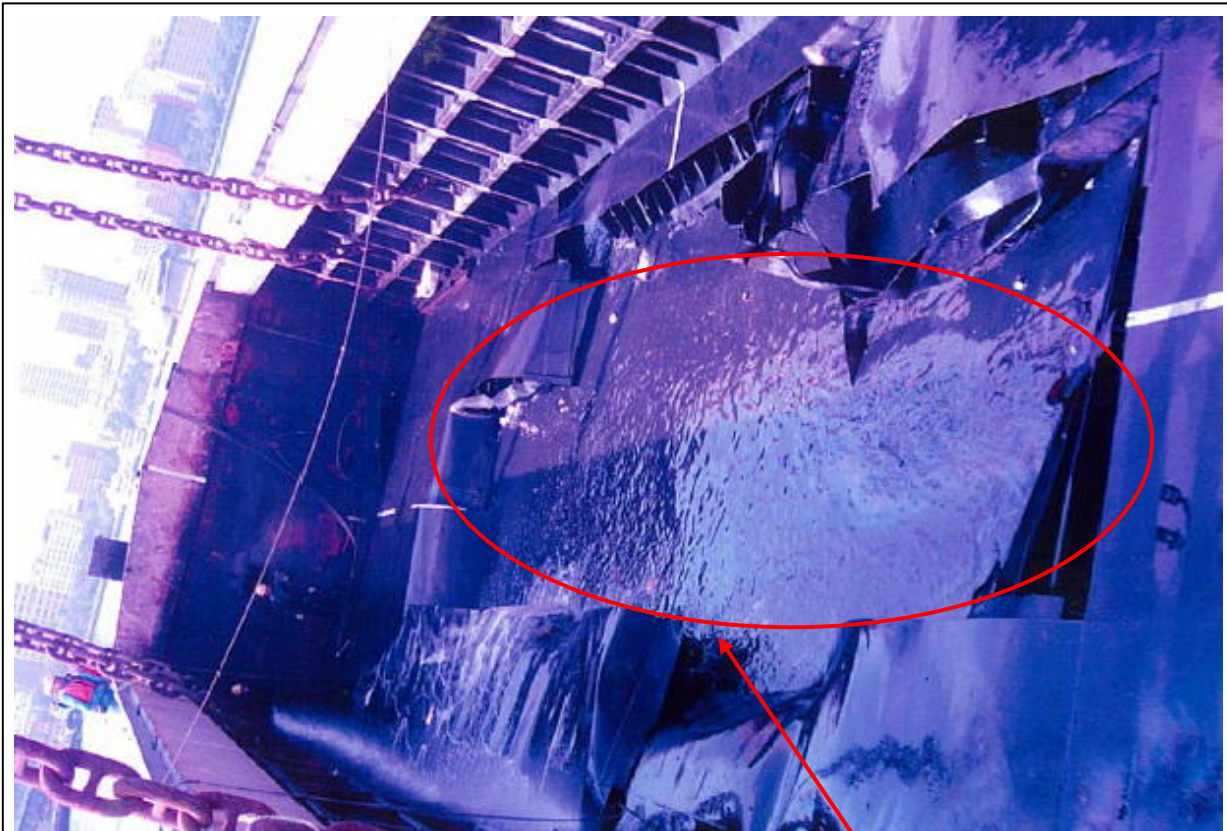
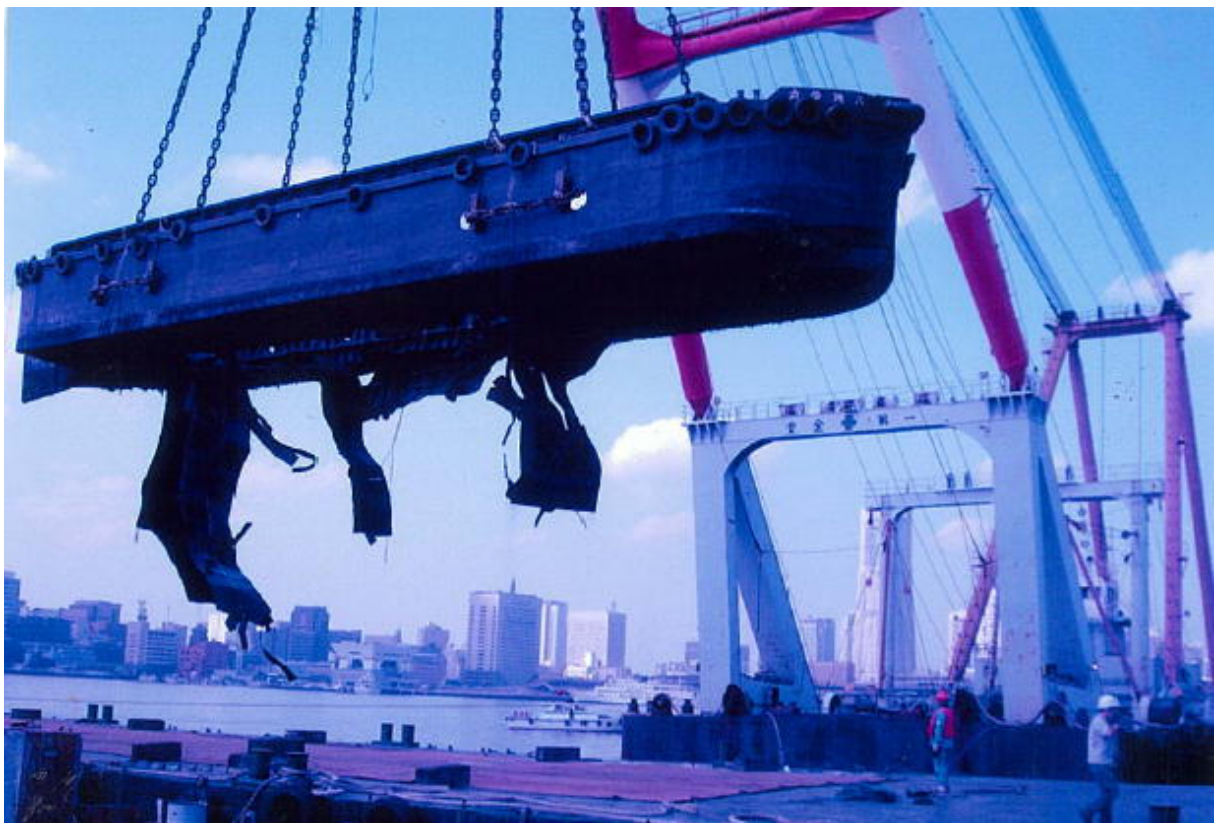
Picture 7—Vessel B Salvaged

In early evening of the day of the accident, the divers that were searching for Stevedore C1 found him on the sea bottom, and he was confirmed dead. Among the four rescued persons, three were bruised. Vessel B suffered breaking and getting hole at the bottom plate and lead to sank by the falling the Cargo.

Hole created by the accident

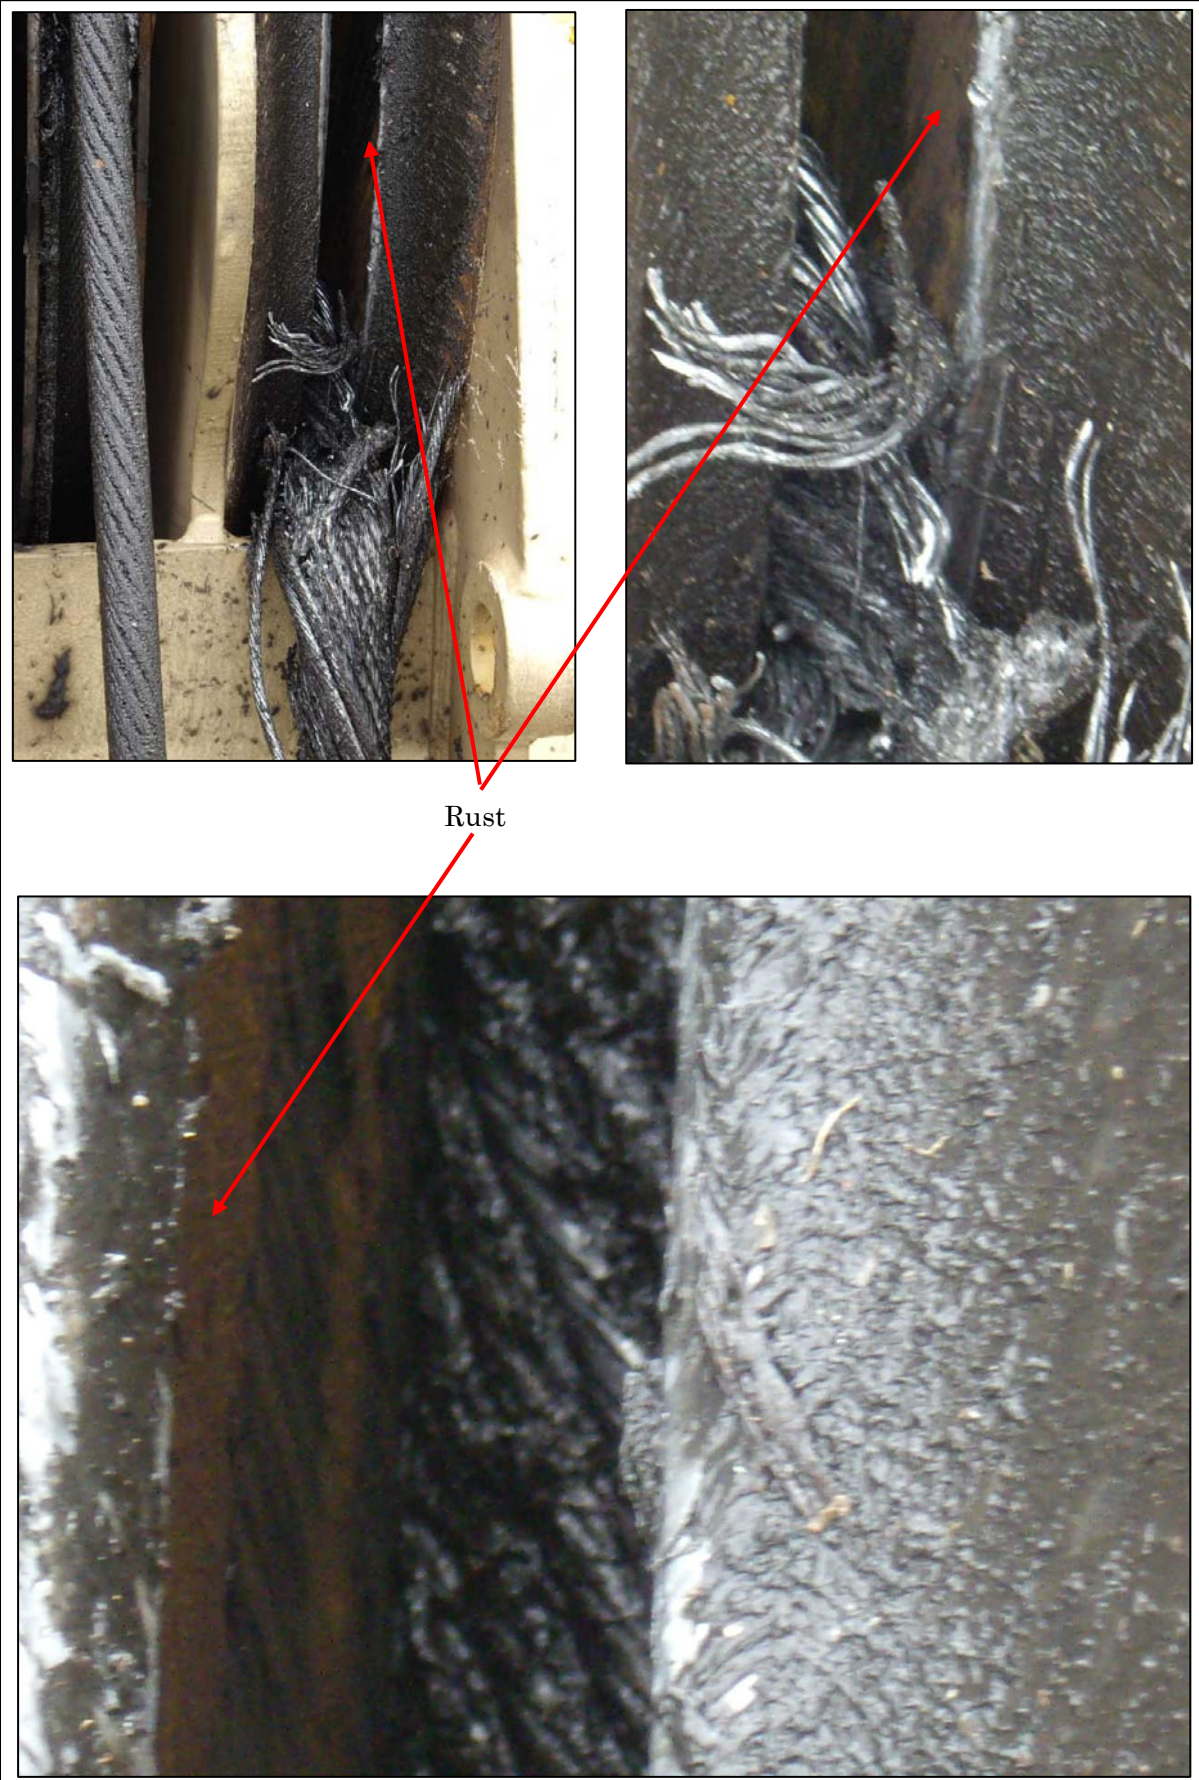
Picture 10—Fractured Main Sheave C and Rust Formation

- (a) Appearance of fractured surface
 - (i) The Rim of Main Sheave C was totally broken and rust was observed in some parts of the fractured surface located on the backside of the wire guide surface. The appearance of a brittle Cleavage fracture¹⁵ at most part of fractured surface could be seen, but hardly to find any

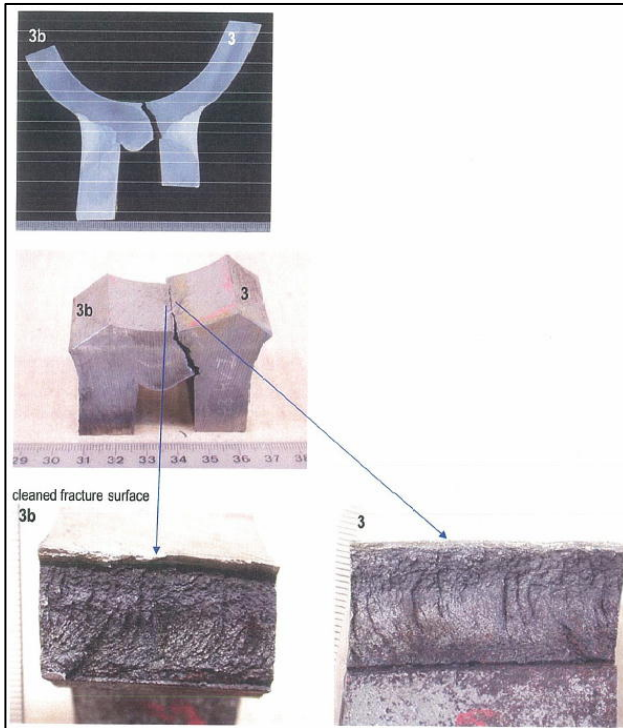
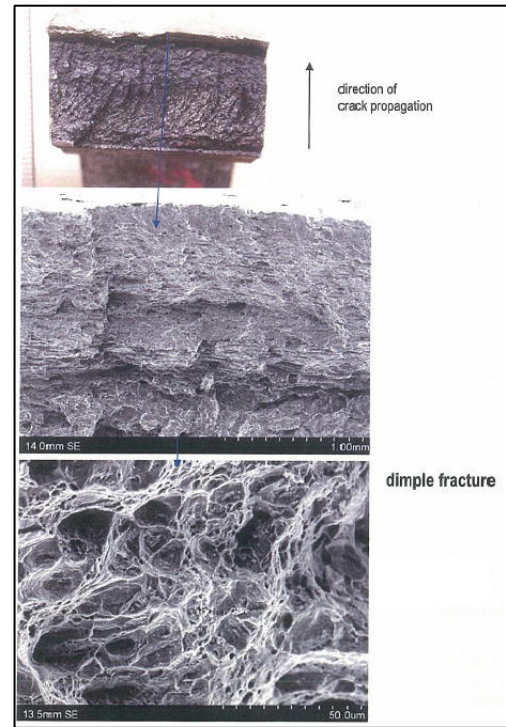
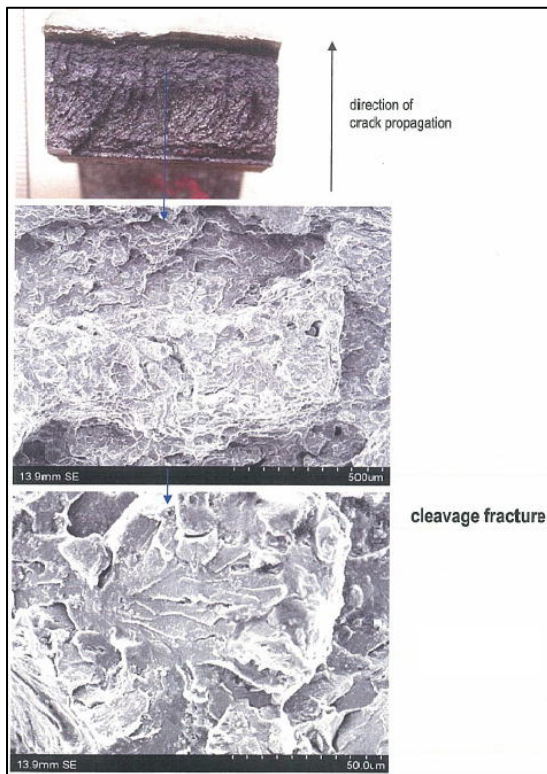
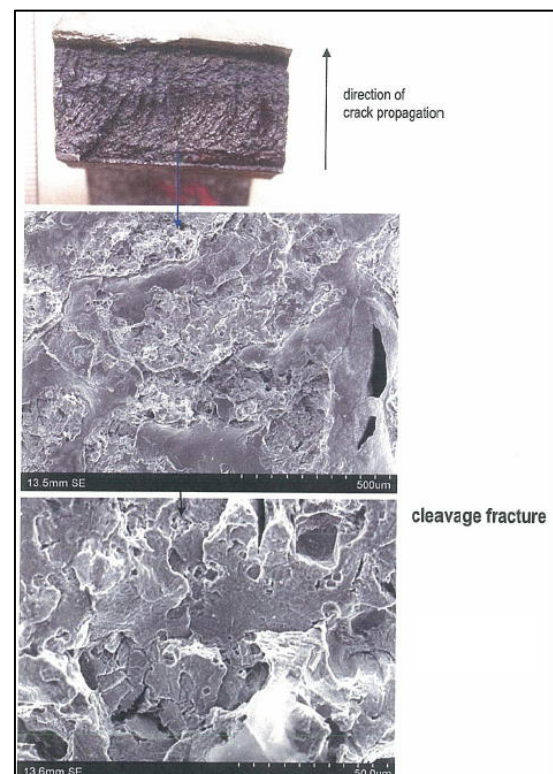
Picture 11—Inspection by Electron Microscope

contraction in the through-thickness direction (typically observed in ductile fractures¹⁶) was observed.

(ii) Ductile dimple¹⁷ fractures were observed in a part of present near the outer surface of the rim.

(iii) Any fatigue-fracture surfaces¹⁸ were not found in the fractured surface.

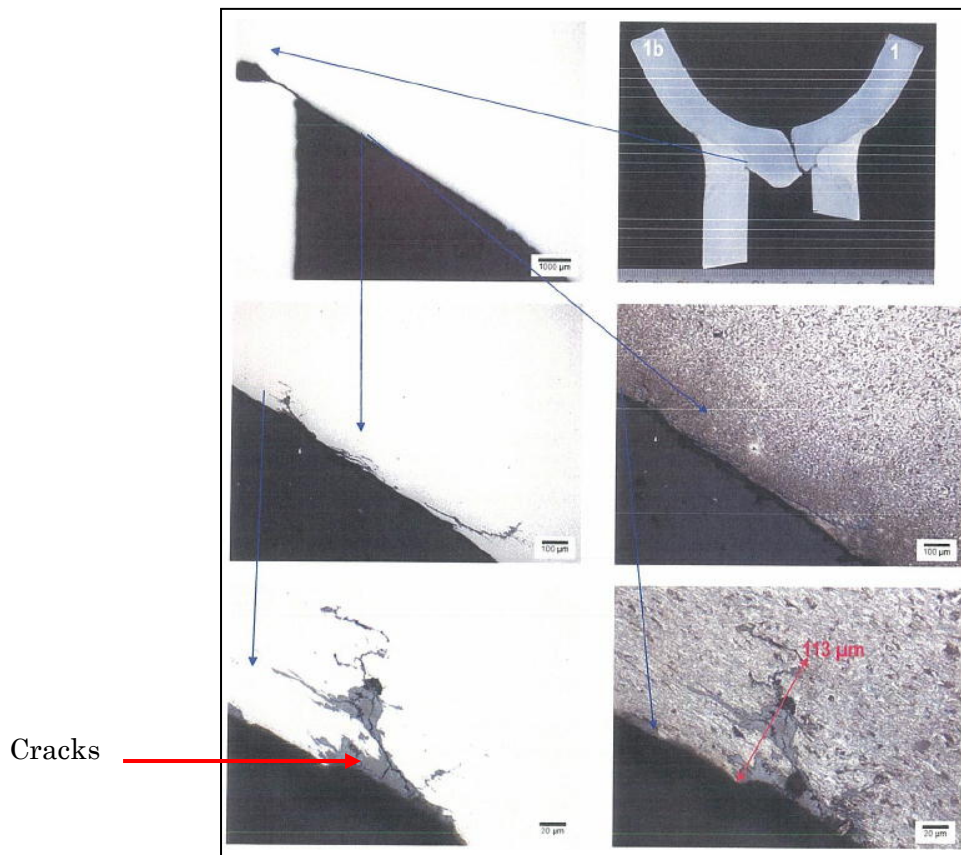
Picture 13—Backside of Wire Guide Surface (cracks found in Main Sheave C)

According to the observation of welded parts between the rim and web, the crack propagation path did not pass through the root of the welding²¹ and could not find the sign of cause of the fracture although the welding have no complete penetration.

Microscopic observation²³ of the rim revealed, on the backside of the wire guide surface, small crack-like overlapping and rolled-in scale²⁴ that occur in the rolling²⁵ process of material production were found. These cracks had depths of 75–113 μm and were filled with oxidized scale. Although the wire guide surface showed a normal metallic structure, the micro structure of the backside of the wire guide surface was stretched significantly and squeezed due to high deformation and, in addition, the micro hardness increase and the tenacity reduce.

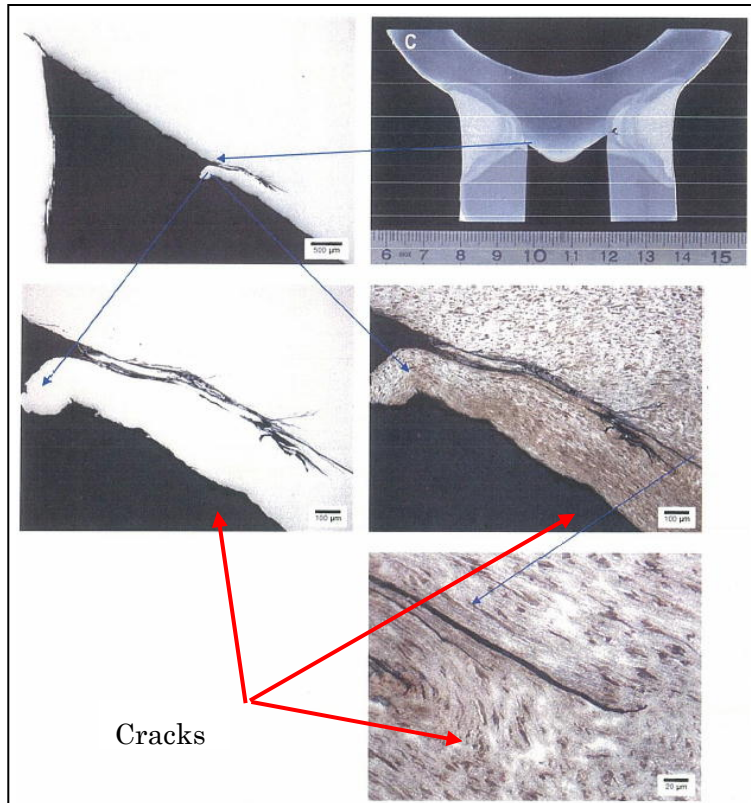
Picture 14—Backside of Wire Guide Surface (cracks found in unfractured Sheave E)

showed, on the backside of the wire guide surface, small crack-like overlapping that occur in the manufacturing process of the angle steel and rolled-in scale that occur in the rolling process of material production were present. These cracks had depths of 62–117 μm and were filled with oxidized scale.

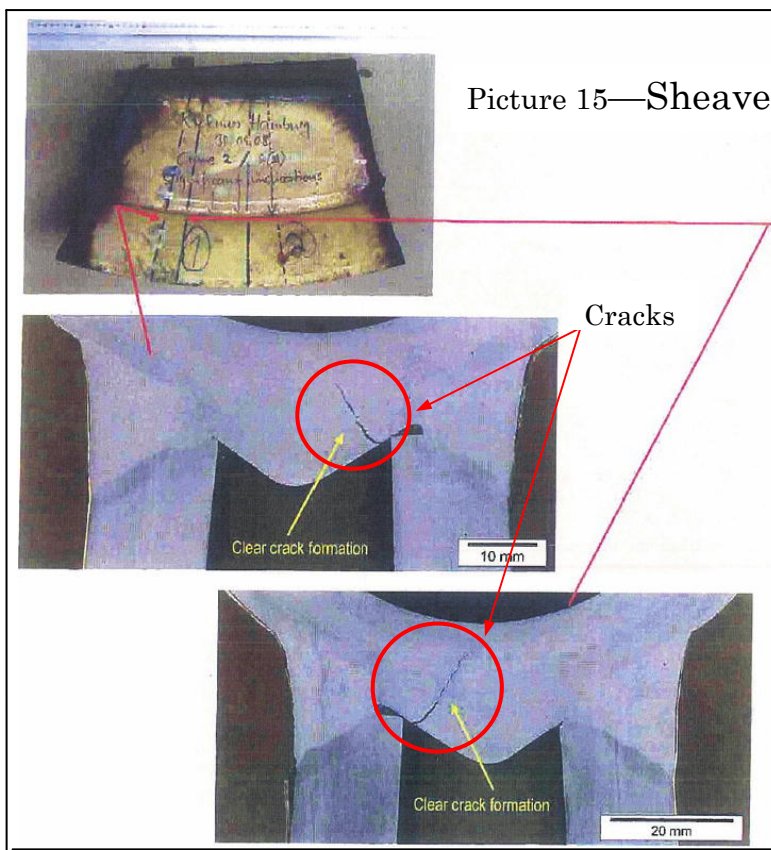
Picture 15—Sheave of a sister ship

Sheaves sampled from Cranes No.2 and No.3 of sister ship were examined. Large cracks were present on the backside of the wire guide surfaces of these sheaves and small crack-like overlapping and rolled-in scale that occurred in the rolling process of material production were present.

Note that no fatigue-fracture surfaces were found in these large cracks.

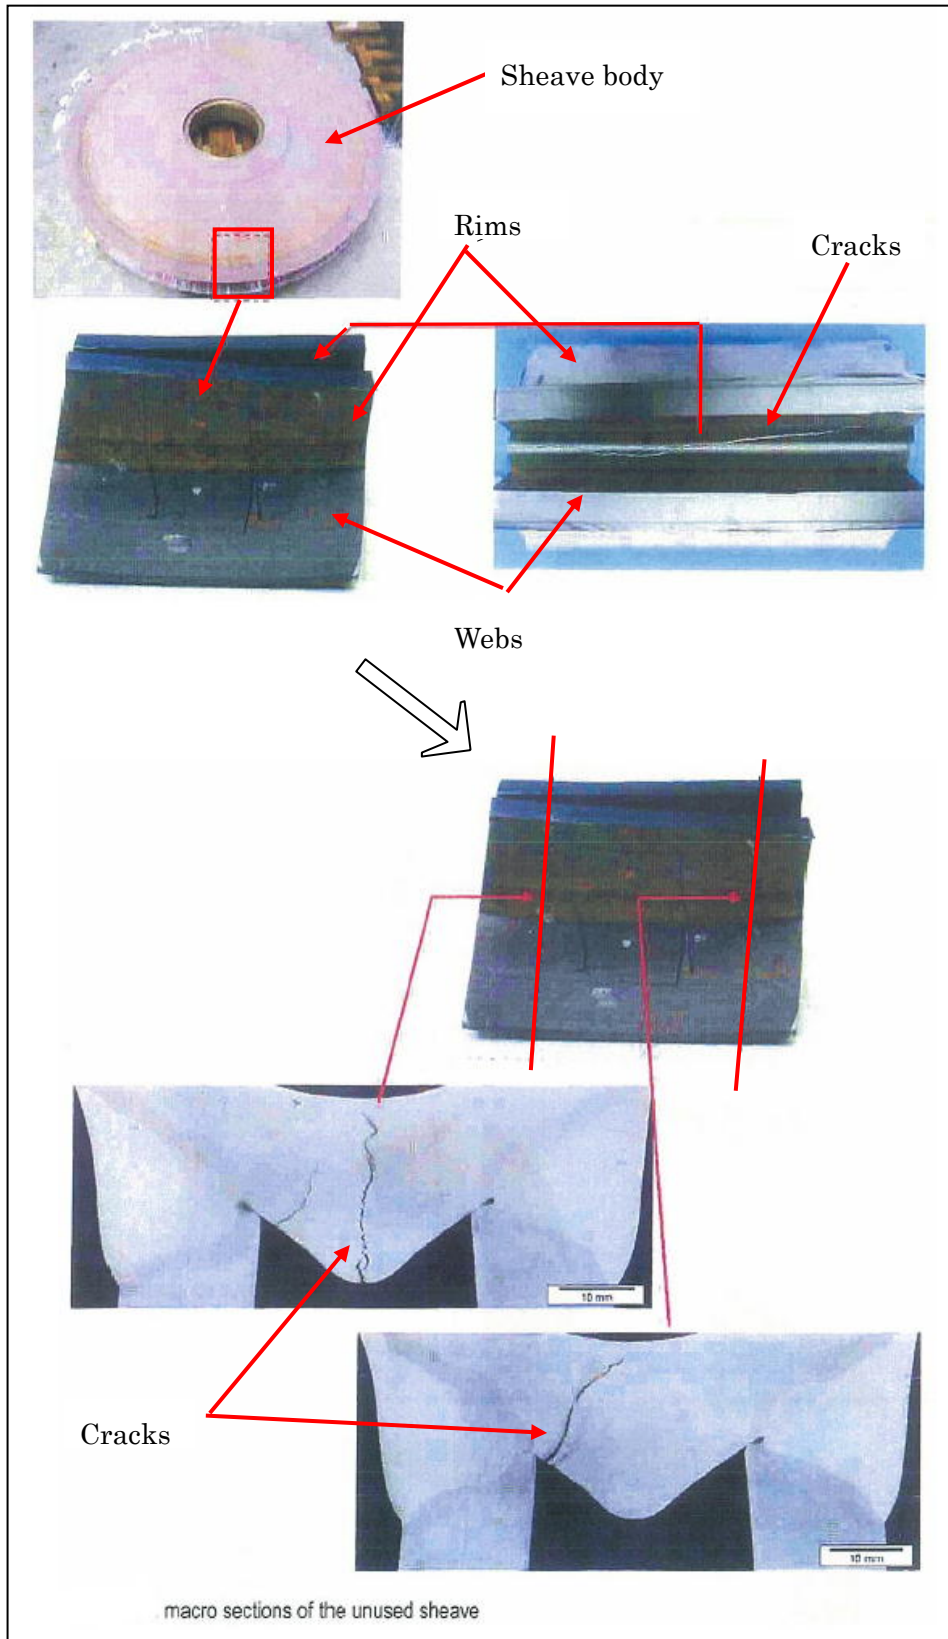
Picture 16—Cracks found in Unused Sheave

In the examination of the unused sheave, cracks that run from the backside of the wire guide reach to near of the wire guide surface were present, and elastic deformation²⁶ was observed relating to these cracks, indicating the persistence of residual stress²⁷ that possibly occurred in the cold forming process during the rim manufacture and the welding between the rim and web. Residual stress was not completely removed from the sheave.

Examination of a cut surface of the unprocessed L-shaped angle steel revealed the existence of the notched surface by formation of crack-like overlapping.
