**MARINE ACCIDENT
INVESTIGATION REPORT**

Vessel type and Name: Cargo ship MARINE STAR
IMO number: 9228629
Gross tonnage: 7,382 tons

Vessel type and Name: Container ship TAKASAGO
Vessel number: 135973
Gross tonnage: 499 tons

Accident type: Collision
Date and time: About 0615 hrs, February 20, 2009 (Local time, UTC+9)
Location: On the Bisan Seto East Traffic Route (off Sakaide Port, Sakaide City, Kagawa Prefecture)
Around 062° true, 2,300 m from Koseijima lighthouse, Sakaide City, Kagawa Prefecture
(Approximately 34°23.1'N, 133°52.5'E)

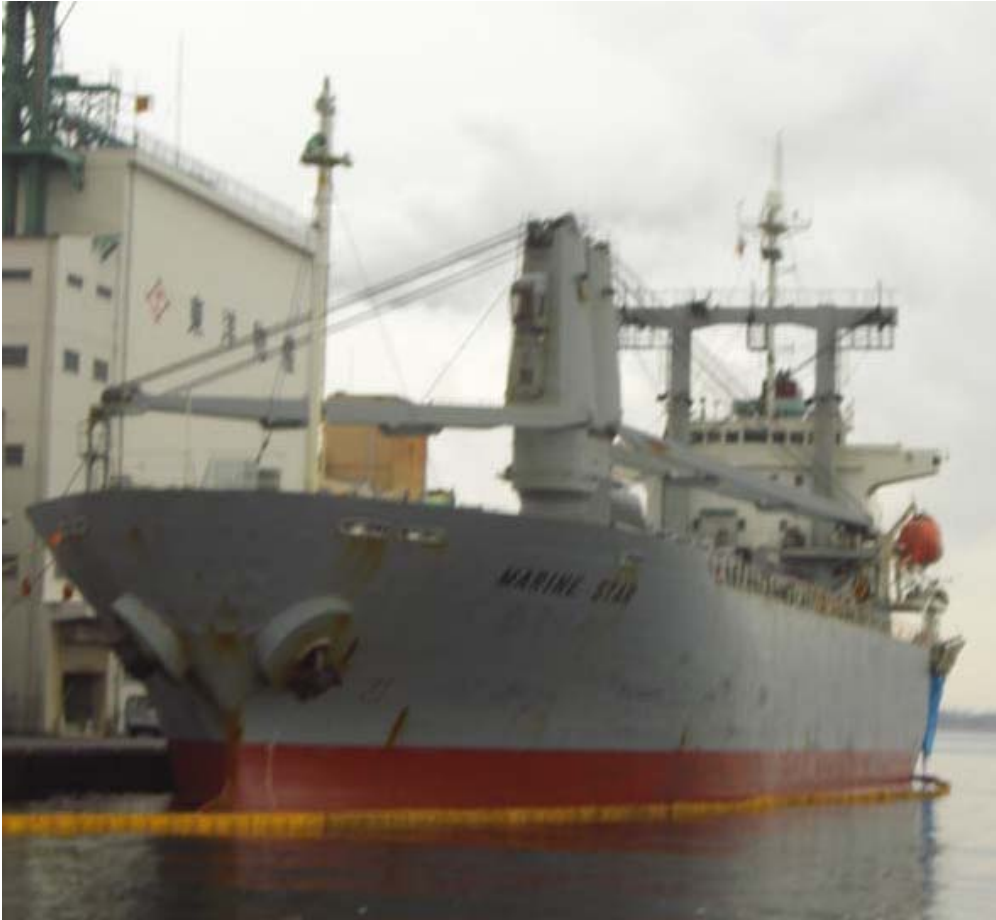
Photo 1: Condition of Ship A

MARINE STAR sustained damage in the form of dents on the port stern shell plate. TAKASAGO sustained damage in the form of dents to the bow. There were no casualties on either ship.

Breakage of the port side stern shell plate and the fuel pipes in the engine room
(Refer to Photos 1 to 3: Condition of Ship A)

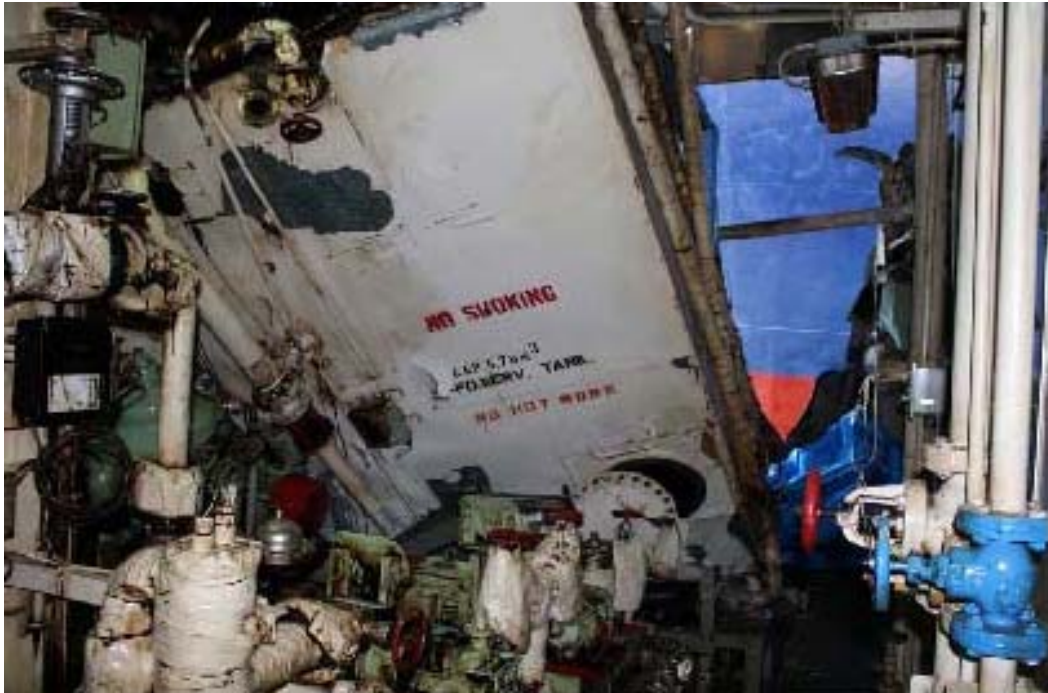
Photo 3: Damage to Ship A (Engine Room)

C/E A thought about explosions and stopped the main engine, because oil spilled out into the engine room from the fuel pipes damaged by the shock of the collision. Some of the spilled oil in the engine room flowed into the sea.

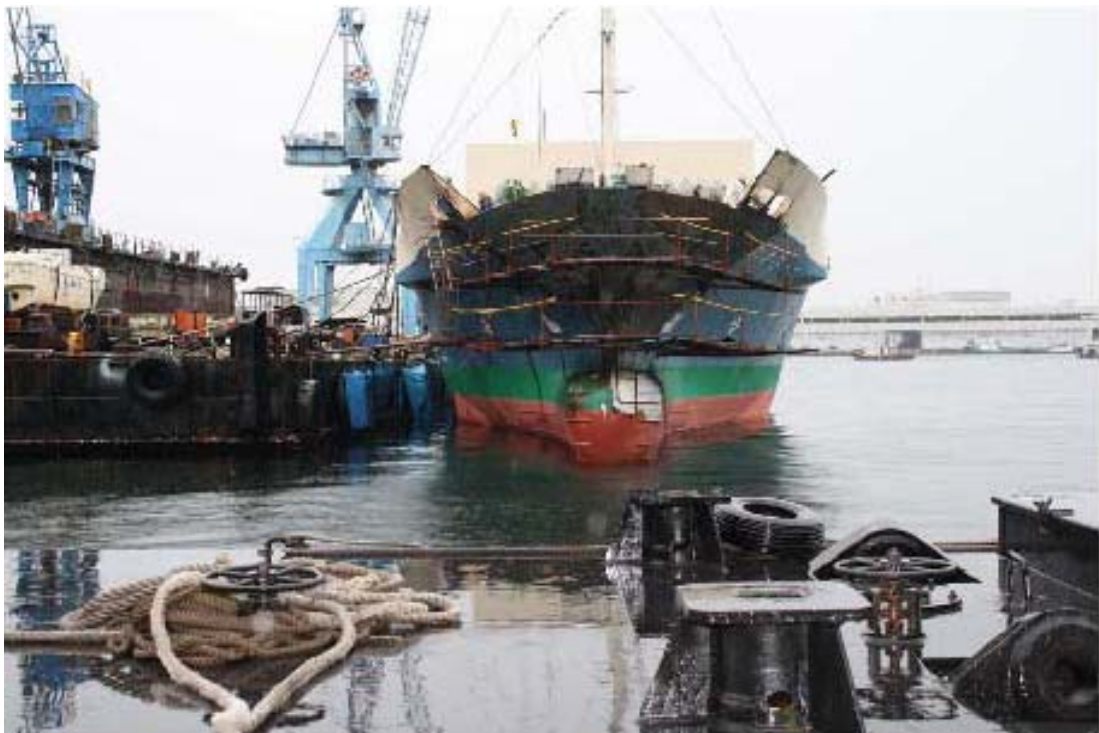
Photo 4: Damage to Ship B

Dents on the bow fashion plate and to the bulbous bow
(Refer to photo 4: Damage to Ship B)
