**MARINE ACCIDENT
INVESTIGATION REPORT**

Vessel type and Name: Cargo ship MARUKA

Vessel type and Name: Fishing vessel KAIRYO MARU No.18

Accident type: Collision

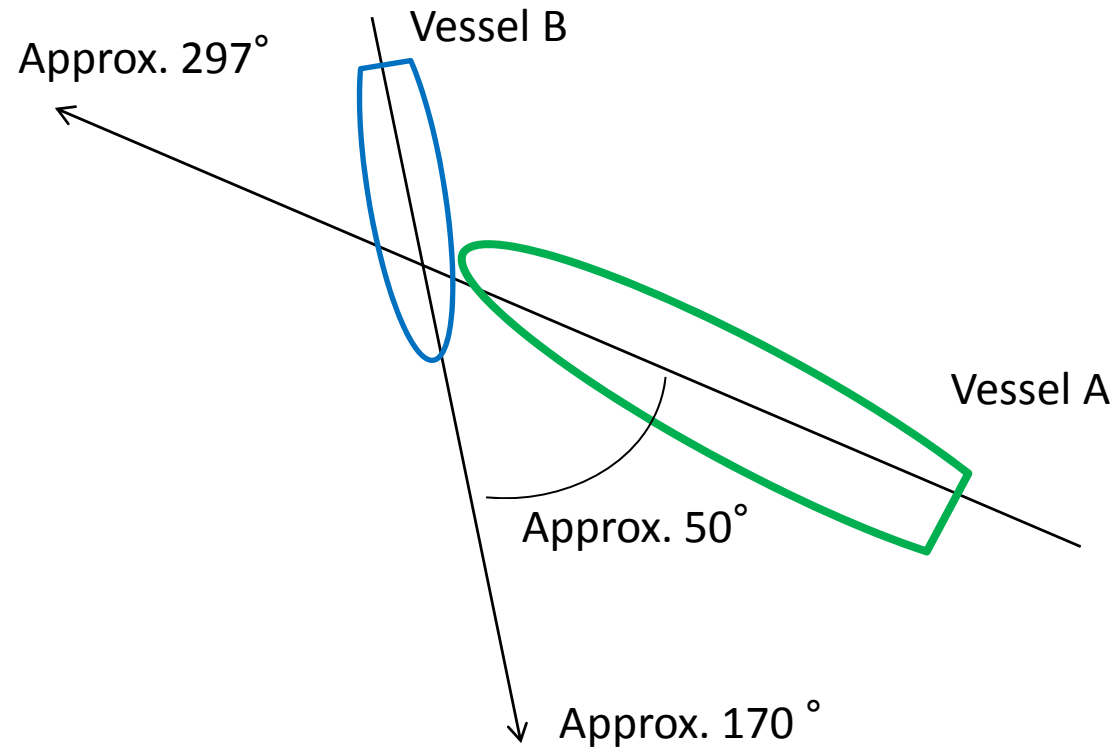
Figure 2: Situation of the Collision of Both Vessels

When Skipper B completed packing of 10 boxes, he felt something in his back and turned around. He sighted the starboard bow of Vessel A approaching from the port side of Vessel B, and immediately after that, Vessel A collided with the port section of Vessel B diagonally from the forward left of Vessel B at an angle of approximately 50°, causing Vessel B to capsize and Skipper B as well as Crew Member B to fall overboard. Skipper B was rescued by Vessel A, although Crew Member B went missing.

- (1) Those on the bridge watch should keep a proper lookout at all times.
- (2) When vessels on the point of starting to navigate come in sight while underway pay attention to the subsequent movements.

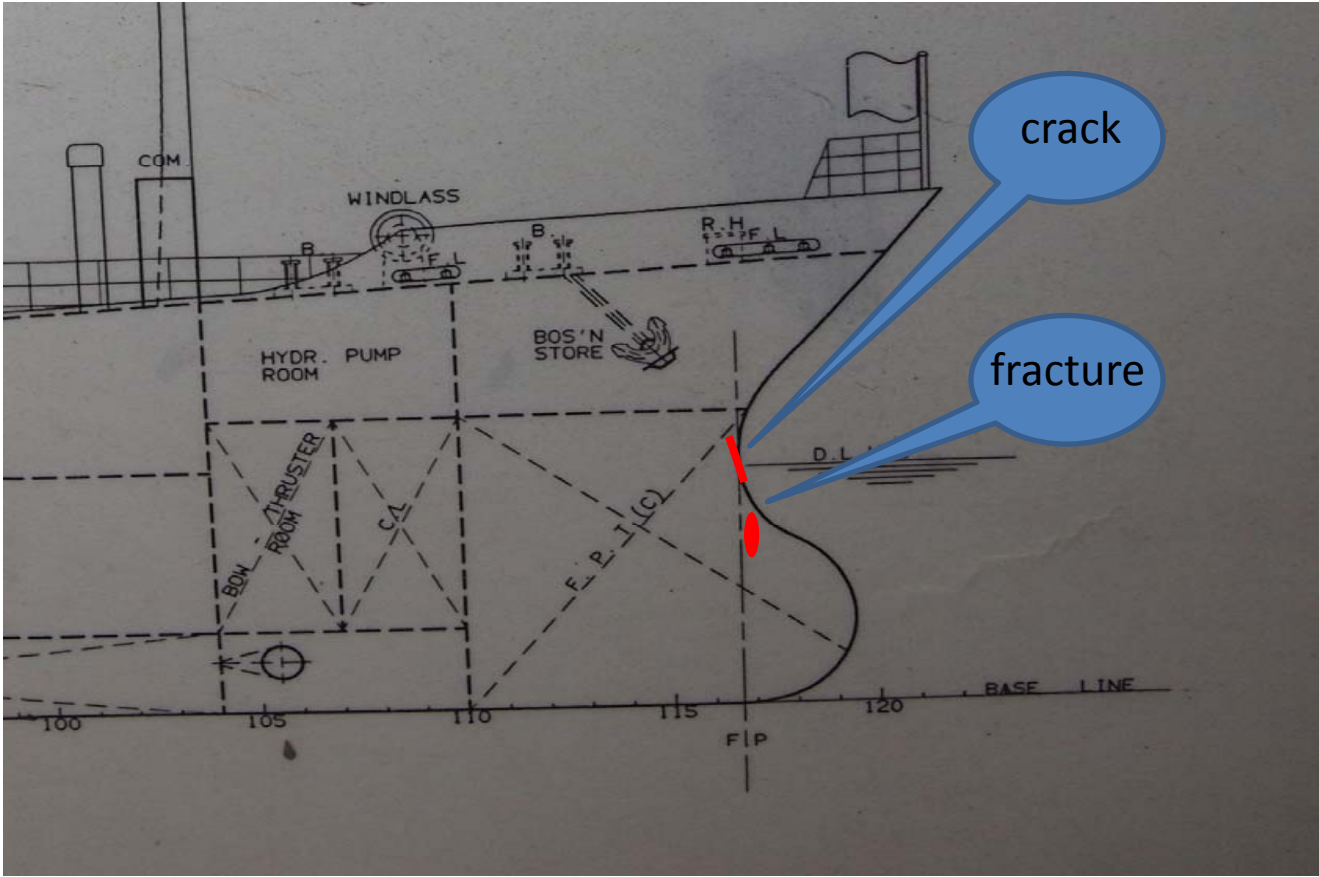
Figure 3: Damage to Vessel A

A fracture at the starboard section of the bulbous bow and a crack at the center of it.

According to 2.3, it is probable that Vessel A sustained a fracture at the starboard section of the bulbous bow and a crack at the center of it, while Vessel B was cut in two parts at the center of the hull, and sank leaving only the bow section over the sea.

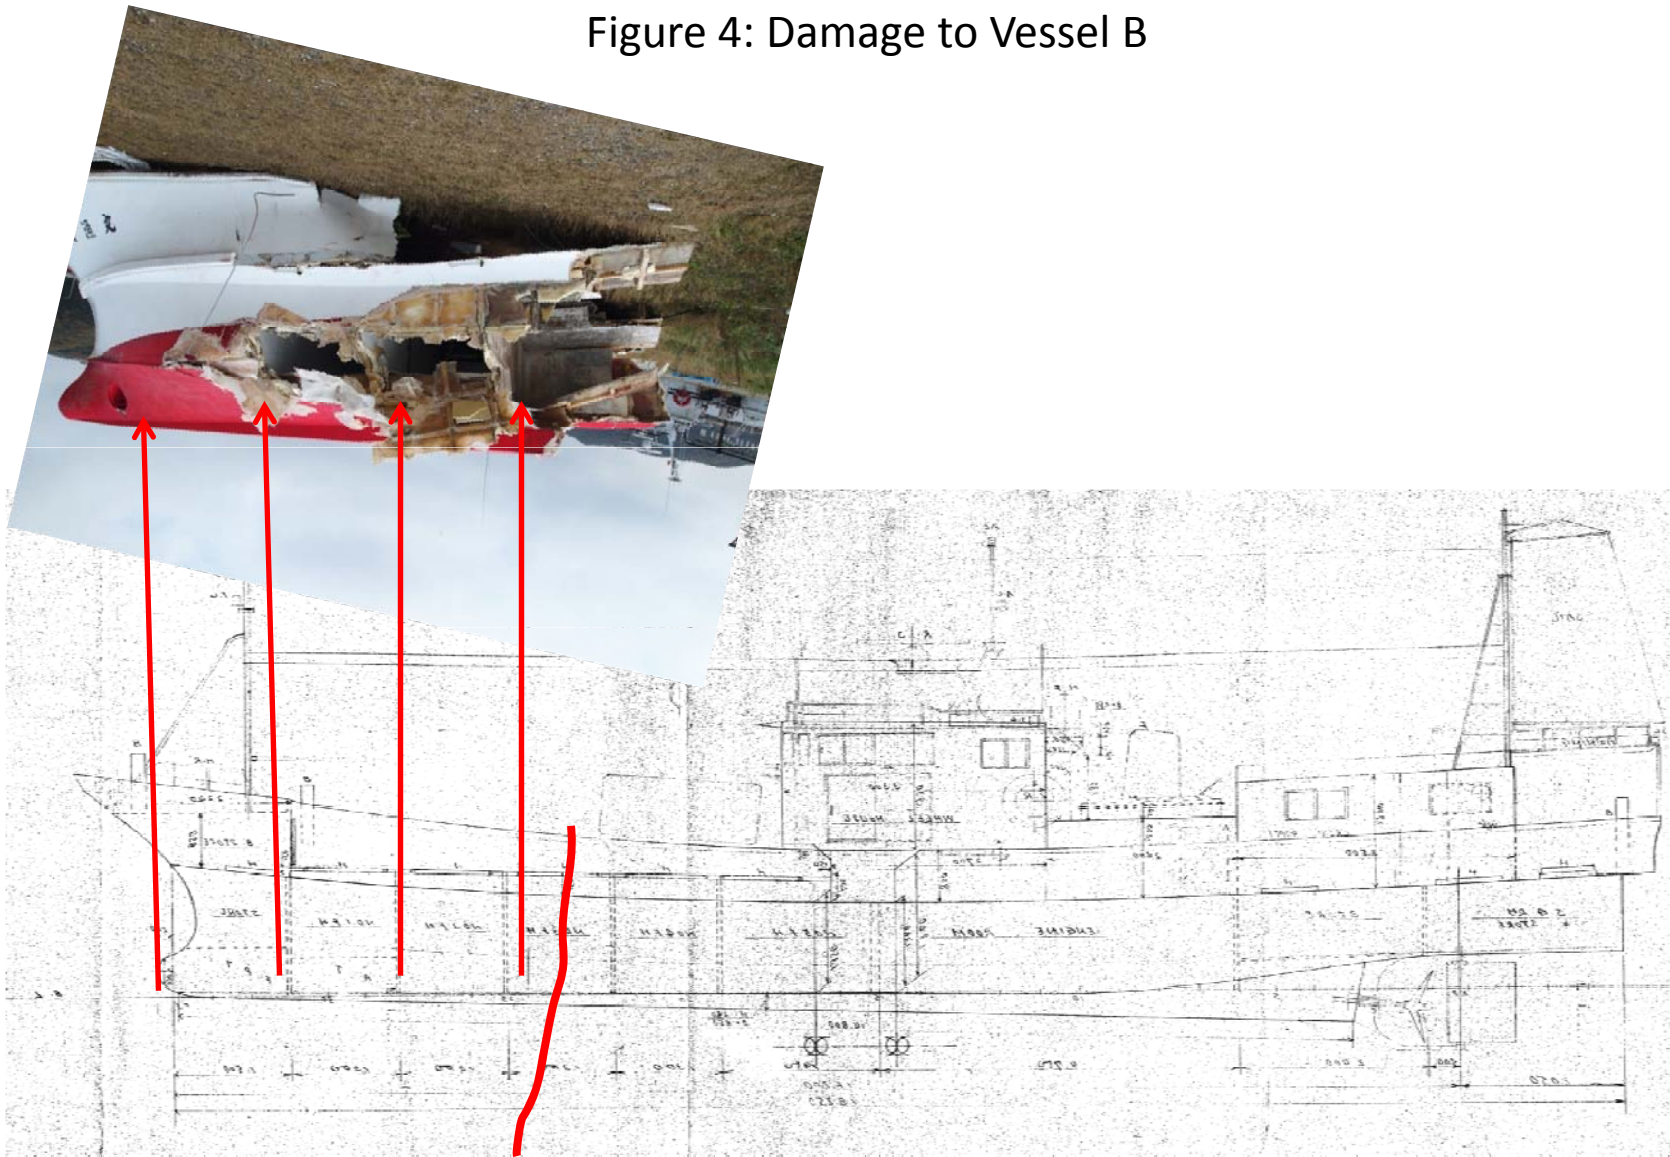
Figure 4: Damage to Vessel B

Cut in two parts at the center of the hull, and sank leaving only the bow section over the sea.

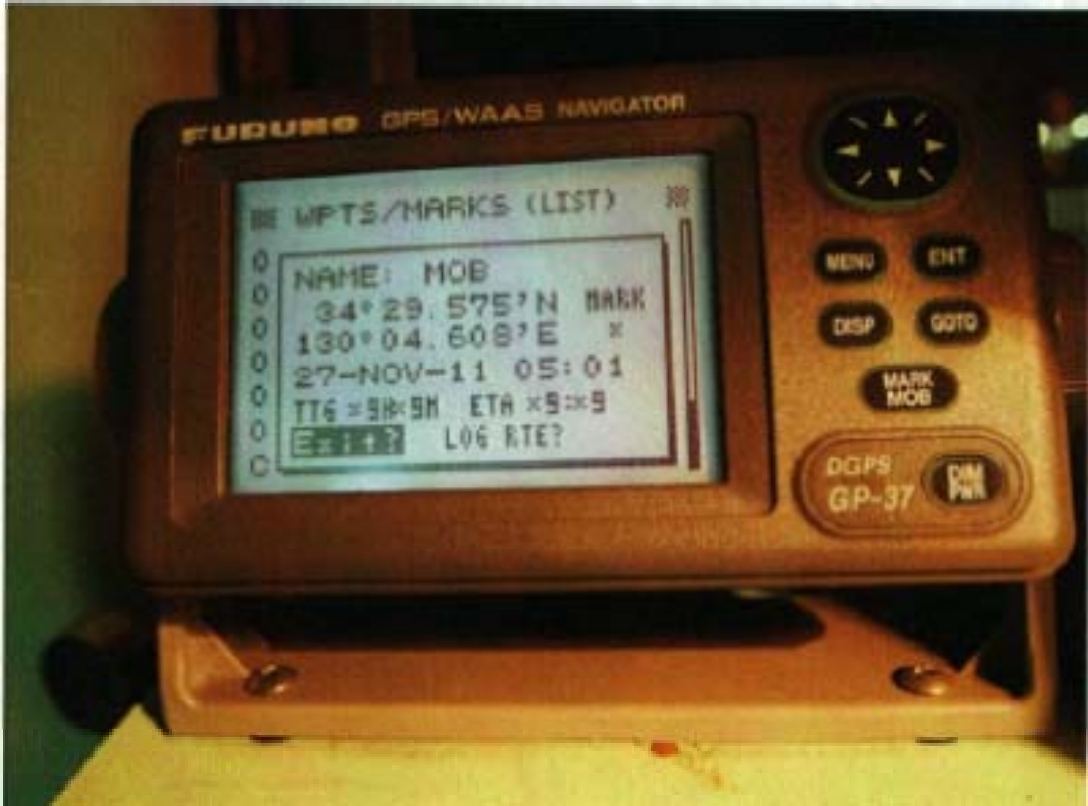
Photo 1: Time and Location Displayed on the Screen of the GPS Receiver of Vessel A

After that, Officer A confirmed that the GPS receiver had recorded 05:01, 34° 29.575’ N, 130° 04.608’ E.

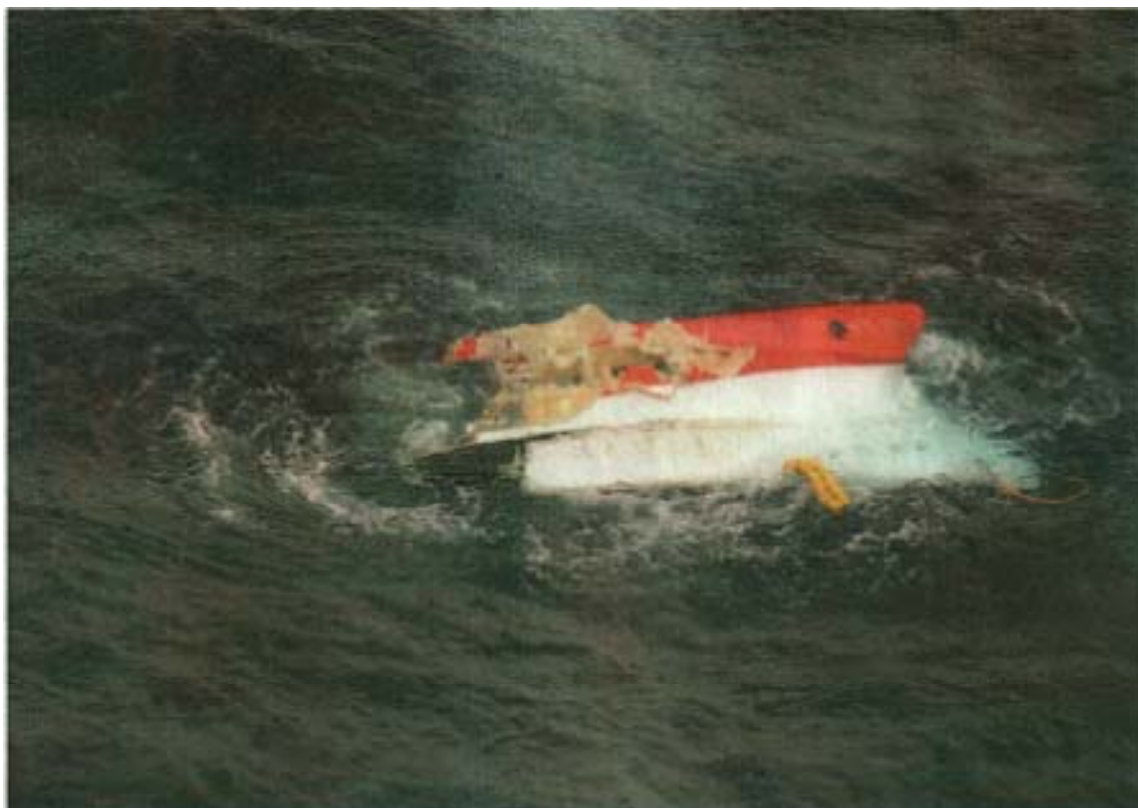
Photo 4: Situation of the Drifting Bow Section of Vessel B

After rising to the surface of the sea, Skipper B held onto a lid of the fish hold floating on the sea. As he later became able to hold onto the bow section of Vessel B drifting nearby, he entered the fish hold through the fracture on it.
