MA2013-11

**MARINE ACCIDENT
INVESTIGATION REPORT**

Vessel type and name: Container ship TIAN FU (TIANJIN)

Accident type: Collision

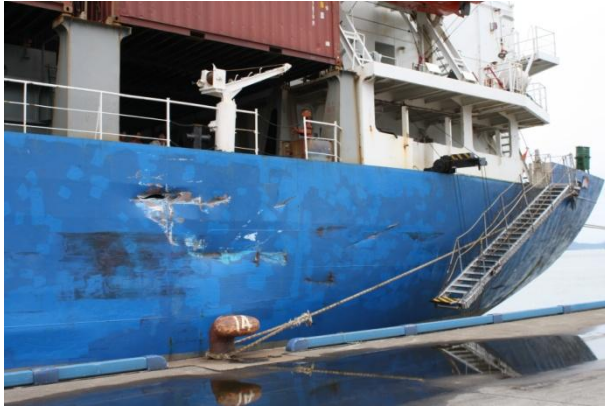
Photo 2.3-1 Damage of Vessel A

Vessel A suffered a crack in the port side shell plate, and the bulwark of the bow of Vessel B was damaged.
