**MARINE ACCIDENT
INVESTIGATION REPORT**

Vessel type and Name: Ro-Ro Passenger Ferry ARIAKE

Accident type: Listing

Date and time: Around 05:06, November 13, 2009 (local time, UTC+ 9 hours)

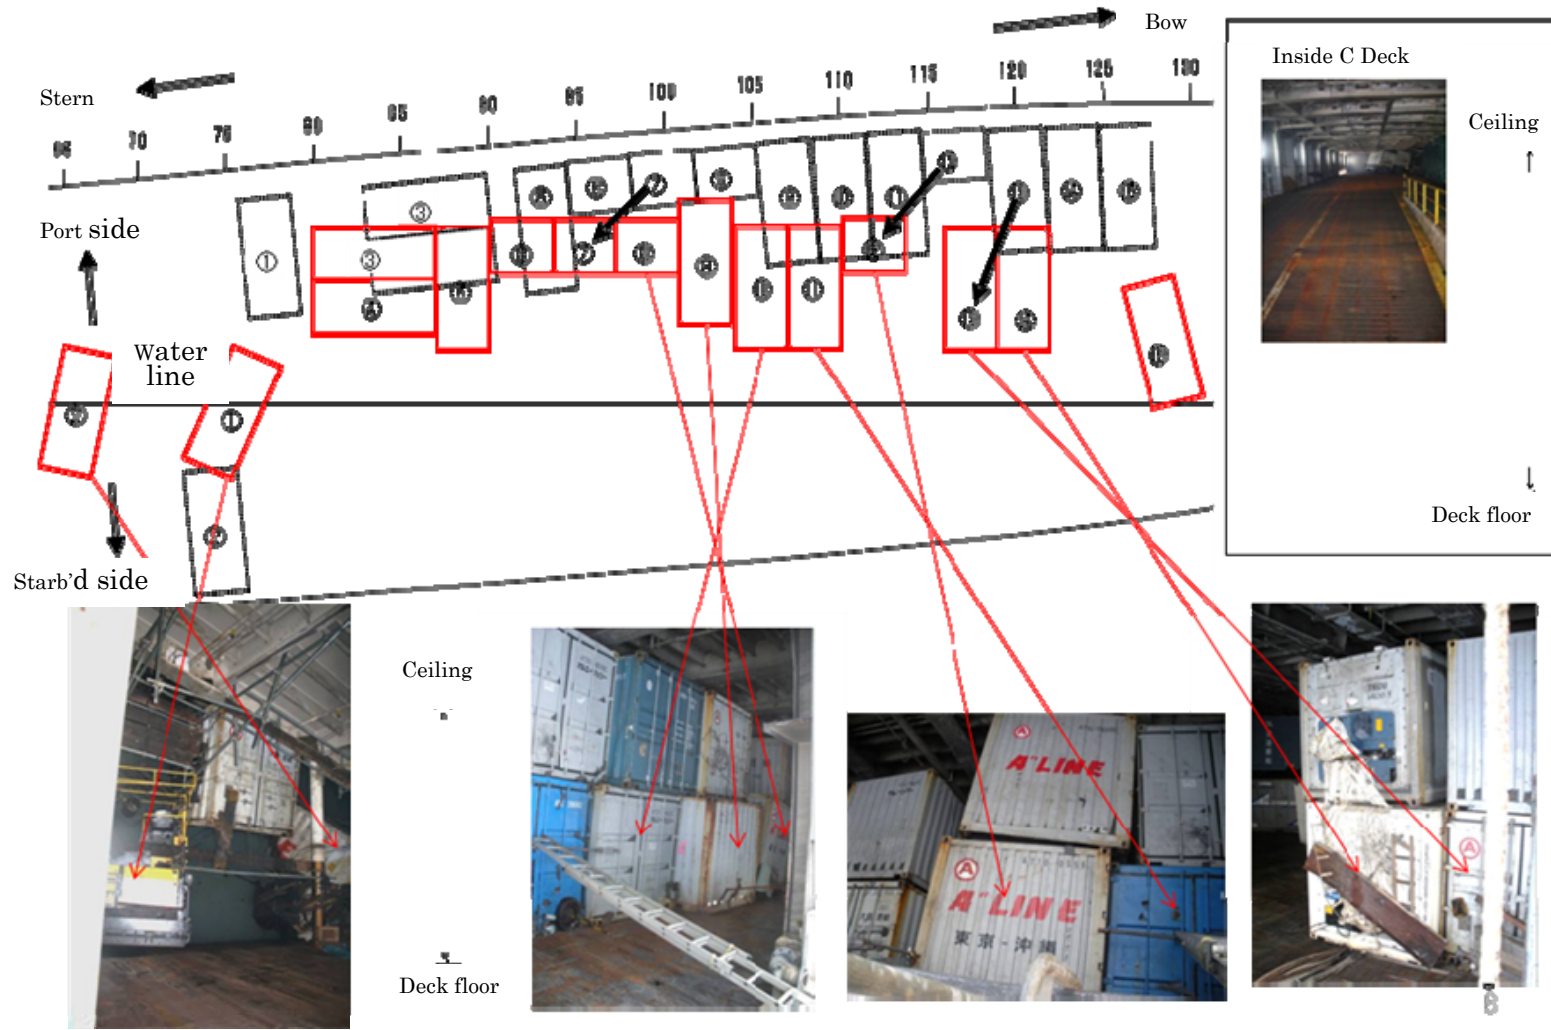
- (1) When the front part of C Deck was seen from the ramp on C Deck and through the opening on the outside plating on the port side, the chassis loaded on the port side of the first row on the bow had rolled while the chassis (two) loaded on the port side of the second row had slid. The condition of the other chassis could not be visually recognized because the outside plating on the starboard side was missing and for other reasons.
- (2) Most of the tires of the recovered chassis were damaged as though they had sustained sideways force, and their landing gears were bent. Also, a broken Sub-Chain was caught in some part of a chassis's body.
- (3) The containers loaded in the port bow block had slid to starboard, while the containers loaded near the broadside on the port side had shifted about 3 meters. The direction the containers

Figure 16: Shifting of Containers and Chassis

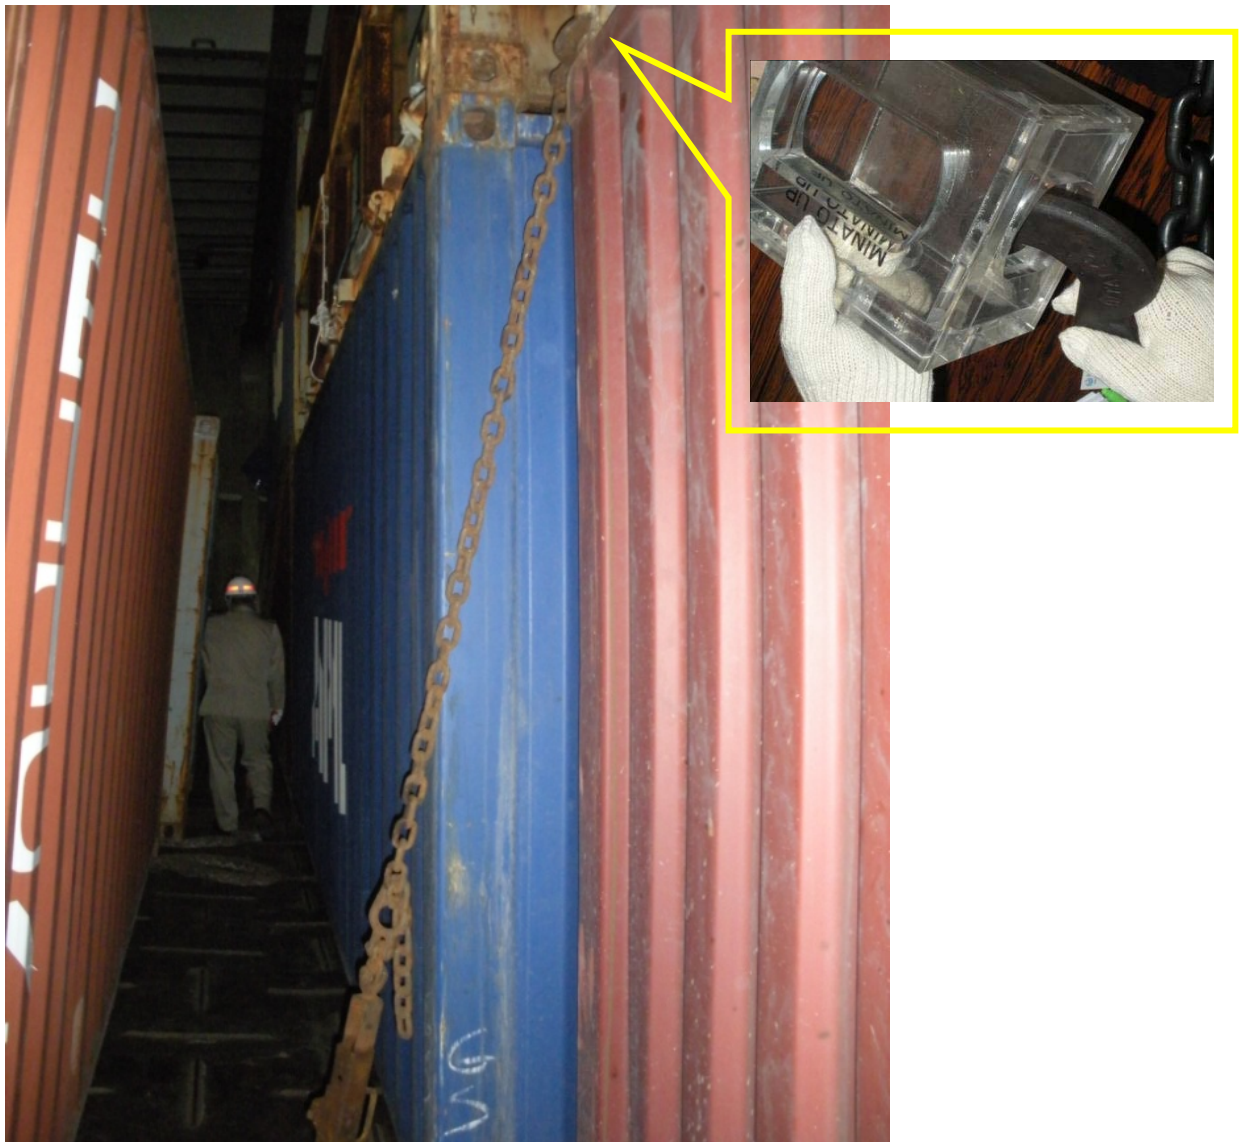
Photo 4: Lashing Condition of Containers

(See Figure 14: Lashing Condition of Containers, Photo 4: Lashing Conditions of Containers)

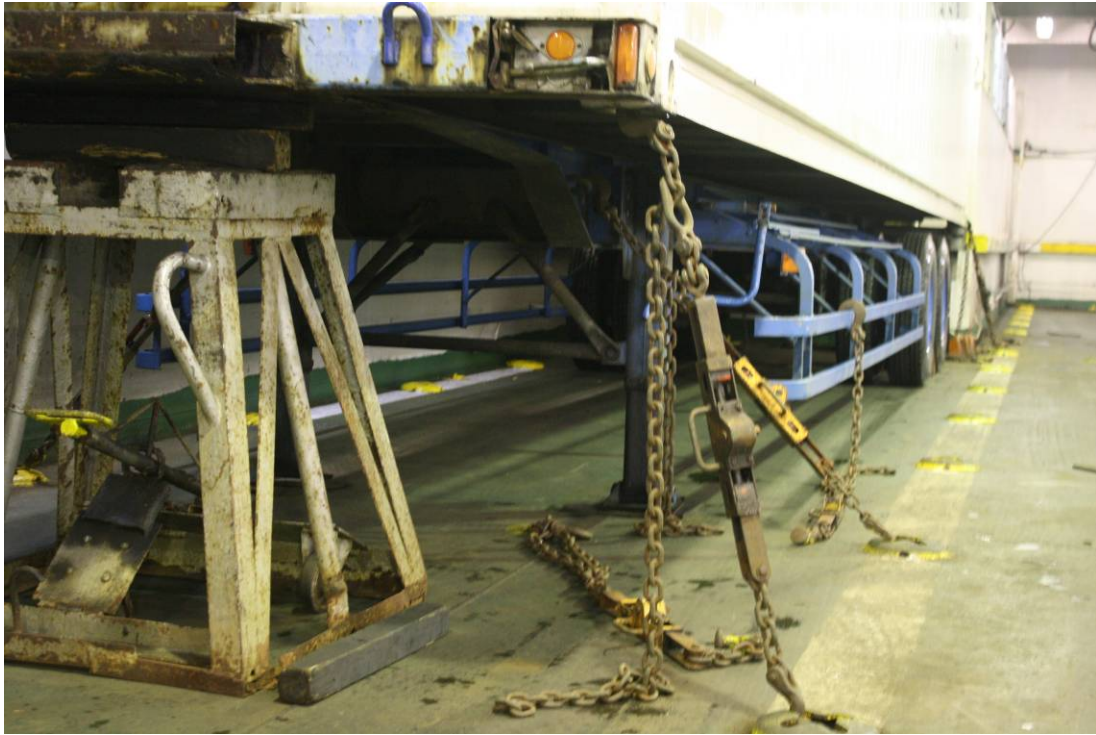
Photo 5: Lashing Condition of Chassis
(6- Point Lashing Chain)

(See Figure 15: Lashing Conditions of Chassis, Photo 5: Lashing Conditions of Chassis (6-Point Lashing Chain))

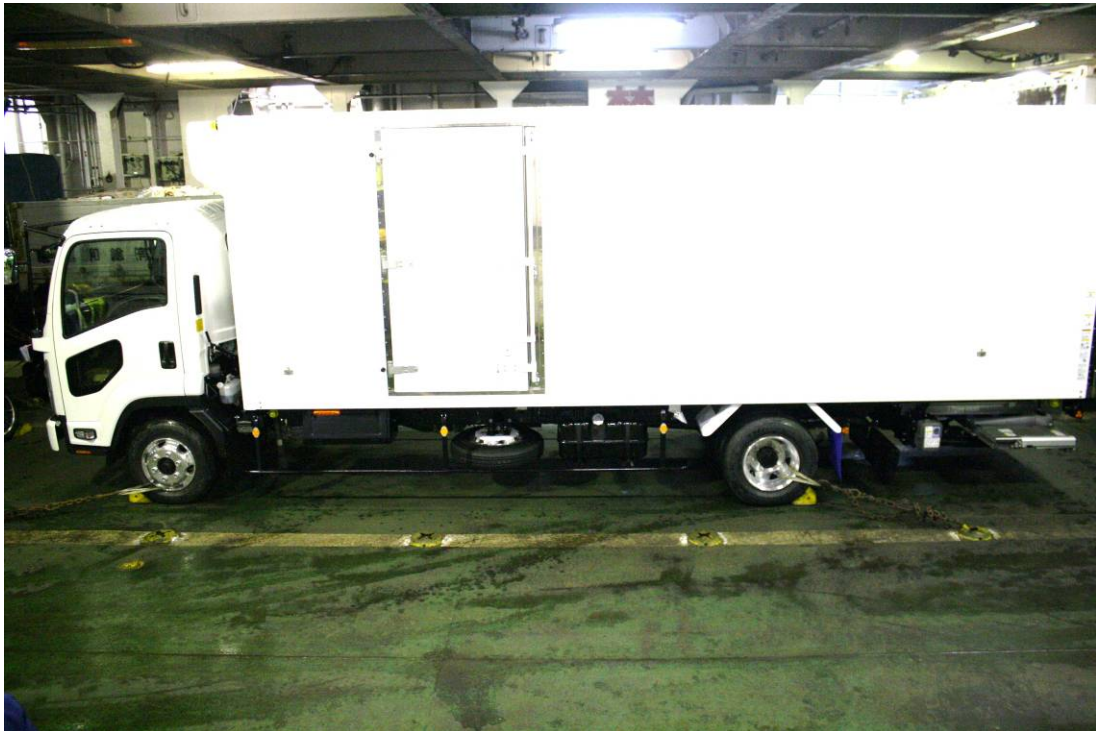
Photo 6: Lashing Condition of Truck

(See Photo 6: Lashing Condition of Truck)

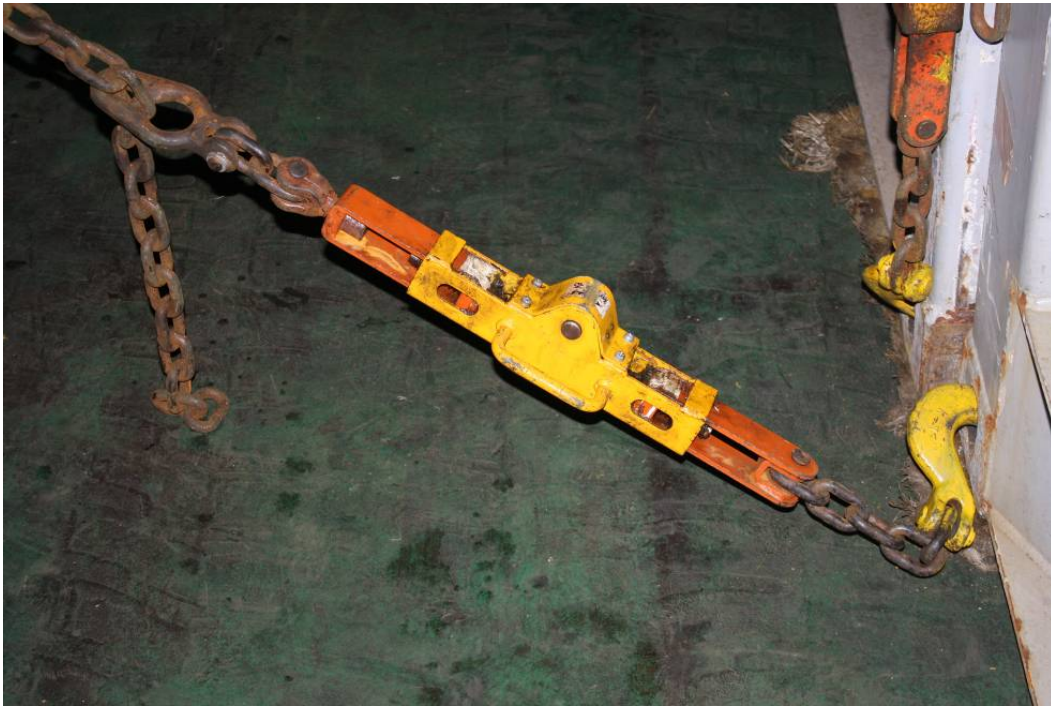
- (4) A few lashing chains remained on D Deck, hung on cloverleaves and on the eye plates on the frames, while hooks of some Sub-Chains were deformed and some other Sub-Chains were broken. In addition, a lashing chain with a metal fitting for a cloverleaf was on a container.
- (5) One of the heavy machines loaded on the port side of D Deck had slid to starboard, and part of it was visible on the water while the lashing chain could not be found.
- (6) The passenger cars loaded on E Deck could not be found, while lashing belts remained hooked on the cloverleaves for small-sized cars.
- (7) The condition of other cargoes like trucks, heavy machines and passenger cars could not be visually recognized.
- (8) The coating of the floor face in the car spaces on D Deck was peeled off. The condition of the floor face on C Deck seemed almost the same.

Photo 9: Twisted Hook of Lashing Chain

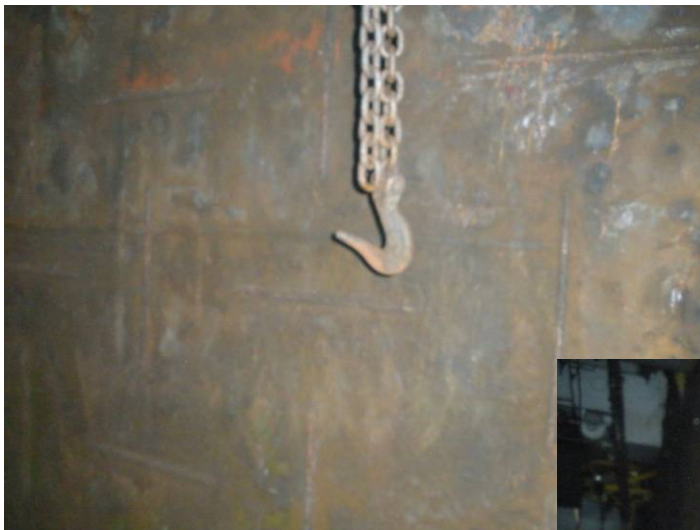
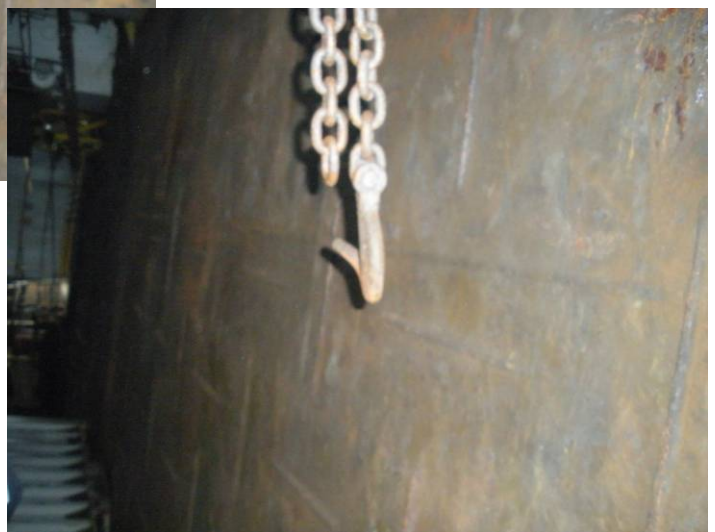
Photo 10: Deformed Hook of Sub-Chain
