**MARINE ACCIDENT  
INVESTIGATION REPORT**

Vessel type and name: Cargo ship SCSC WEALTH

Accident type: Fatality of a stevedore

Date and time: At about 14:20, May 10, 2011 (local time, UTC + 9 hours)

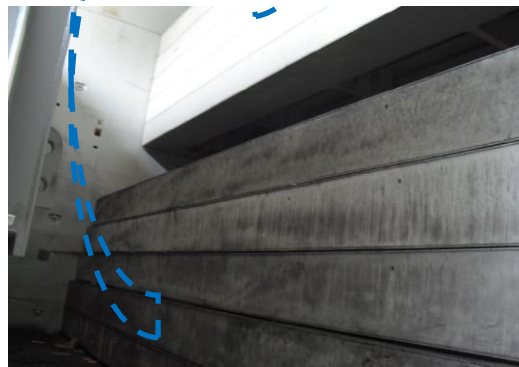
Photo 2.1-6 Tween deck hatch covers that were placed on the bow side of the inner bottom plating in No.2 cargo hold (Photographed during a previous voyage, prior to the accident)

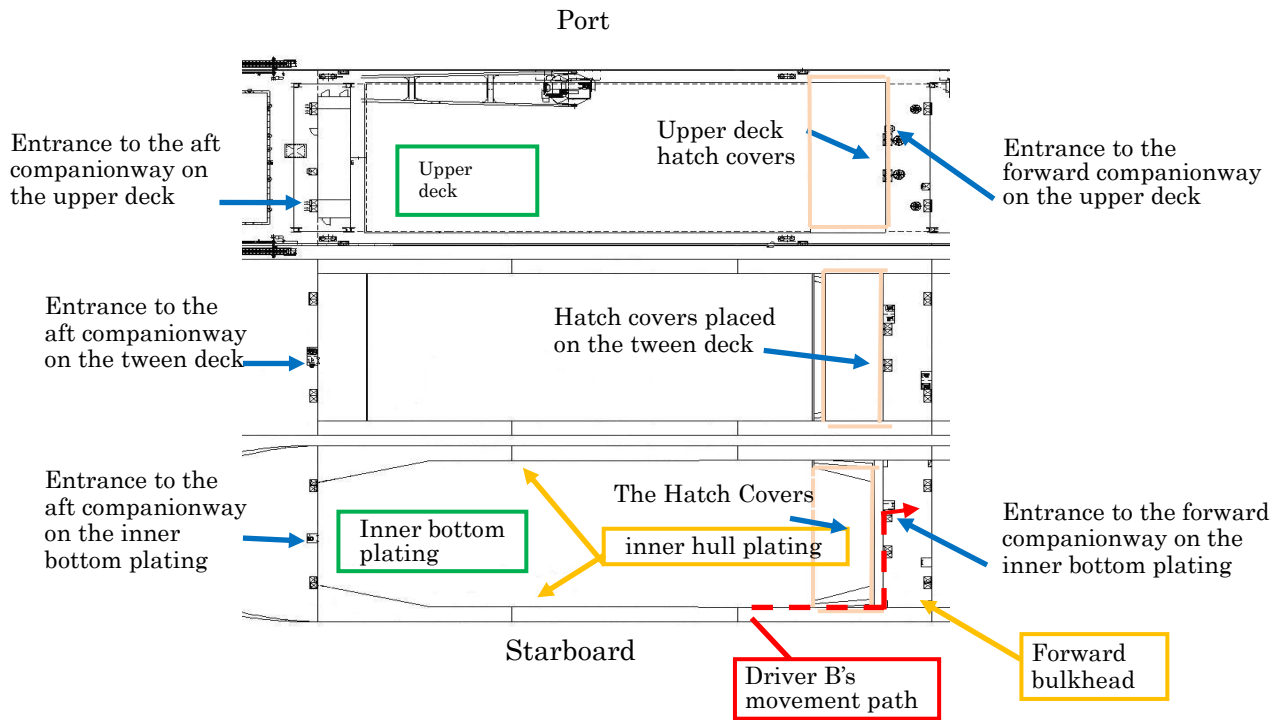
Figure 2.1-4 View of No.2 cargo hold

When Driver B passed through the space between the Hatch Covers and the forward bulkhead, he did not feel that it was dark. He was able to walk without turning his body sideways in such a way that neither shoulder came into contact with any of the Hatch Covers or with the forward bulkhead.

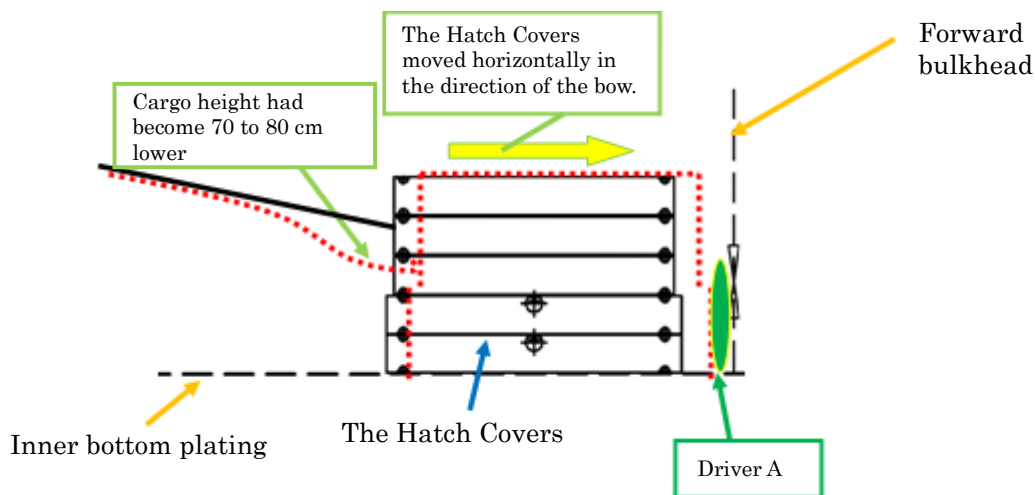
Figure 2.1-5 Illustration of the movement of the Hatch Covers

At about 14:20, when Driver B was operating Bulldozer 2 to level cargo loaded on the stern side, he heard a loud sound from the bow side. He therefore approached the Hatch Covers and looked at them. Cargo was previously present up to a height equal to the height of the fourth lowermost hatch cover among the Hatch Covers. However, the cargo height was now found to be 70 to 80 cm lower. Consequently, he thought that the Hatch Covers had moved in the direction of the bow.

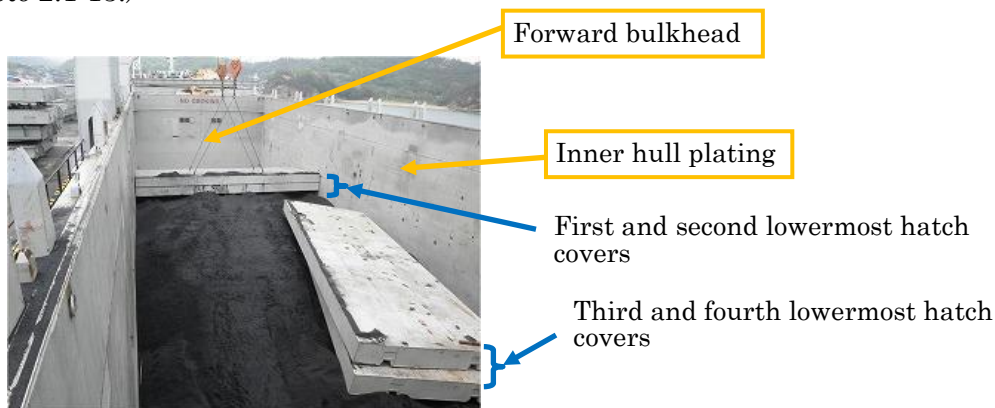
Photo 2.1-13 Removing the Hatch Covers, 2

The Cargo Handling Workers used the aft crane to lift the third and fourth lowermost hatch covers among the Hatch Covers one-by-one, and moved them onto the cargo on the stern side. There were then two remaining hatch covers. Next, when lifting the upper remaining hatch cover, an attempt was made to lift it by pulling it in the stern direction by means of a truck-mounted crane. The purpose of this attempt was to prevent the upper hatch cover from hitting Driver A, who had been caught. However, the upper hatch cover was unable to be lifted. (See Photo 2.1-13.)

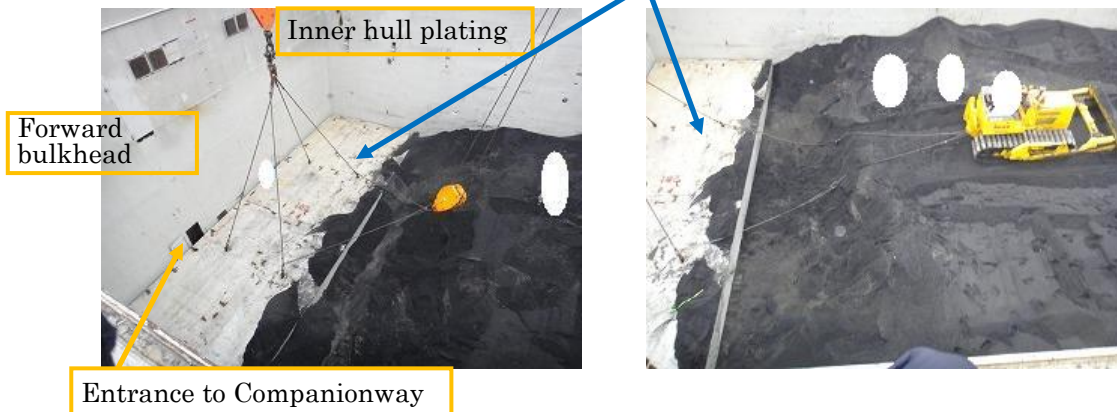
Photo 2.1-14

The Cargo Handling Workers used shovels to dig down the cargo in the vicinity of the remaining two hatch covers that were on the stern side. While lifting the aforementioned two hatch covers with the aft crane, they were pulled in the stern direction by bulldozer 2. As a result, the bow side of the hatch covers was raised, and Driver A, who was caught, fell onto the inner bottom plating. Ambulance squad members and the Cargo Handling Workers lifted the second lowermost hatch cover to some extent. The situation was such that the lowermost hatch cover had adhered to the second lowermost hatch cover. If lifting had been performed in this state, and if the lowermost hatch cover had dropped, there would have been a risk of Driver A being hit. Therefore, sleepers were placed between the hatch covers and the inner bottom plating.

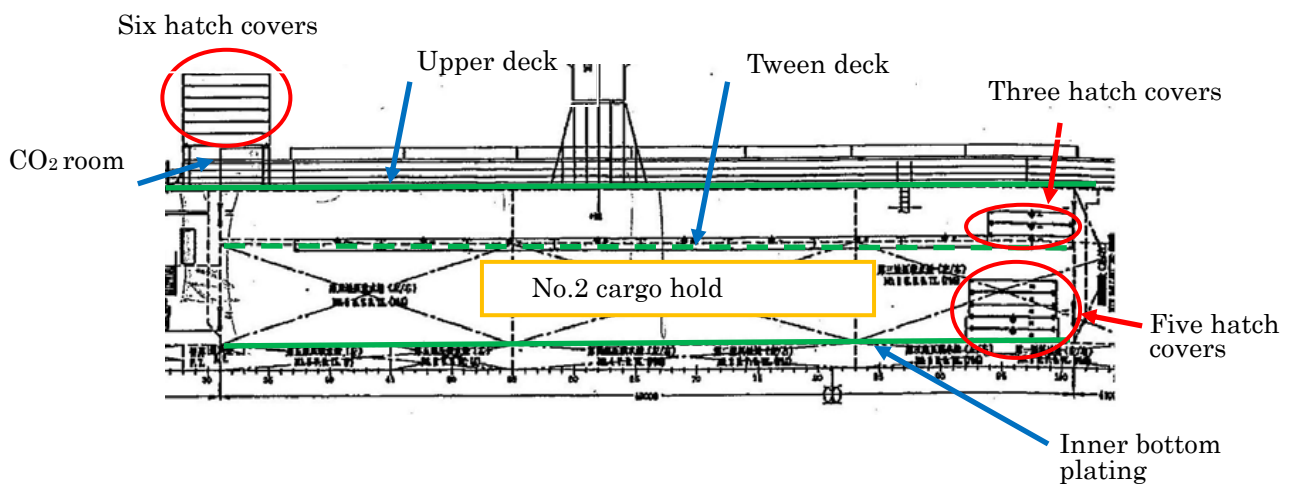
Figure 2-6.3 Places to put tween deck hatch covers that were opened

The gap between the forward bulkhead and the hatch covers placed on the inner bottom plating in No.2 cargo hold was approximately 94 cm.

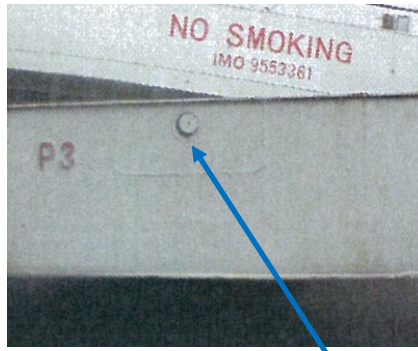
On the following day of the occurrence of the accident, the foreman opened the lid on the upper surface of a hatch cover and found that a Fixing Pin was housed inside. When he pushed the Fixing Pin by hand, the pin protruded outside from the side surface of the hatch cover.

Photo 2.6-6 Fixing Pin in the housed state

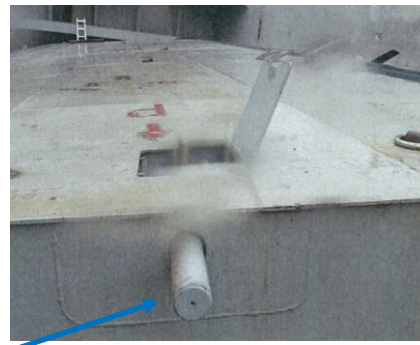
Photo 2.6-7 Fixing Pin in the protruded state

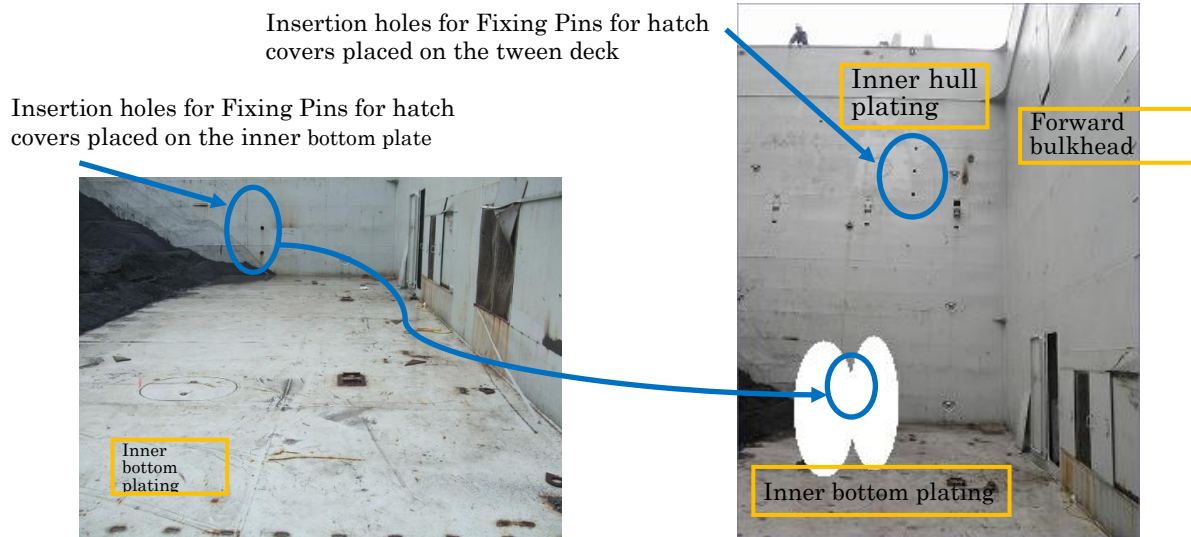
In the inner hull plating on each of the port side and the starboard side on the bow side of No.2 cargo hold, the following insertion holes were provided: two insertion holes for Fixing Pins to fix the bottom two hatch covers among the hatch covers placed on the inner bottom plating; and three insertion holes for Fixing Pins for the hatch covers placed on the tween deck.

Photo 2.6-8 Fixing Pin insertion holes provided in No.2 cargo hold inner hull plating (1)

Photo 2.6-9 Fixing Pin insertion holes provided in No.2 cargo hold inner hull plating (2)
