**MARINE ACCIDENT
INVESTIGATION REPORT**

Vessel type and name: Cargo ship GUANG DA

Accident type: Fatality during mooring operation

Date and time: At around 07:08 on January 11, 2012 (local time, UTC+9 hours)

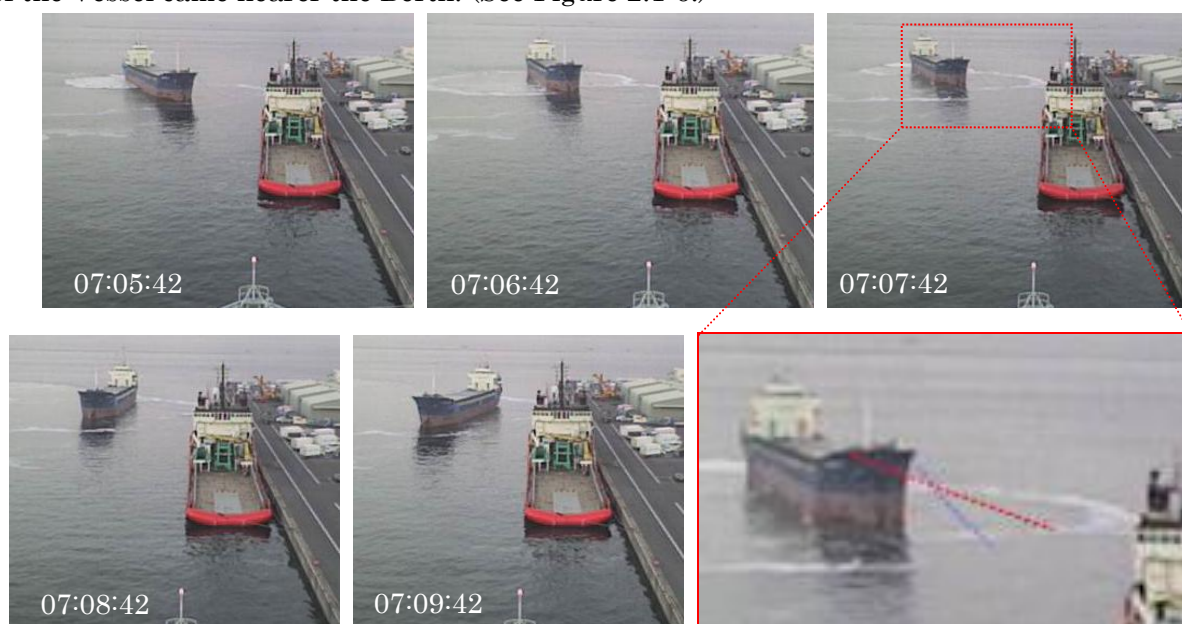
Figure 2.1-6 Images of the Berth (between 07:05:42 and 07:09:42)

(4) At around 07:05, whitecaps occurred around the stern of the Vessel. At 07:07:42, the mooring line sent out from the starboard bow to the Berth became taut. At 07:08:42, the stern of the Vessel came nearer the Berth. (See Figure 2.1-6.)

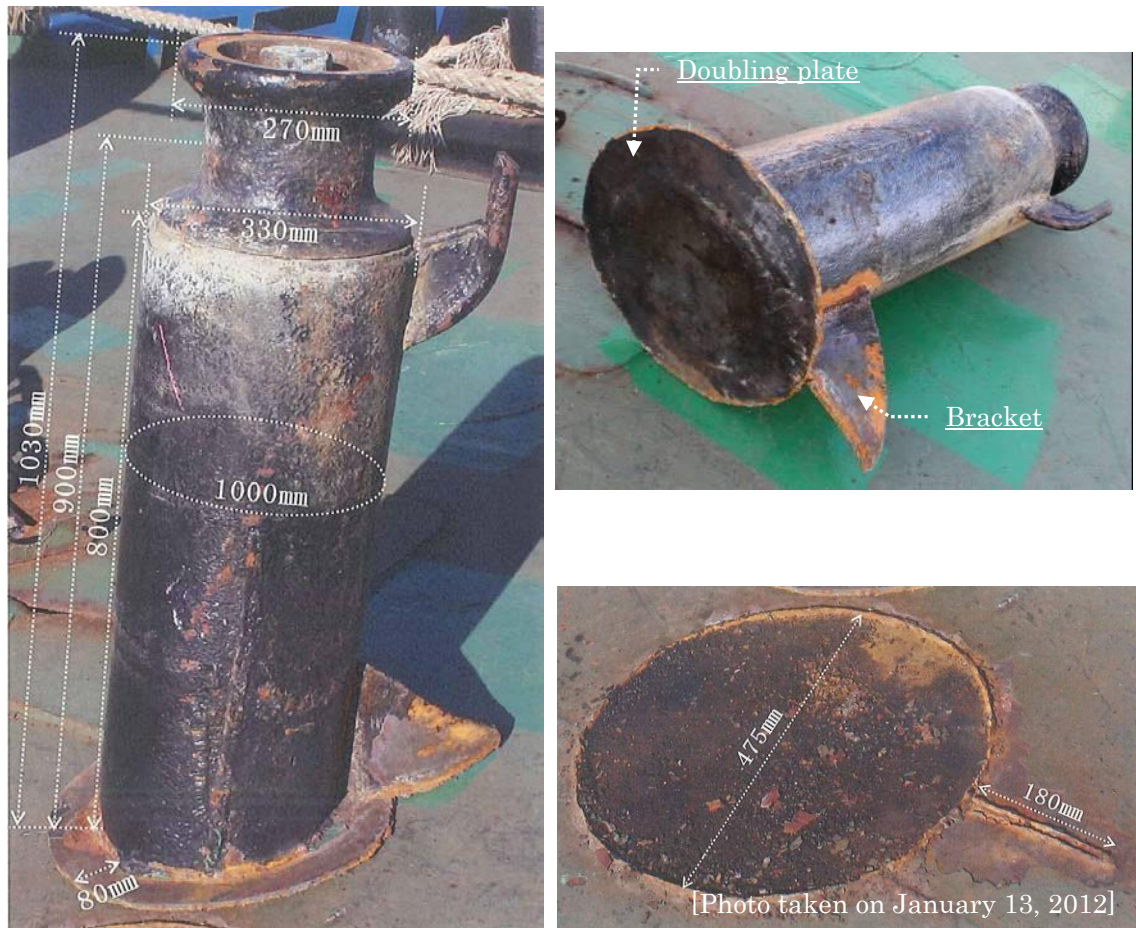
Figure 2.6-1 The Stand Roller

- 1) The Stand Roller consists of a cylindrical stand and the roller fitted on the top of the stand. The stand was installed on the doubling plate that had been welded on the deck, and had a bracket. The doubling plate was a disc.
- 2) The safe working load*²⁰ (SWL) has not been displayed on the Stand Roller. The roller was not fixed ; therefore, was able to be rotated by hand.
- 3) Some of the measurements of the Stand Roller are as follows.
 - a. Various measurements: shown in Figure 2.6-1
 - b. Thickness of the doubling plate: about 10 mm
 - c. Thickness of the bracket: about 12.5 mm
 - d. Inclination of the stand: about 13° towards the bracket

- (1) The Doubling Plate Circumference Weld and the Bracket Weld of the Stand Roller were broken. Part of the tip of the bracket underwent plastic deformation while the Stand Roller and the doubling plate underwent no plastic deformation.
- (2) No bulge, dent or other plastic deformation was found on the deck where the Stand Roller had been welded.

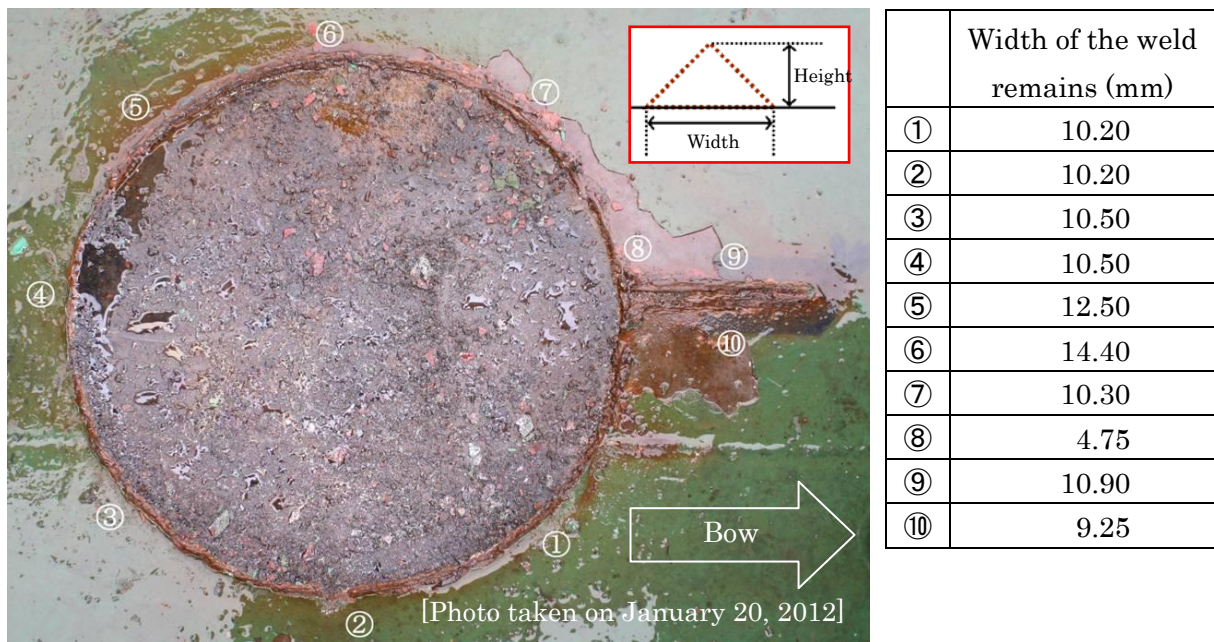
Figure 2.6-2 Measurements of the weld remains

The weld remains of the doubling plate were almost continuous while missing in some parts, forming a circle of inverted “V” protrusions. The weld remains of the bracket were left on the bow direction. The width of the weld remains was measured, and was as shown in Figure 2.6-2. The highest point of the weld remains was about 6 mm high.

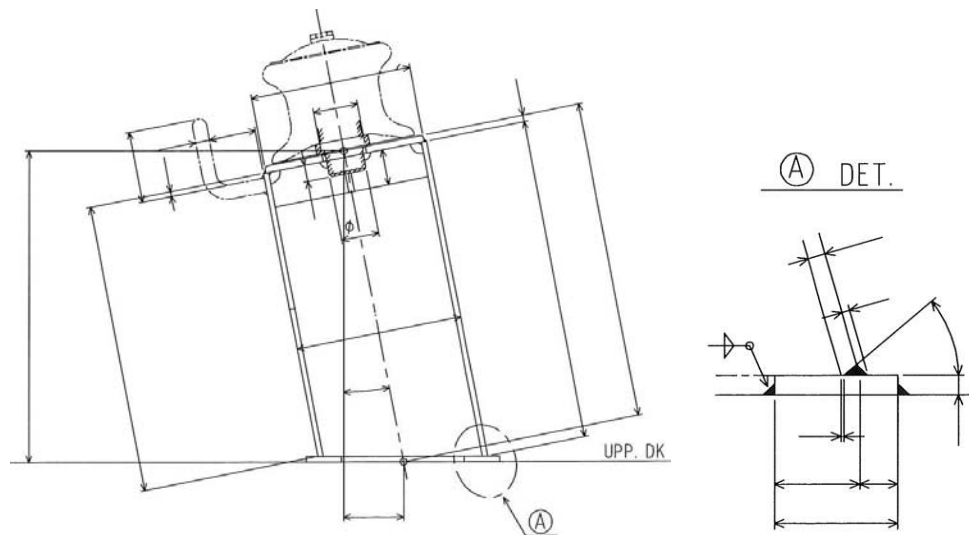
Figure 2.6-3 Example of stand roller installation

- 1) Doubling plates would be welded after making a hole in their center or slots in them. Brackets would be provided in four directions around the stand roller as it is subjected to substantial lateral load. (See Figure 2.6-3.)

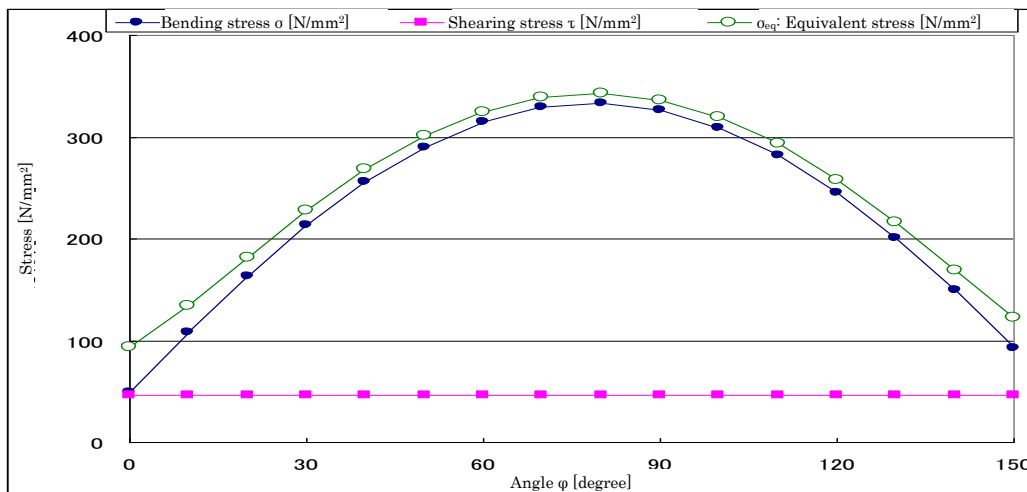
Figure 2.9-2 Stress Changes on the Doubling Plate Circumference Weld

2) Based on the data in Table 2.9-3, the tensile force of a mooring line at which the fillet weld on the doubling plate circumference would break first among all the welds is calculated as 439 kN assuming that the leg length of the Doubling Plate Circumference Weld and that of the Bracket Weld are the standard values. Figure 2.9-2 shows the corresponding stress changes when such breakage occurs on the Doubling Plate Circumference Weld.

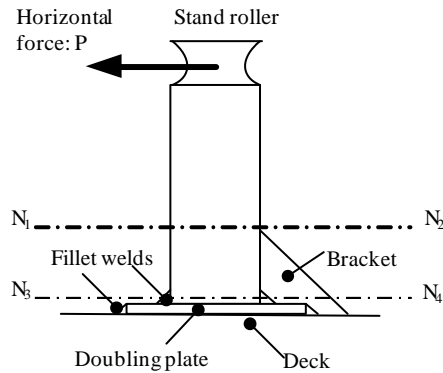
Figure 2.9-3 Places other than the Doubling Plate Circumference Weld that can possibly break

Places other than the Doubling Plate Circumference Weld were assessed for strength against possible rupture. For this assessment, Cross Section N₁ – N₂ (which includes the weld at the upper end of the bracket) and Cross Section N₃ – N₄, both shown in Figure 2.9-3, were chosen. For the assumption described in (2) 2) above to be valid, it must be verified that those cross sections will not break with the tensile force of a mooring line indicated in (2) 2).

- 2) The discrepancy between those scenarios and the accident in the mode of rupture suggests that the Stand Roller did not break in a mode of ductile fracture of the fillet weld as assumed in the calculations. This is also supported by the fact that the doubling plate and the deck showed few signs of permanent (plastic) deformation.

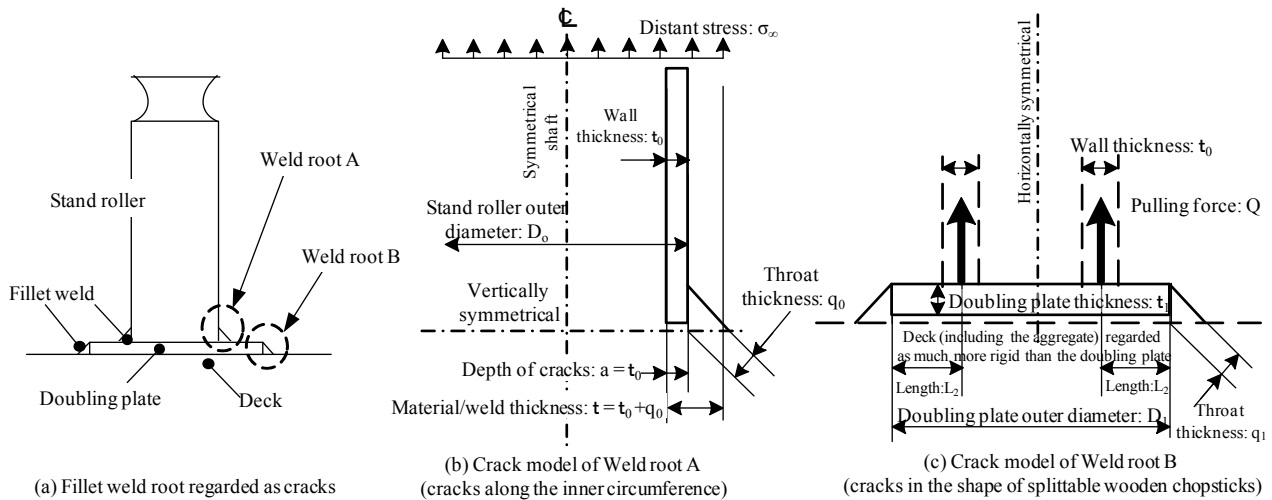
Figure 2.9-4 Crack models of fillet weld roots

existing model regarding the fillet weld roots as cracks as outlined in Figure 2.9-4. Where the weld leg length of the stand bottom and that of the doubling plate circumference are 7 mm and the tensile force on a mooring line is 167 kN (which is the breaking strength of the Line), the calculation results of stress intensity factor for the fillet weld root are shown in Table 2.9-4.

2) The results show that, with the same tensile force of 167 kN on a mooring line, the fillet weld root of the doubling plate circumference has a greater stress intensity factor than that of the stand bottom. This suggests that the fillet weld root of the doubling plate circumference can develop rapid fracture, which matches the actual fracture observed in the accident.

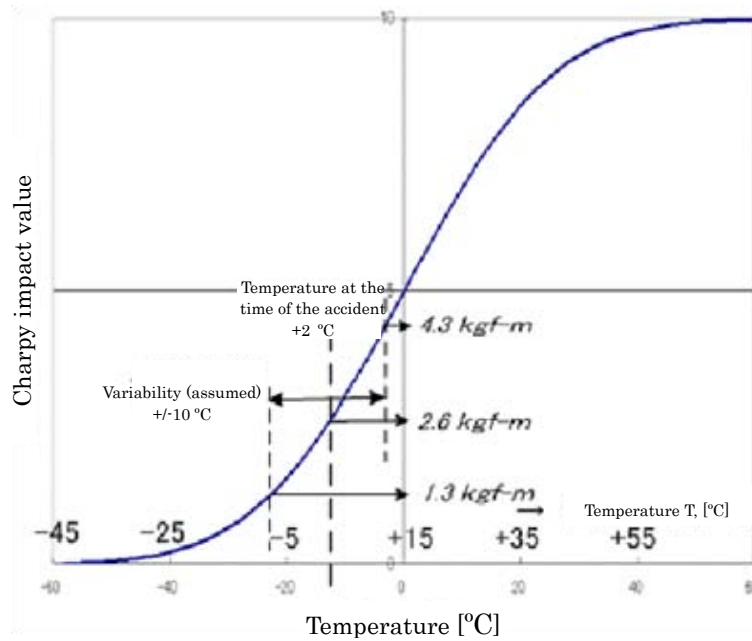
Figure 2.9-5 Relationship between the temperature of the fillet weld and Charpy impact value

2) As shown in Figure 2.9-5, the Charpy impact value was estimated at 25.5 N·m (2.6 kgf·m) at the temperature (about 2°C) at which the accident occurred. With an assumed variability of +/-10°C factored in, the Charpy impact value was then estimated at 12.7 to 42.1 N·m (1.3 to 4.3 kgf·m).

It is highly likely that the Stand Roller broke in a mode of brittle fracture (low stress fracture) originating from the root of the fillet weld on the doubling plate circumference. Possible causes include lack of fillet weld length and incorrect fillet welding conditions (incorrect welding material, incorrect current/voltage, etc.). The temperature (about 2°C) at the time of the accident is thought to also have contributed to the occurrence of the fracture.
