MA2013-4

**MARINE ACCIDENT
INVESTIGATION REPORT**

Vessel type and name: Chemical tanker KYOKUHO MARU NO.2
Vessel number: 137077
Gross tonnage: 388 tons

Accident type: Fatality of a crewmember
Date and time: February 7, 2012, about between 12:26 to 12:29
Location: Sakai-senboku Section 7, Hanshin Port
Near 204° true, 2,600 m from the south lighthouse
at the south breakwater at Yamato River,
Sakai-senboku, Sakai City, Osaka, Japan
(Approximately 34°34.6'N, 135°23.1'E)

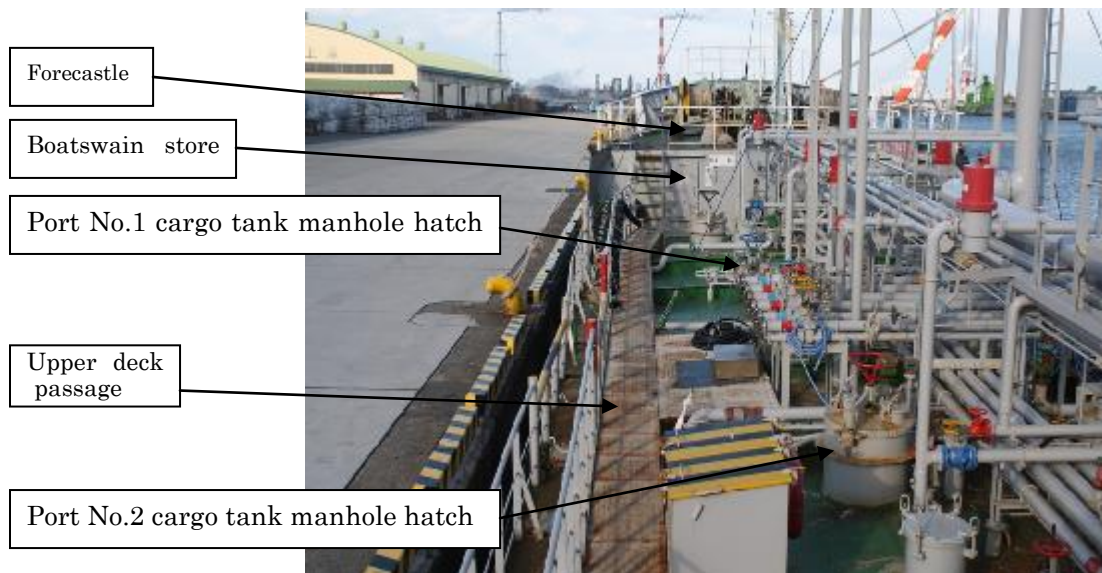
(Photo 2.1-2 On Upper Deck of the Ship (Viewed from Bridge toward Port Bow))

At around 12:25, the chief officer, near the starboard No.1 cargo tank, directed the second officer, who was near the port No.1 cargo tank, to open the manhole hatch of the cargo tank. When the second officer was opening the manhole hatch, the chief officer smelt chloroform and cautioned the second officer against entering the cargo tank to avoid chloroform gas inhalation, and saw the second officer nodded in assent.

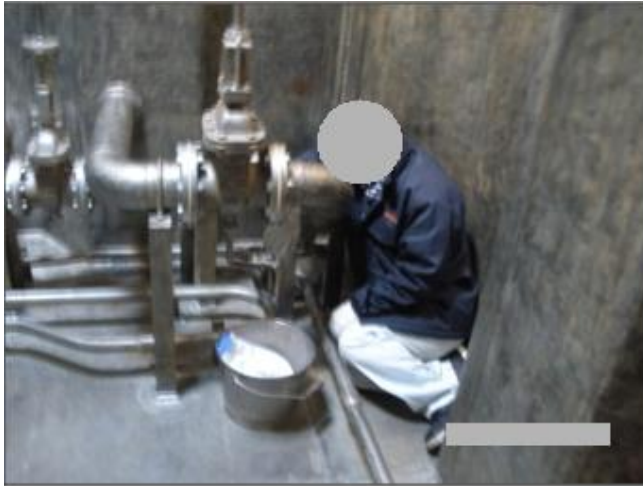
(Photo 2.1-4 Situation where second officer was found)

※ This Photo 2.1-4 shows a situation where the second officer was found collapsed. Reproduced with the help of the Ship's crew at the on-site investigation.

- 4) At around 12:29, the chief engineer looked into the port No.1 cargo tank through its manhole hatch whose cover had been opened, found the second officer collapsed as if leaning against the bulkhead near the suction well, and reported the finding to the chief officer and the master.

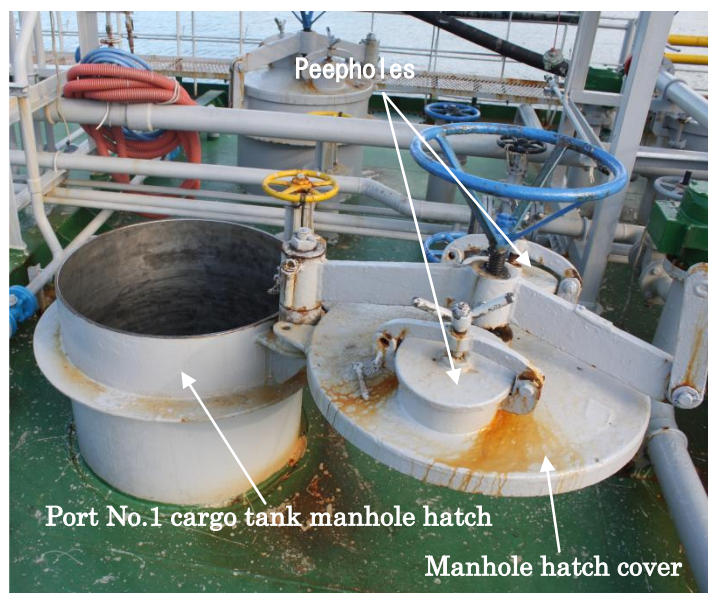
(Photo 2.5-1 Port No.1 Cargo Tank Manhole Hath)

The hatch covers have two peepholes to observe liquid surface below.

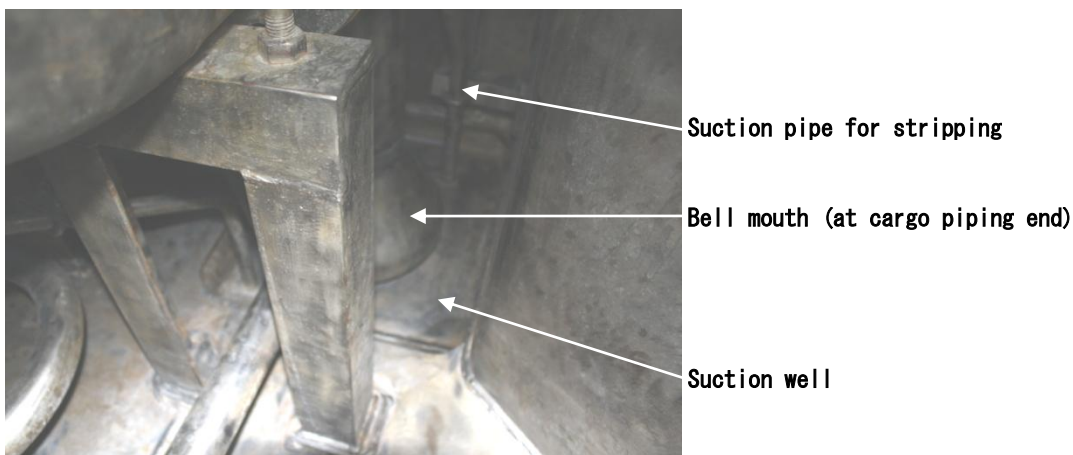
(Photo 2.5-5 Suction Well, etc.)

According to the Procedure & Arrangement manual for equipment*¹⁵ (P&A manual), the Port No.1 cargo tank had a capacity of 80.164 m³, and the suction well (44 x 38 x 6 cm) had a capacity of approximately 0.01 m³.

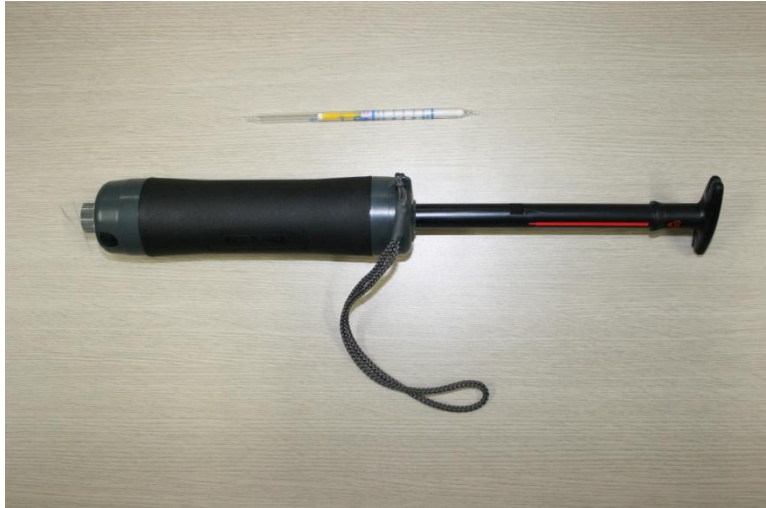
(Photo 2.5-8 Gas Detector and Detector Tube)

The Ship was furnished with "a toxic gas detector and detector tubes" (hereinafter referred to as "gas detector") but the crew of the Ship had never used them. It was required in the operation manual and in Attached Table 8-3 pursuant to Section 10, Article 2 of the Notification*¹⁸ providing standards for the transportation of dangerous goods by vessels (Ministry of Transport Notification No. 549, 1979), that the chemicals to which toxic gas detection is required include chloroform, and that a toxic gas detector must be used for chloroform gas detection. Furnishing respirators and eye protectors for escaping in emergencies was also required, and the Ship was furnished with them.
