MA2014-12

**MARINE ACCIDENT
INVESTIGATION REPORT**

Vessel type and name: LNG tanker PUTERI NILAM SATU

Accident type: Collision

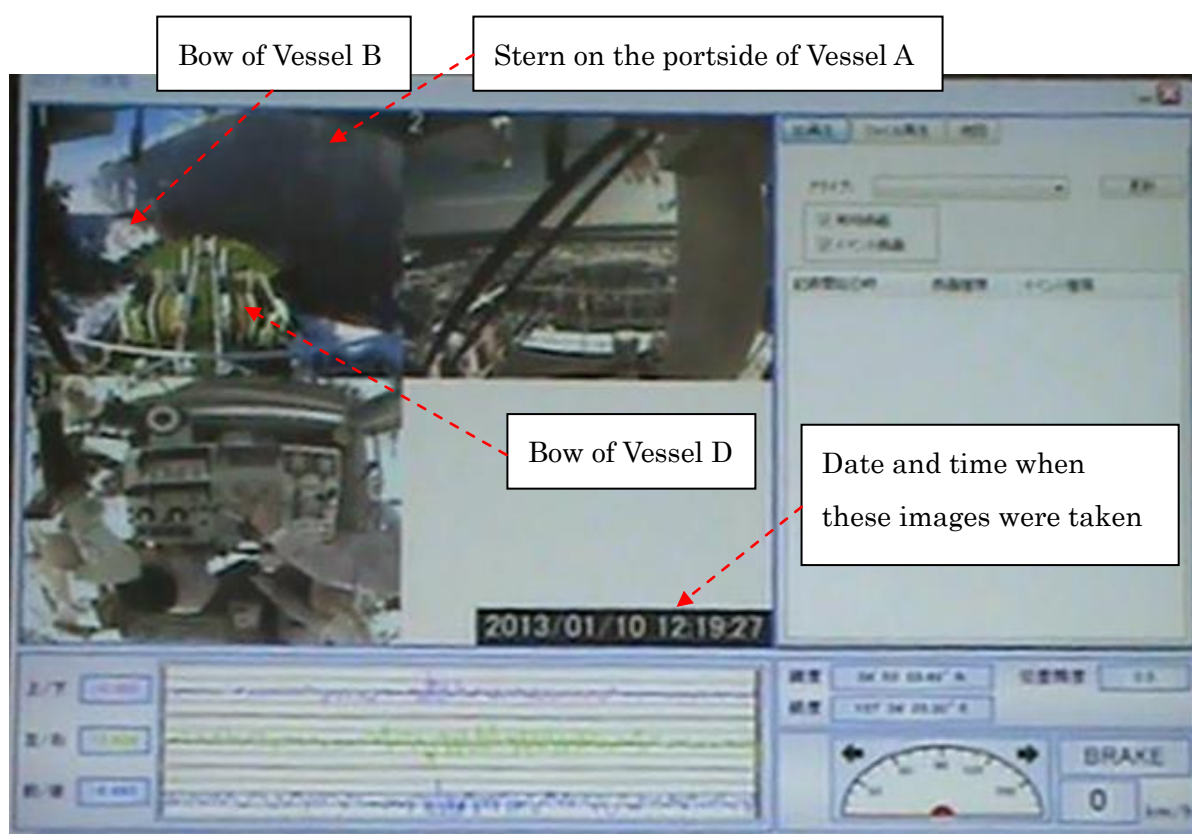
Photo 2.1-1 Image at the time of collision taken by the image recorder equipped in Vessel D

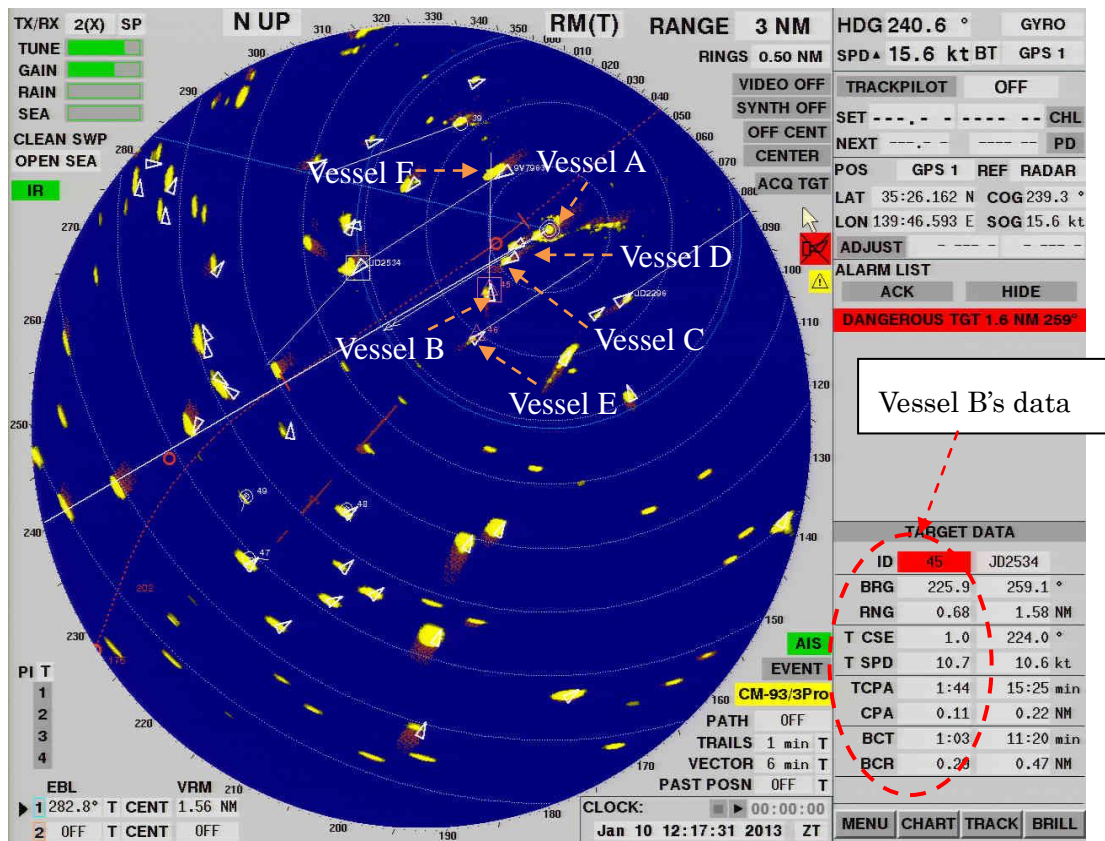
According to the VDR information recorded by Vessel A, the period when the information of Vessel B was shown in the radar of Vessel A was between 12:17:00 and 12:18:30. The following shows the details (See Photo 2.1-2).

Photo 2.1-2 Image of radar taken by Vessel A

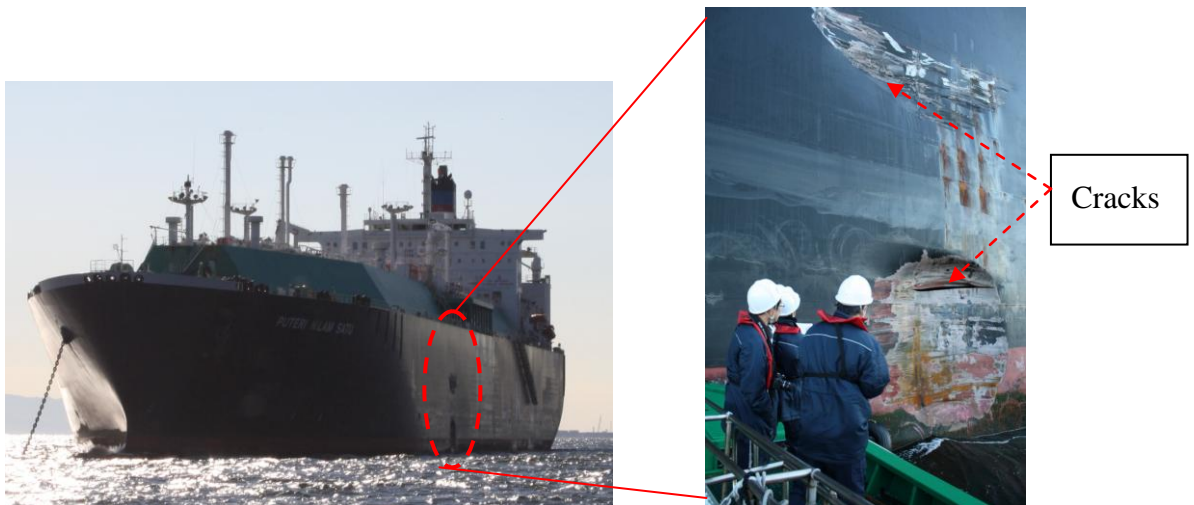
Vessel A received some dents and cracks on its hull around the center of the portside and Vessel B received crushes on its hull of the bow and some dents on the bulbous bow.

Photo 2.3-1 Damaged state of Vessel A

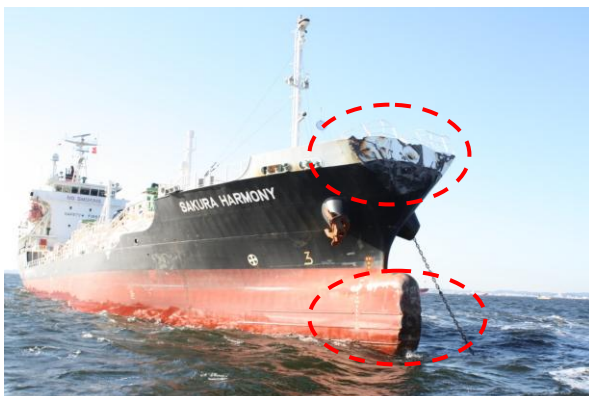
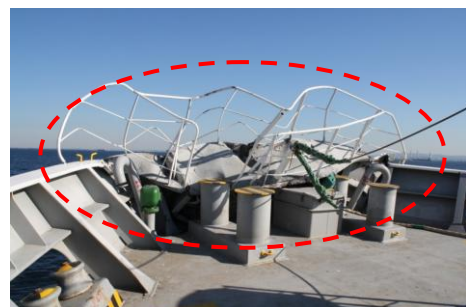
Photo 2.3-2 Damaged state of Vessel B

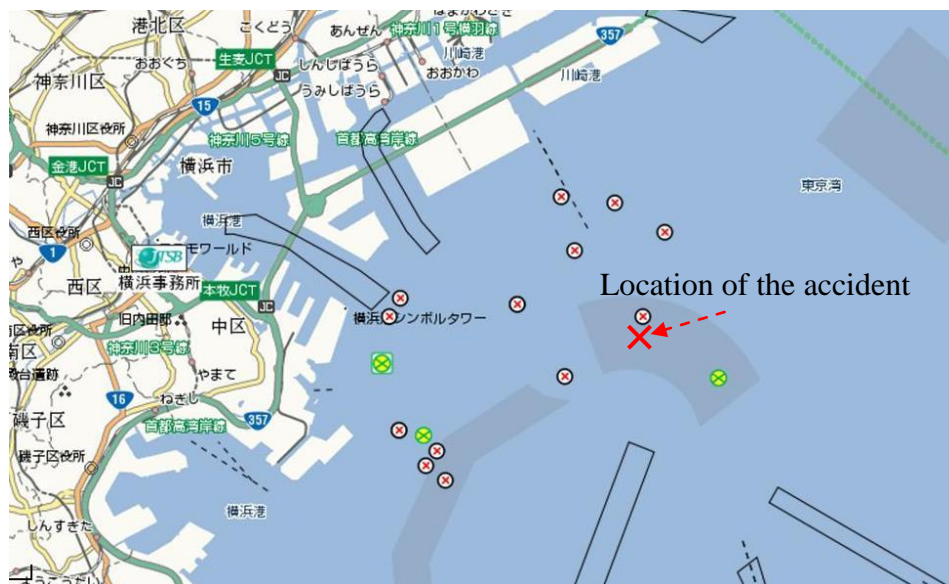
1989 involving cargo ships and tankers being proceeded outside the traffic route in the vicinity of the area near the location of this accident under the condition where the visibility was not limited is 16. The breakdown is as follows. (See Attached diagram 2.8-1.)

Attached diagram 2.8-1 Locations of Collisions

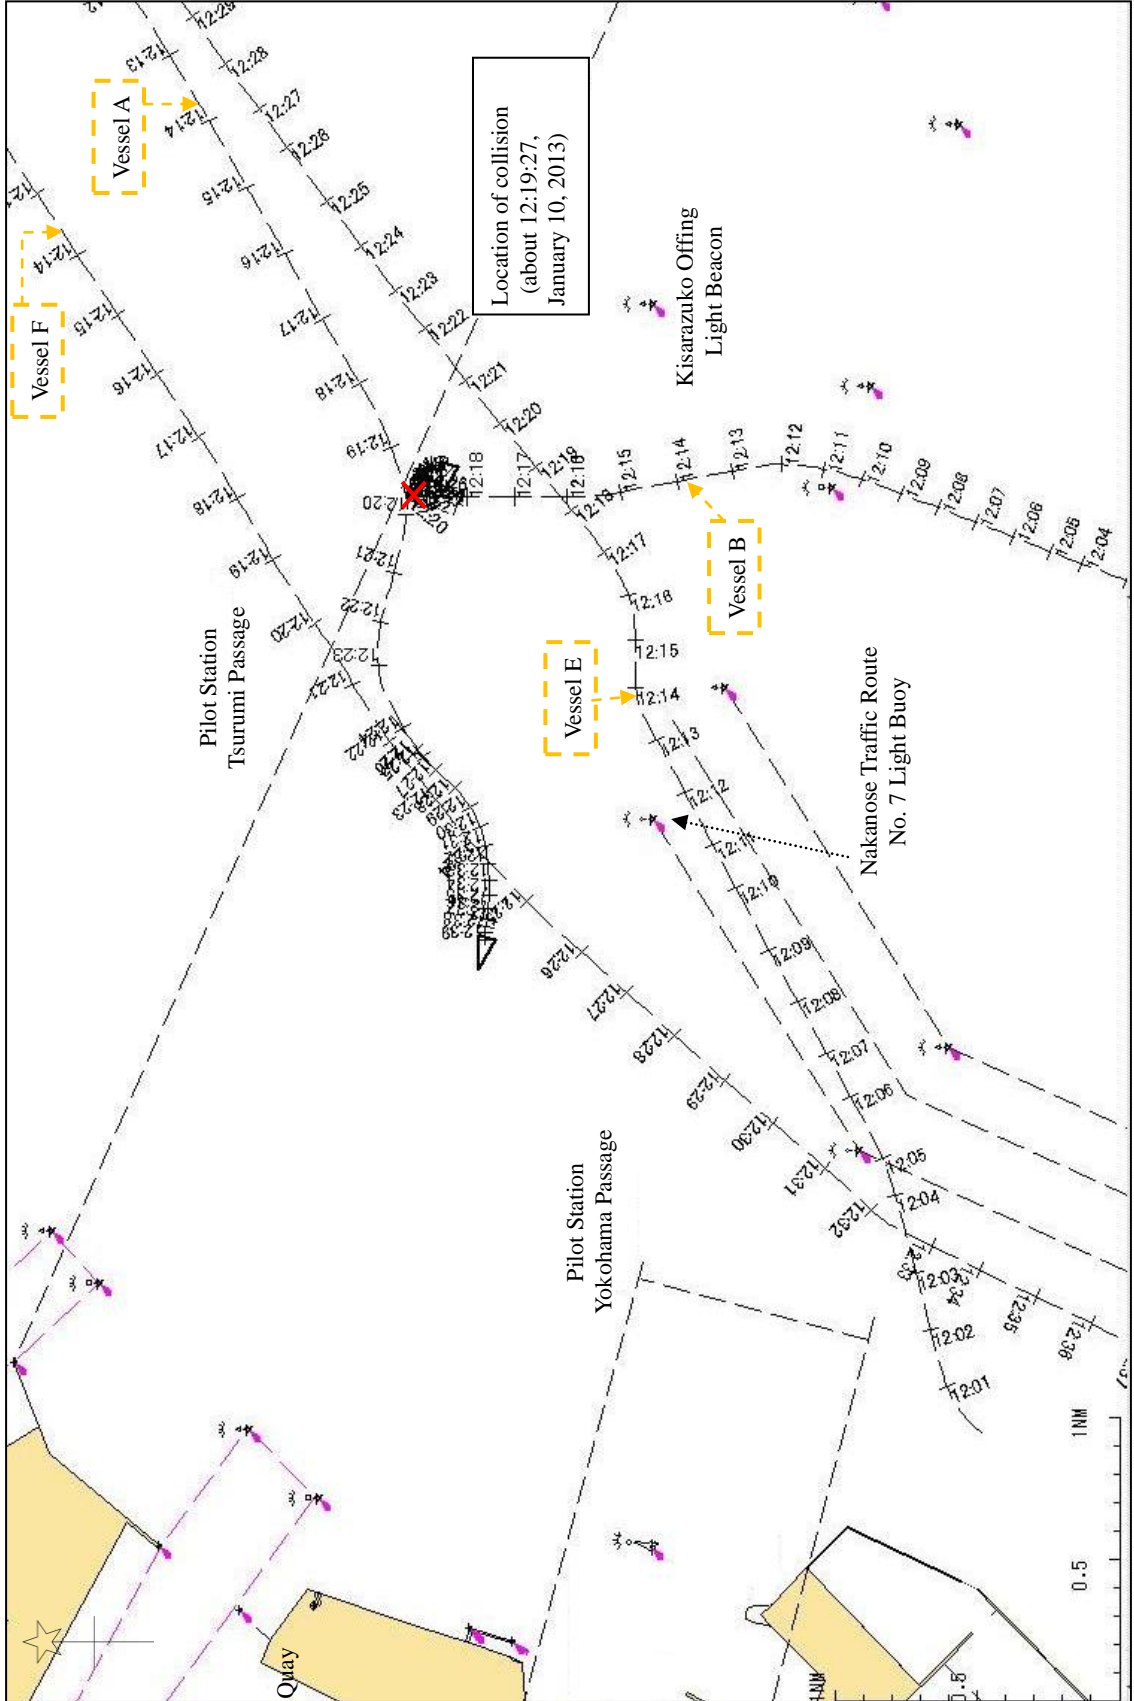
Figure 3 Situation of Vessels A, B, C, and D at the time of the accident
