**MARINE ACCIDENT  
INVESTIGATION REPORT**

Vessel type and name: Container ship PANCON SUCCESS

Accident type: Fatality of a crew member

Date and time: Around 20:25 on February 7, 2013

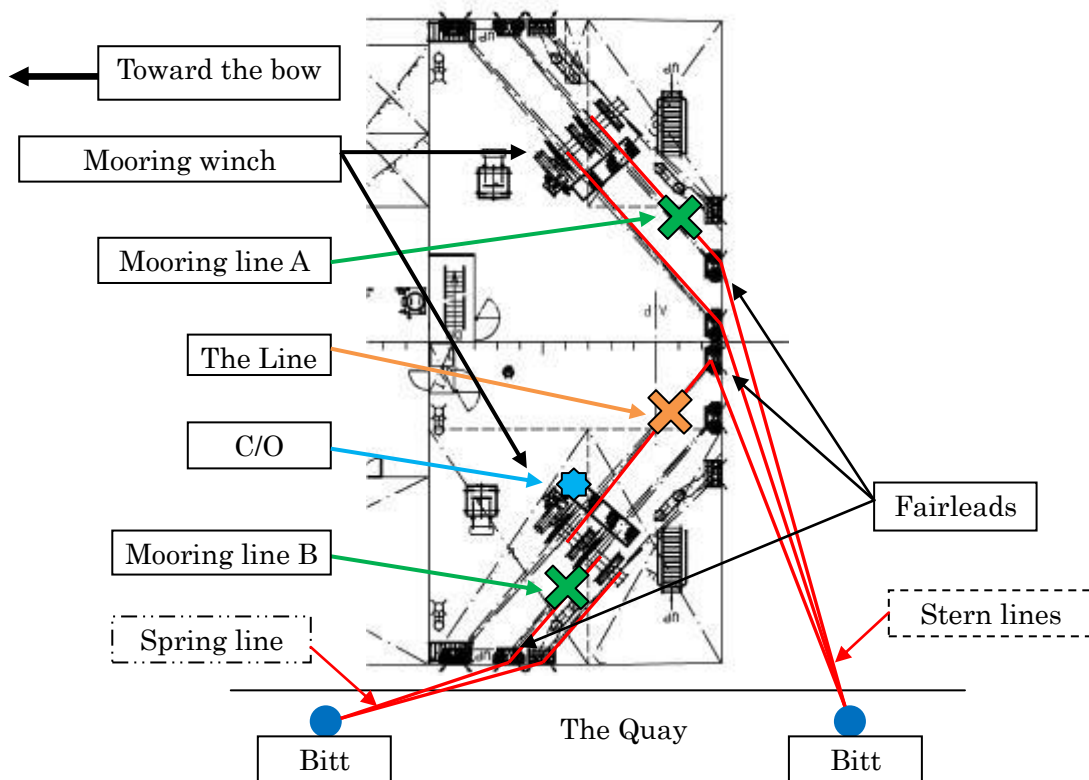
Figure 2-1 Stern Section of the Vessel

On the Vessel, while Mooring Line B was being replaced, the stern line (hereinafter referred to as “the Line”) that led from the portside mooring winch to the bitt on the Quay through the fairlead at the central part of the Vessel’s stern was severed at around 20:25 and the Line struck the C/O on his buttocks, knocking him down.

X marked on the line indicates the severed point.

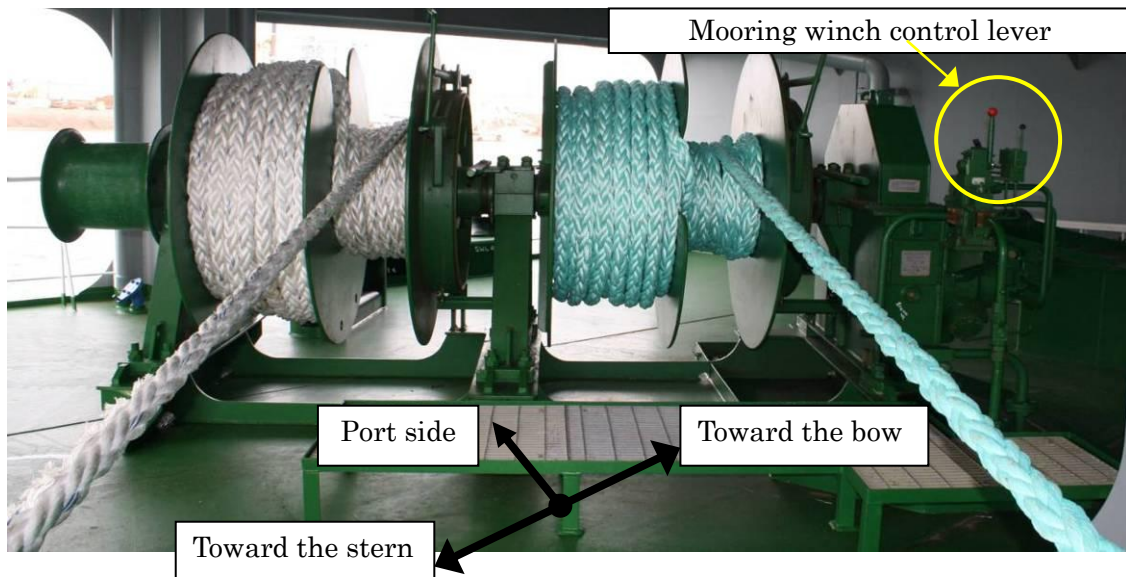
Photo 2-2 Port Side Mooring Winch

At the time of the accident, the C/O was operating the mooring winch on the port side; he disengaged the clutch of the winch's starboard side hawser drum while applying its brake and engaged the clutch of the portside hawser drum while releasing its brake.

(At the time of the accident, the mooring line on the stern side ran through the portside fairlead and the mooring line from the portside fairlead was wound on the warping end.)

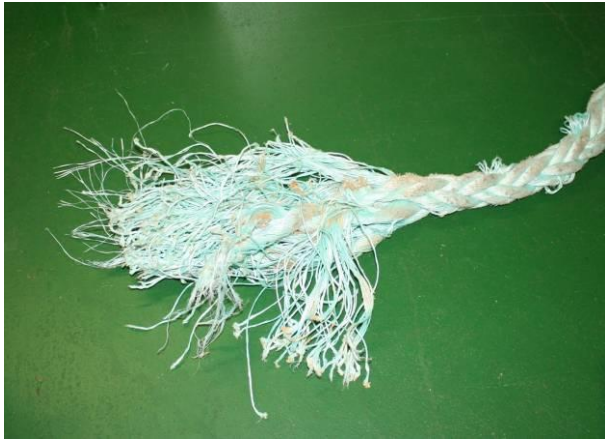
Photo 2-3 Severed End of the Line

The Line was found to have severed at a point approximately 4 m away from the hawser drum and the cut ends of the yarn<sup>\*9</sup> were on almost the same plane showing melt marks.

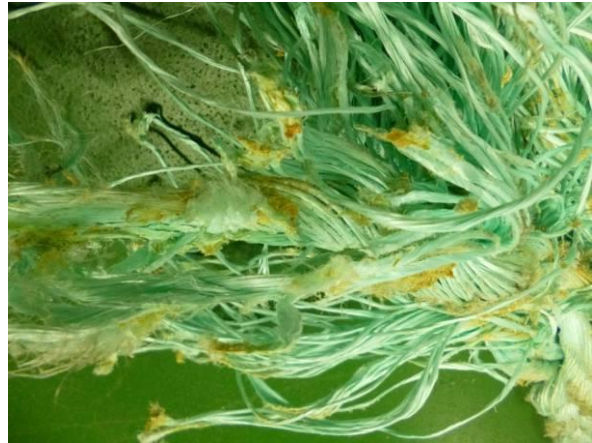
Photo 2-4 Melt Marks on the Severed End of the Line

Based on the fact that the yarn of the severed end of the Line was on almost the same plane and found to be melted, it is estimated that the Line had severed at the fairlead, a curved part at its base or some edge in the hull when it was tensioned.

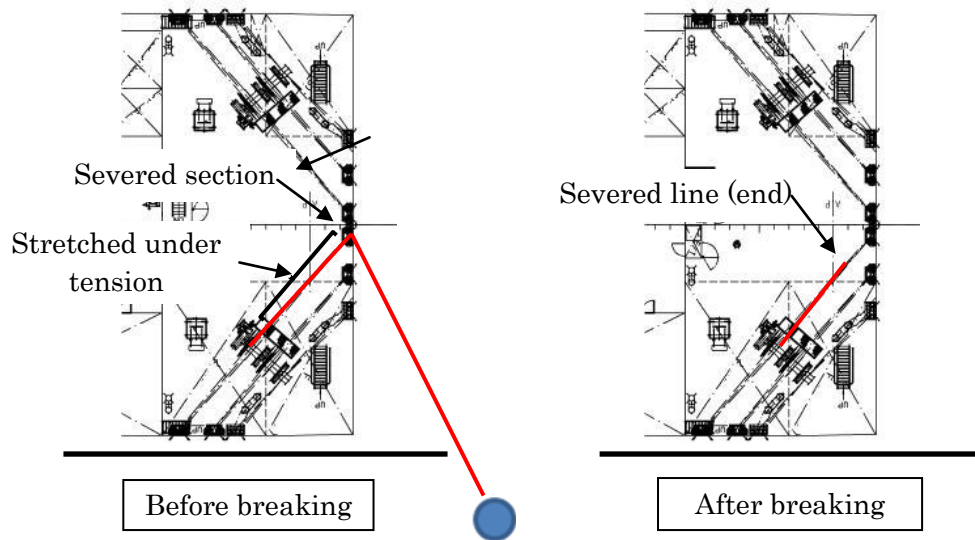
Figure 2-5 State Before and After Severance of the Line

The Line is reported to have severed on the deck, but according to the findings from past studies and the like, a line mooring a ship is stretched under tension and if it is severed at a fairlead or something at the stern, one end resiles toward the mooring drum and the other end toward the mooring point on the quay as does a stretched rubber band; so the mooring line's severed end on the mooring drum side is estimated to have reached the aft side of the drum and then returned to the drum's fore side, and so was found remaining on the deck.

The Line was probably tensioned with a force greater than its strength due to the swaying of the moored Vessel and the Line was also subject to compression force caused by the swaying of the Vessel in the section bent by the fairlead. Then, the Line probably underwent an instantaneous force exceeding its tensile and shear strength, finally resulting in severance.

Past studies have shown that the breaking load of a line at a curved section is reduced to 90% of its breaking load determined by tensile test.
