MA2014-8

**MARINE ACCIDENT  
INVESTIGATION REPORT**

# MARINE ACCIDENT INVESTIGATION REPORT

<b>Accident type</b>	Fatality of a stevedore
<b>Date and time</b>	Around 16:22, August 13, 2013 (local time, UTC+9 hours)
<b>Location</b>	Funabashi Chuo Wharf South B Berth in Katsunan District, Port of Chiba in Chiba Prefecture (approximately 35°40.4' N, 139°58.5' E)
<b>Summary of the Accident</b>	On the cargo ship WELLINGTON STAR, one of the stevedores on the upper deck deceased after being caught between a container and a sludge shore connector steel box while they were loading containers with a deck crane at Funabashi Chuo Wharf South B Berth in Katsunan District, Port of Chiba, at approximately 16:22 on August 13, 2013.
<b>Process and Progress of the Investigation</b>	<p>(1) Setup of the Investigation The Japan Transport Safety Board appointed an investigator-in-charge and two other investigators to investigate this accident on August 13, 2013.</p> <p>(2) Collection of Evidence On-site investigation and interviews on August 15, 2013 Interviews on August 20, 21, 23, 27, and 29, September 10, and October 7 of 2013 and February 3 of 2014</p> <p>(3) Comments from Parties Relevant to the C

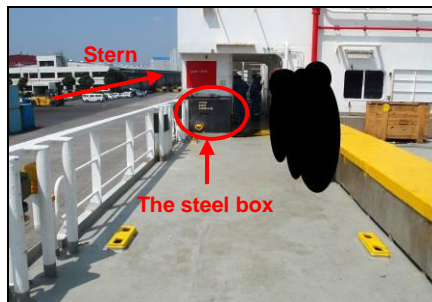
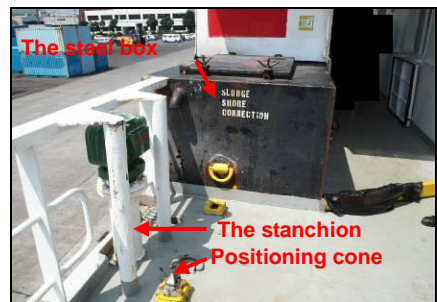
Photo 2, Photo 3: Situation around the loading area

(2) On the stern side of the "stern-most area on the upper deck on the starboard side toward the front of the poop where containers were loaded" (hereinafter referred to as "the loading area"), there was a sludge shore connector steel box (hereinafter referred to as "the steel box"). On the side of the vessel, a protective stanchion for a vent pipe (hereinafter referred to as "the stanchion") was installed. The space between the back end of the container and the steel box was approximately 110cm when a container was loaded in the loading area.

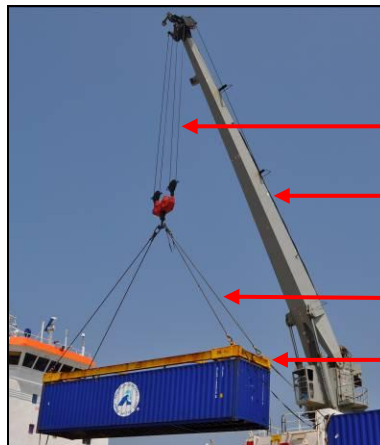
Photo 5: Situation of container lifting

- (5) The total weight of the container, which had been lifted at the time of this accident, was approximately 24t.
- (6) The container was easily swung in this situation due to the facts that spreaders were attached to the top and that all 4 slings attached to the 4 corners of the spreaders were hung on a single crane hook, which was lifted by cargo wires.

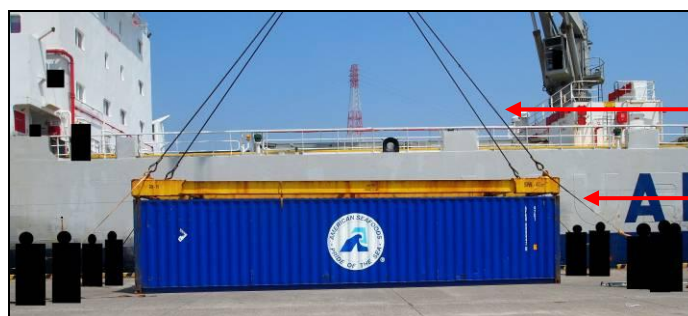
Photo 6: Situation in which stevedores held the tag lines

The winchman operated #4 deck crane, and the deckman and other stevedores divided between the berth and the upper deck to control the swinging of the containers by holding the tag lines connected to spreaders; and the foreman supervised the loading work on the bow side of the loading area. They began lifting the containers to load them at approximately 16:10.

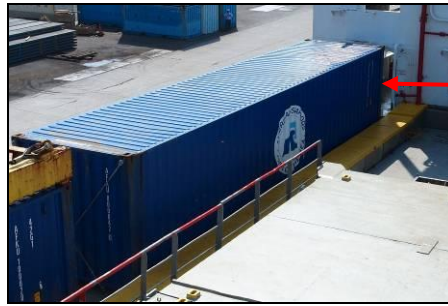
Photo 7: Situation of the view from around the operation seat of #4 deck crane

The winchman operated the deck crane to lift the container from the berth to the upper deck and gradually moved the container from the bow side of the loading area toward the loading area. At this point, he could no longer see the stern side of the loading area due to the lifted container.

- (4) It is highly probable that the winchman, who was operating #4 deck crane, could not see the stern side of the loading area because of the container that was being lifted.

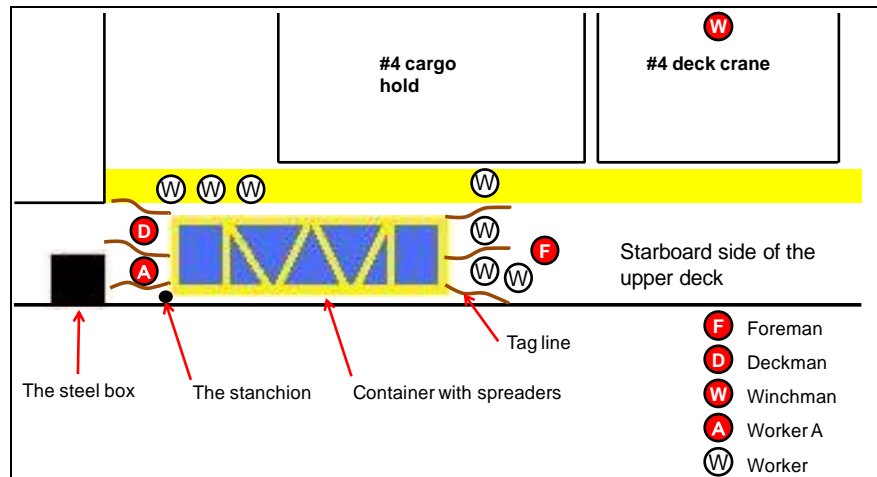
Figure 2: Situation at the time of this accident

When the deckman held the tag line, he saw stevedore A on his right and the steel box behind stevedore A and thought it was a narrow and dangerous place. Immediately after telling stevedore A that he should change his position because the area was dangerous, the container's right edge on the stern side was caught by the stanchion. The deckman saw the container swinging toward the stern side when it was released.

When the container swung toward the stern side at approximately 16:22, the deckman evacuated toward the back and saw that stevedore A was caught between the container and the steel box.

- (3) It is probable that stevedore A, who was standing by the steel box, which was behind him, at the stern side of where the container was being moved, deceased because he was caught between the container and the steel box when the right edge of the stern side of the container was caught by the stanchion and the container swung toward the stern side after being released while the container was being lifted above the upper deck and was moving to the loading area.

- (1) Conduct comprehensive hazard prediction activities before work
- (2) ensure that safety check is carried out before work by the foreman
- (3) ensure that the stevedores comply with the work procedure
- (4) ensure that no stevedore enters hazardous areas (indicating hazardous areas with notices, ropes, safety cones, etc.)
