MA2015-1

**MARINE ACCIDENT
INVESTIGATION REPORT**

Vessel type and name: Cargo ship JNS-2
IMO number: 8869701
Gross tonnage: 1,500 tons

Accident type: Collision (contact with fishing gear)
Date and time: At around 11:01 on March 8, 2012
Location: Off the west of Iwaishima, Kaminoseki-cho, Yamaguchi Prefecture
On a true bearing of around 255°, at a distance of 8.4 nautical miles from the
Iwaishima Lighthouse (Approximately 33°44.9'N, 131°49.8'E)

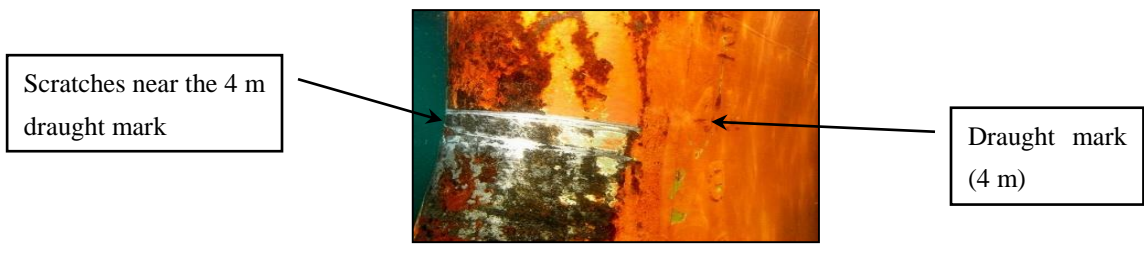
Photo 1 Scratches on the bow

Scraped-off paint and scratches were found on the tip of the bow near the 4 m draught mark. (See Photo 1.)

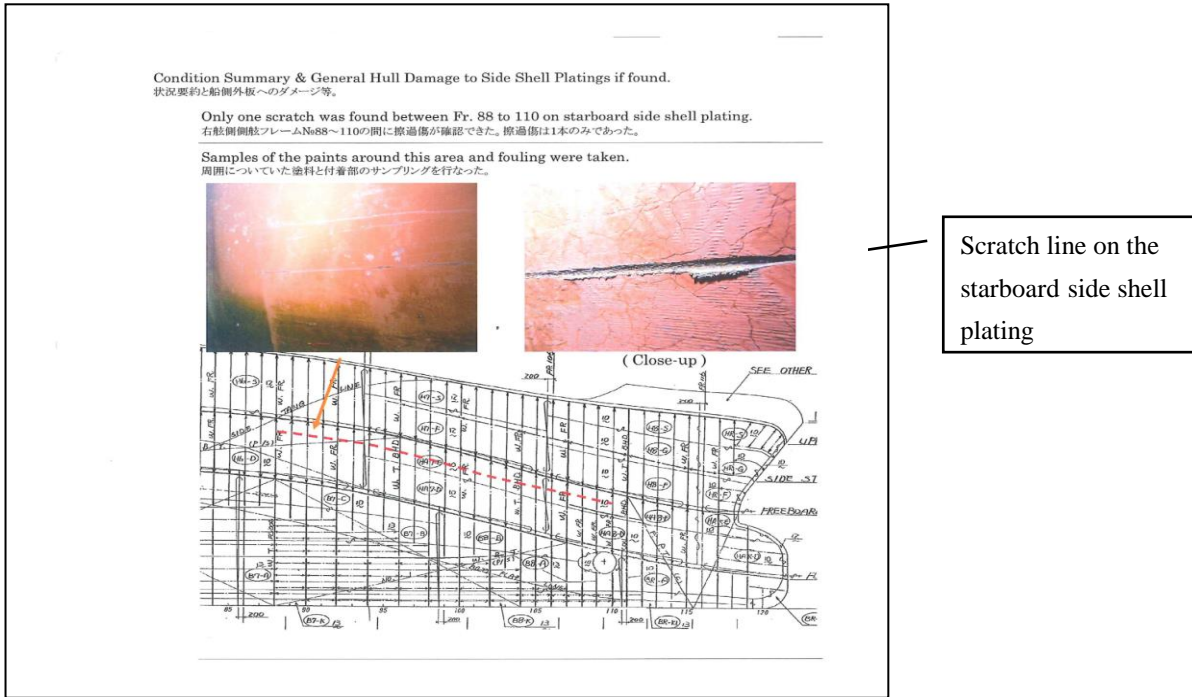
Photo 2 Scratch line on the starboard side shell plating

A scratch line was found on the starboard forward side shell plating (between frames No. 88 and No. 110). (See Photo 2.)

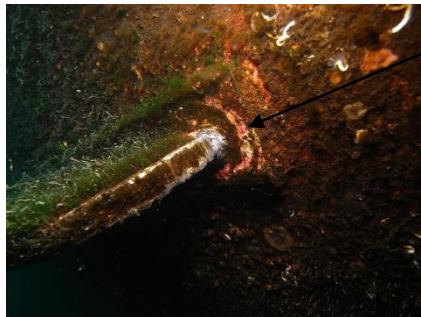
Photo 3-1 Front end of starboard bilge keel

Both the starboard and port bilge keels had scratches on the front ends. (See Photo 3-1 and Photo 3-2.)

Scratches on the front end of the starboard bilge keel

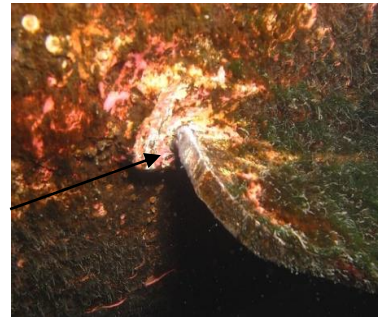
Photo 3-2 Front end of port bilge keel

Scratches on the front end of the port bilge keel

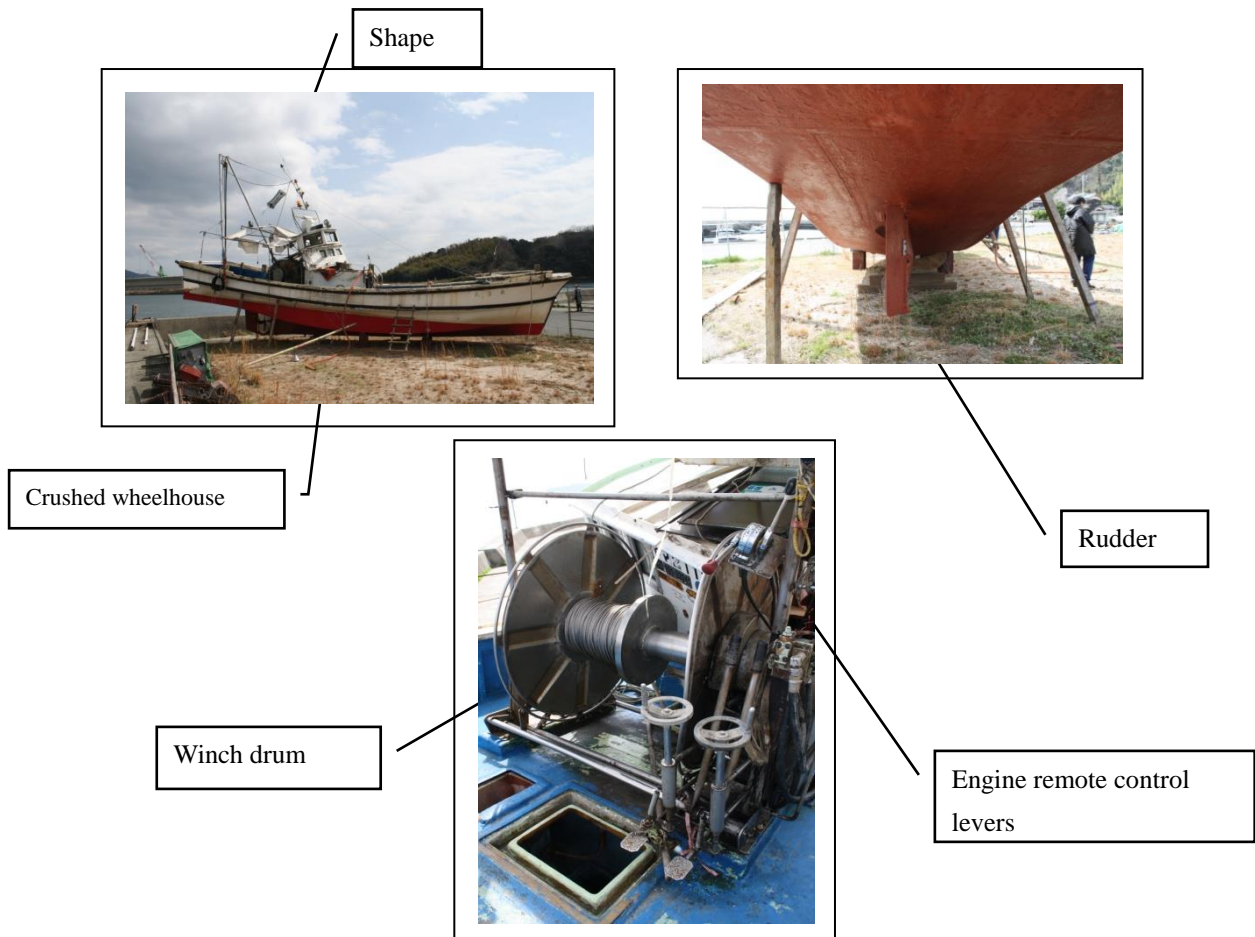
Photo 4 Salvaged Vessel B

The wheelhouse was found to be crushed. An hourglass-shaped shape that had been exhibited to indicate a vessel engaged in fishing operation was found deformed into a cylindrical shape.
