**MARINE ACCIDENT
INVESTIGATION REPORT**

Accident type	Injury of worker
Date and time	September 11, 2013, at about 17:00 (local time, UTC +9 hours)
Location	Nakashima Quay No. 3, Port of Himeji, Himeji City, Hyogo Prefecture 160° true, 540 m from Shikama Higashi East No.2 Breakwater Lighthouse, located in Himeji City (approximately 34°46.2' N, 134°39.6'E)
Summary of the Accident	The cargo ship GREEN HOPE, carrying the master and 20 crew members, was discharging a cargo of timber at Nakashima Quay No. 3, Port of Himeji. At about 17:00 on September 11, 2013, deck crane No. 1 collapsed and caused injury to the crane operator.
Process and Progress of the Investigation	<p>(1) Setup of the investigation</p> <p>The Japan Transport Safety Board appointed an investigator-in-charge and one other investigator to investigate the accident on September 12, 2013.</p> <p>(2) Collection of evidence</p> <p>On-site investigation and interview on September 13 and 14, 2013, interview on September 19 and 20, and November 5, 6 and 20, 2013, interview on April 22, May 26, and July 25, 2014, collection of questionnaire on October 2 and 8, 2013, January 20, April 25, May 9 and 27, June 4, July 2 and 28, Au

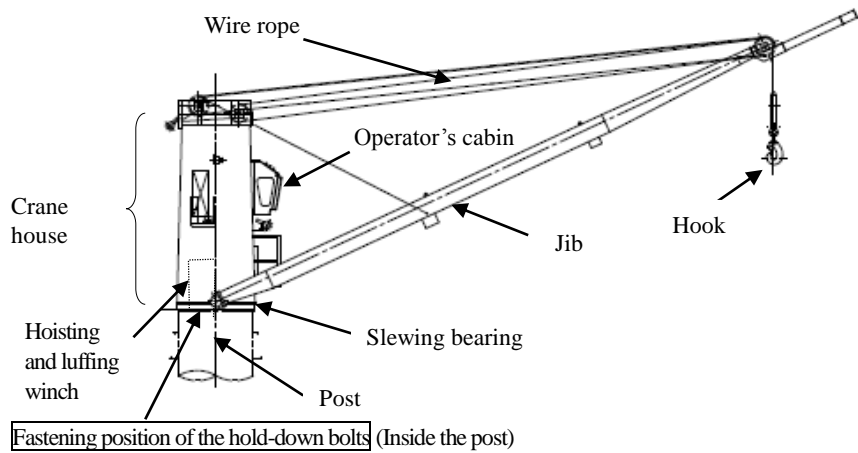
Figure 1: Side view of the crane

The outer circumference of the slewing bearing was fastened to the crane house by 60 bolts (hereinafter referred to “crane-side bolts”), while the inner circumference was fastened to the post by 60 bolts (hereinafter referred to as “hold-down bolts”). (See Figures 1 and 2.)

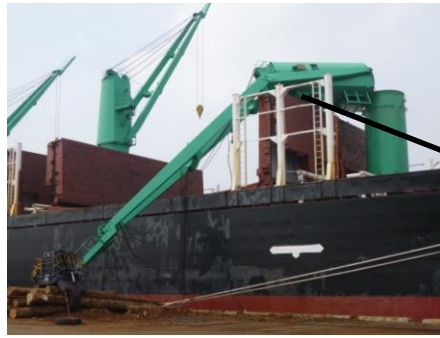
Photograph 3: The collapse of the crane

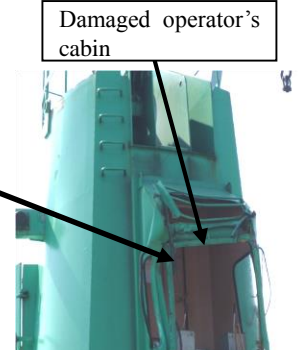
Photograph 4: Damage to the operator's cabin

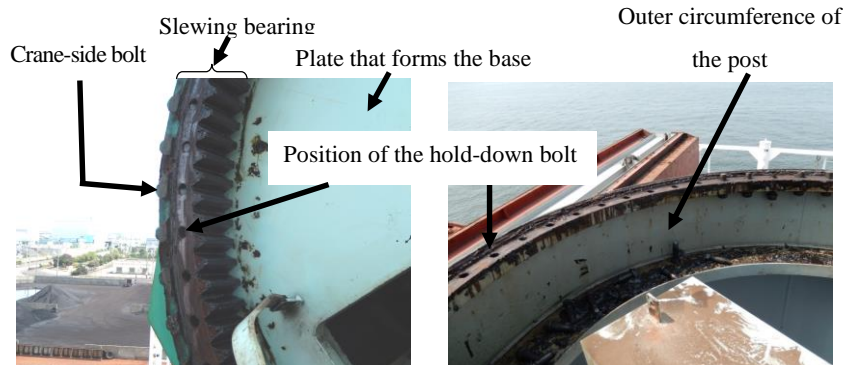
② When the crane collapsed, all the hold-down bolts were fractured, and the upper end of the post tore open. (Refer to photographs 5 and 6).

Among the hold-down bolts, two bolts had rusted completely over the entire surface of the fracture.

Photograph 5 (left): Collapsed state of the crane (lower part of the crane)

Photograph 6 (right): Upper end of the post at the lower part of the crane

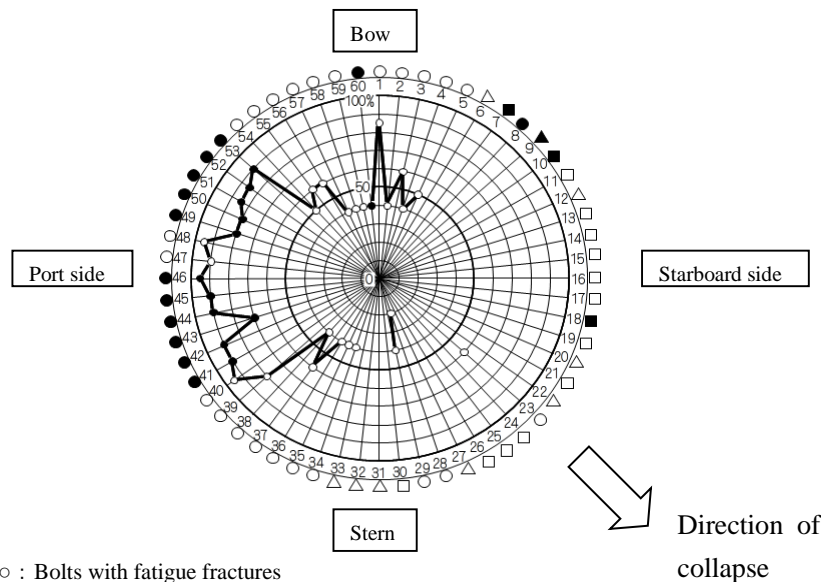
Figure 4: Distribution of damage for all the hold-down bolts

- (1) There were fatigue fractures (fractures caused by repeatedly applied loads) on 36 hold-down bolts, mostly located on the port side of the post. There were also only ductile fractures (fractures caused by loads above the tensile strength) on the 24 remaining hold-down bolts, mostly located on the starboard side of the post. (Refer to photographs 7 and 8, and Figure 4.)

●○ : Bolts with fatigue fractures

■□ : Bolts with ductile fractures only

▲△ : Bolts with ductile fractures only (cup and cone type)

Bolt in position 8: Did not become detached. (Unable to compute the surface area of the fatigue fracture)
