**MARINE ACCIDENT
INVESTIGATION REPORT**

MARINE ACCIDENT INVESTIGATION REPORT

Vessel type and name: Cargo ship JIA HUI

Accident type: Collision

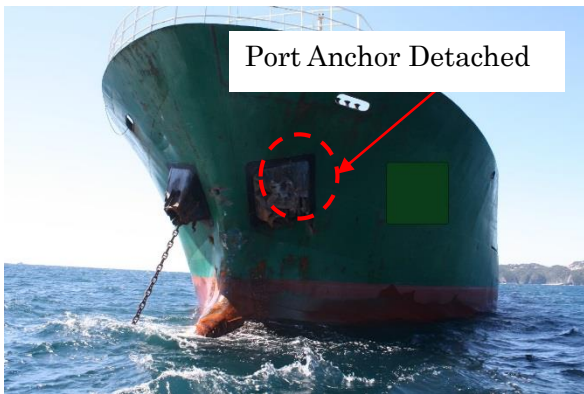
Crush on the Port Bell
Mouth

Vessel A had the crown and arm part of the port anchor detached, crushing on the port bell mouth, holes in the bow area, and dent damage with crack in the bulbous bow. (See Photo 2.3-1 to Photo 2.3-3)

Photo 2.3-1 Damages at the Port Anchor

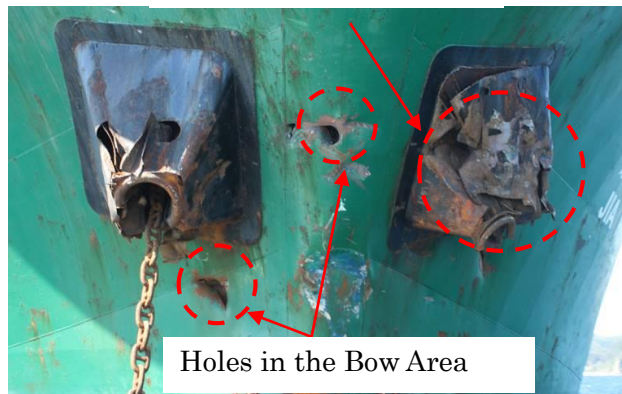
Photo 2.3-2 Damages in the Bow Area

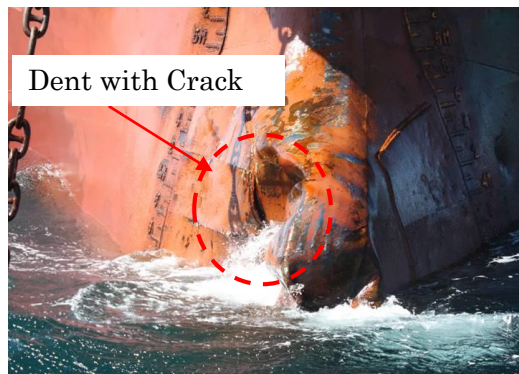
Photo 2.3-3 Damages in the Bulbous Bow.

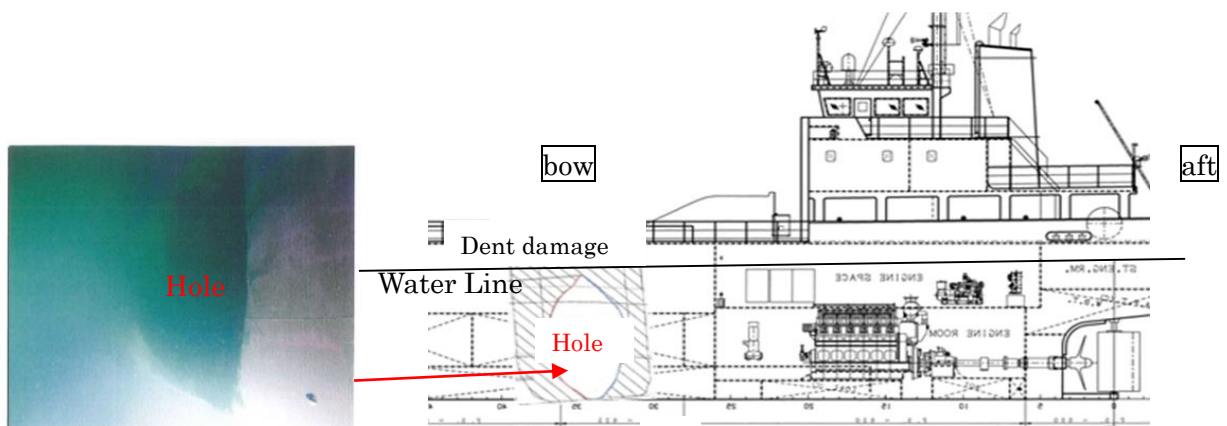
According to the reply to the questionnaire by Salvage Co., Ltd. (hereinafter referred to as "Company D") and information from the Japan Coast Guard, Ship B had a hole of about 3.5m in width and about 5.5m in height at the outside planking of the shipboard in the portside midship. (See Figure 2.3-1)

Figure 2.3-1 Damage Conditions of Ship B (Photo was provided by Company D)

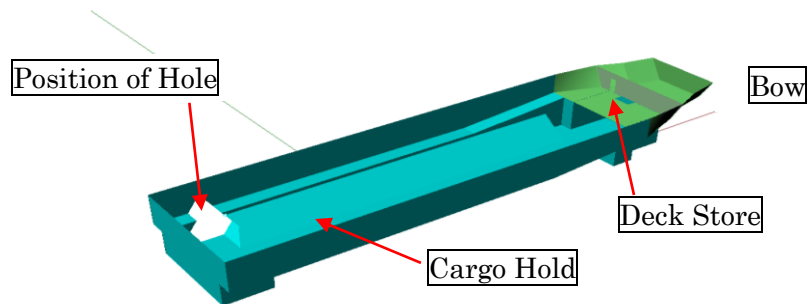
The flooded compartments were the cargo hold, deck store, FOT (P) and No.4WBT(P).
(See Figure 2.10-2)

Figure 2.10-2 Outline Drawing of Flooded Compartments

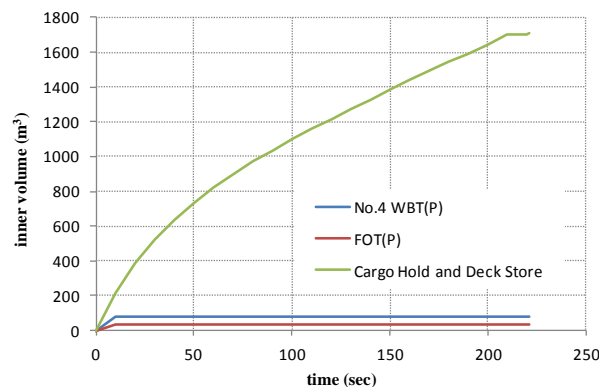
After Vessel A moved away, No.4 WBT(P) and FOT(P) tanks of Ship B became fully flooded after 10 seconds. The hull listed to the port side, and the flooding volume to the cargo hold and deck store was about 820m³ after 1 minute, about 1,210m³ after 2 minutes, and about 1,540m³ after 3 minutes.

Figure 2.10-3 Time Series Variation of the Flooding Volume

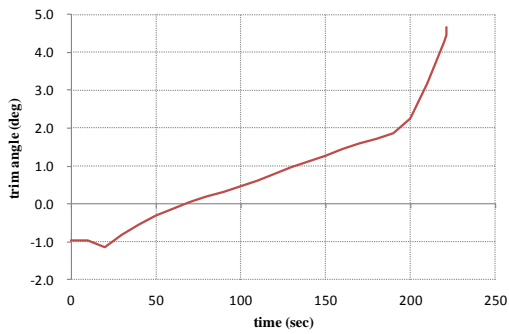
Figure 2.10-4 Change in the Trim Angle

After Vessel A moved away from Ship B, the area near the engine room of the cargo hold of Ship B was flooded. The buoyancy on the stern side was secured and the bow was sinking, because there was no damage in the area behind the bulkhead at the front part of the engine room.

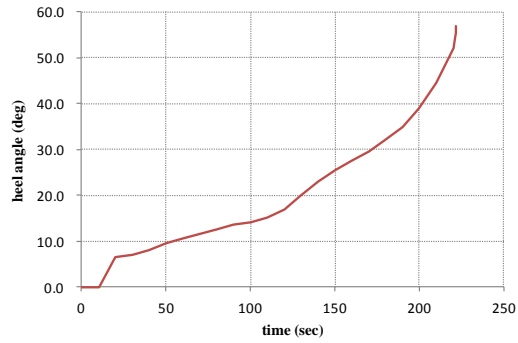
Figure 2.10-5 Change in the Heel Angle

Before 1 minute after Vessel A moved away, Ship B sank rapidly, listed sideways about 10.5° further to the port, then the sinkage and listing to the port side increased further; the port edge on the deck reached to sea level after 2 minutes, the port deck was under the water after 3 minutes, and a large part of the hull was under water after 3 minutes and 30 seconds.

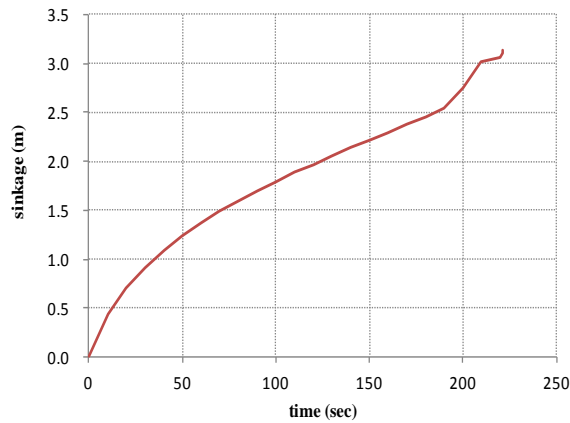
Figure 2.10-6 Change in Sinkage

Sinkage increased sharply when the flooding started, and as the difference between the sea surface and the water level in the ship became smaller, it increased at an almost constant ratio afterwards and reached about 1.2m after 1 minute, about 1.9 m after 2 minutes, and about 2.4m after 3 minutes.
