MA2016-3

**MARINE ACCIDENT  
INVESTIGATION REPORT**

<b>Accident Type</b>	Grounding
<b>Date and time</b>	Around 22:29, on December 20, 2014 (local time, UTC +9 hours)
<b>Location</b>	East of Uma Shima Island, Imabari City, Ehime Prefecture Around 153 degrees true bearing, 120m from Nagasehana lighthouse (Approximately 34° 07.0' N, 132° 59.5' E)
<b>Summary of the Accident</b>	<p>Cargo ship MIGHTY ROYAL, with 23 crews including a master onboard, was sailing northwest under pilotage of a pilot in the Naka Suido in the Kurushima Kaikyo Traffic Route and went aground at the shallow area on the east of Uma Shima, Imabari City, Ehime Prefecture at about 22:29 on December 20, 2014.</p> <p>MIGHTY ROYAL had some holes in the port side bottom, but there were no casualties.</p>
<b>Process and Progress of the Investigation</b>	<p>(1) Set up of the Investigation</p> <p>The Japan Transport Safety Board appointed an investigator-in-charge and another marine accident investigator to investigate this accident on December 21, 2014.</p> <p>(2) Collection of Evidence</p> <p>Interviews on December 21, 2014; January 8, 19, 20, 21, 23, March 6, 18, April 22, 23, June 29, 2015; On-site investigation and i

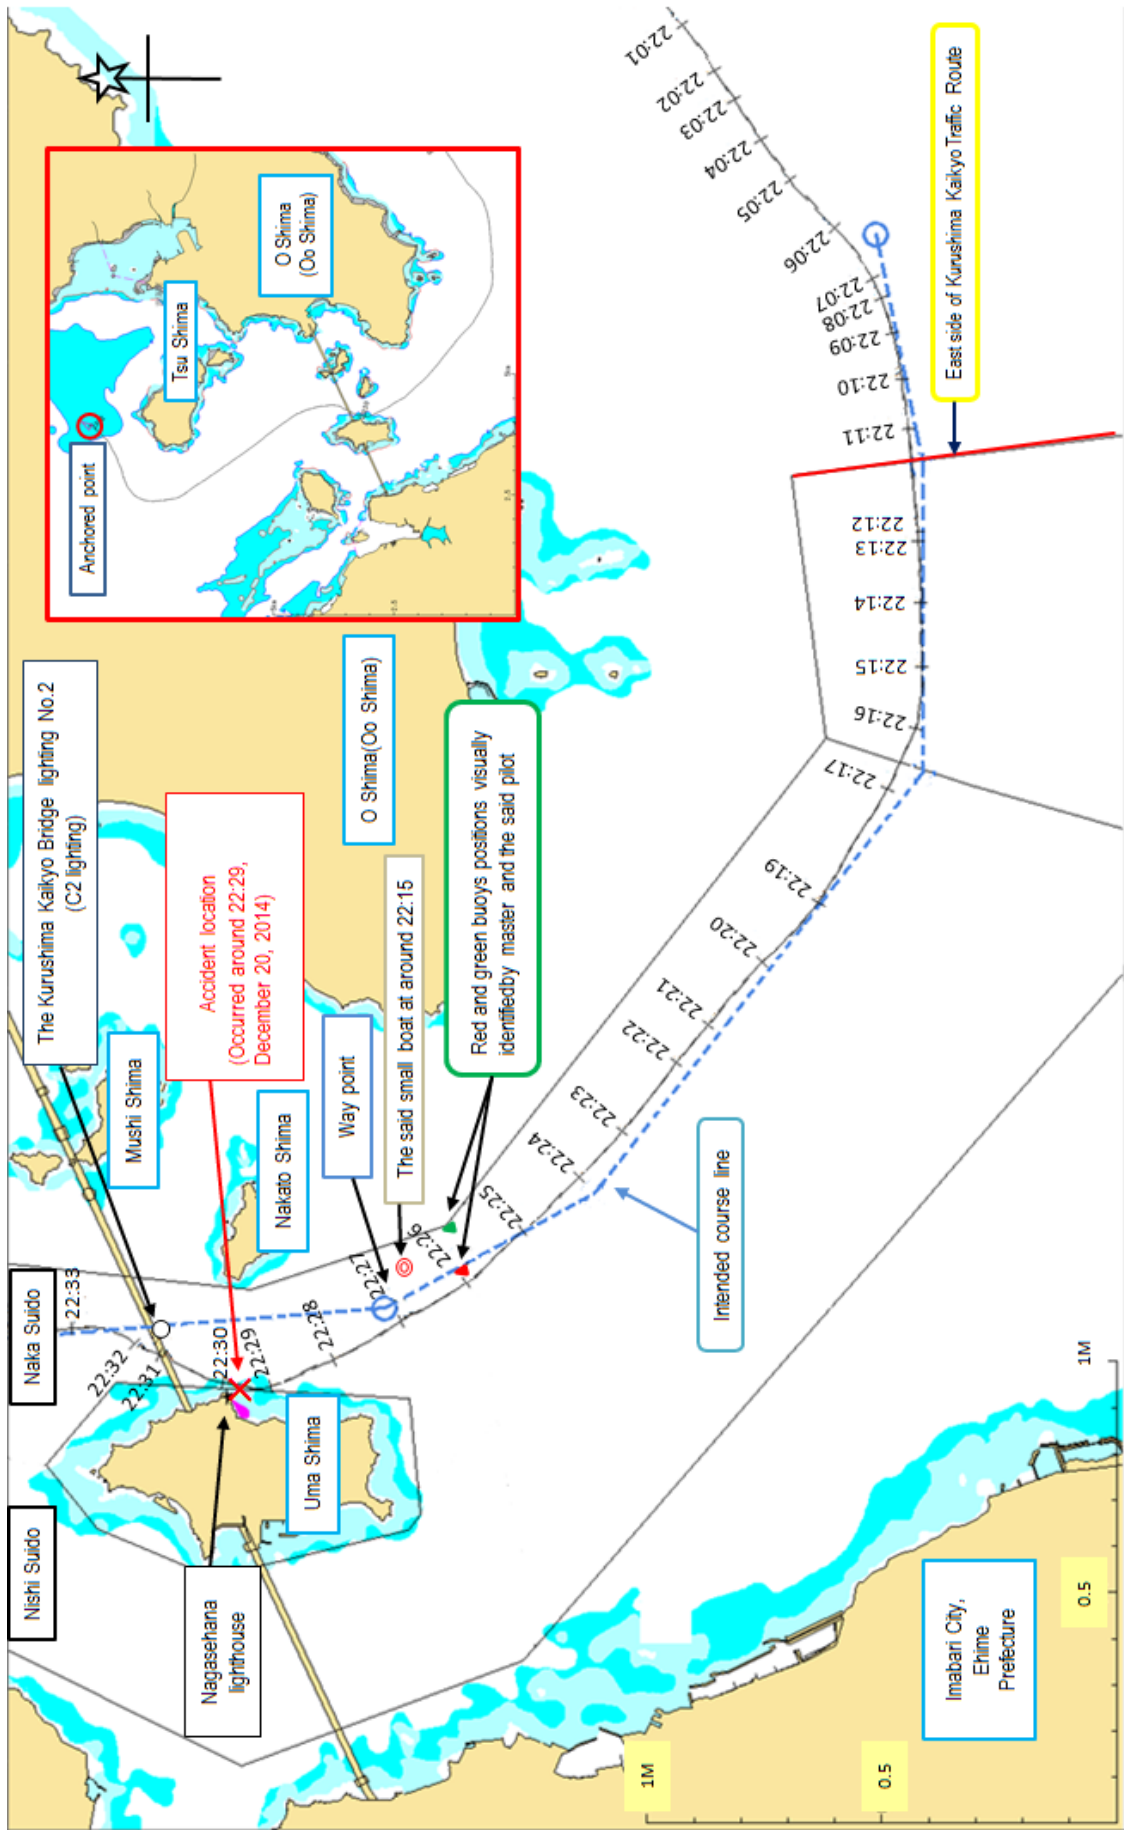
Attached Figure 1 Navigation Route Diagram

<p><b>Probable Causes</b></p>	<p>It is probable that this accident was occurred because the Vessel, while sailing northwest at night in the Naka Suido in between the Uma Shima and the Nakato Shima in the Kurushima Kaikyo Traffic Route just after the tidal current turned northward, took hard port as the Vessel came close to the said small boat on the starboard bow and despite taking hard starboard after the said small boat moved to the port bow, came close to the said small boat, and therefore, went aground at the shallow area on the east of Uma Shima.</p> <p>It is probable that the Vessel came close to the said small boat because while the Vessel sailing northwest in the Kurushima Kaikyo Traffic Route, the said pilot, when recognized the said small boat near the south end of the Naka Suido, thought that the said small boat would sail away from the course line of the Vessel upon lighting the daylight signalling lamp and continued sailing.</p>
