MA2016-10

**MARINE ACCIDENT
INVESTIGATION REPORT**

Accident type	Fatality of a crew member
Date and time	Around 22:15 on October 14, 2015 (local time, UTC+9 hours)
Location	Soma Port Berth 5, Fukushima Prefecture On a true bearing of approximately 251° and at a distance of 0.7 nautical miles (M) from North Breakwater Lighthouse, Soma Port (approximately 37° 51.3' N, 140° 57.2' E)
Summary of the Accident	<p>At around 22:15 on October 14, 2015, while the cargo ship ASIAN INFINITY was moored at Soma Port Berth 5 for cleaning work inside the cargo hold with the master and 16 other crew members (all nationals of the Republic of the Philippines) on board, the third officer fell from the 2nd deck of the No.2 cargo hold into the lower cargo hold.</p> <p>The third officer was taken to hospital, where he was pronounced dead.</p>
Process and Progress of the Investigation	<p>(1) Set up of the Investigation The Japan Transport Safety Board appointed an investigator-in-charge and two other marine accident investigators to investigate this accident on October 15, 2015.</p> <p>(2) Collection of Evidence October 16 and 17, November 4, 5, 17 and 26: On-site investigations and interviews</p> <p>(3)

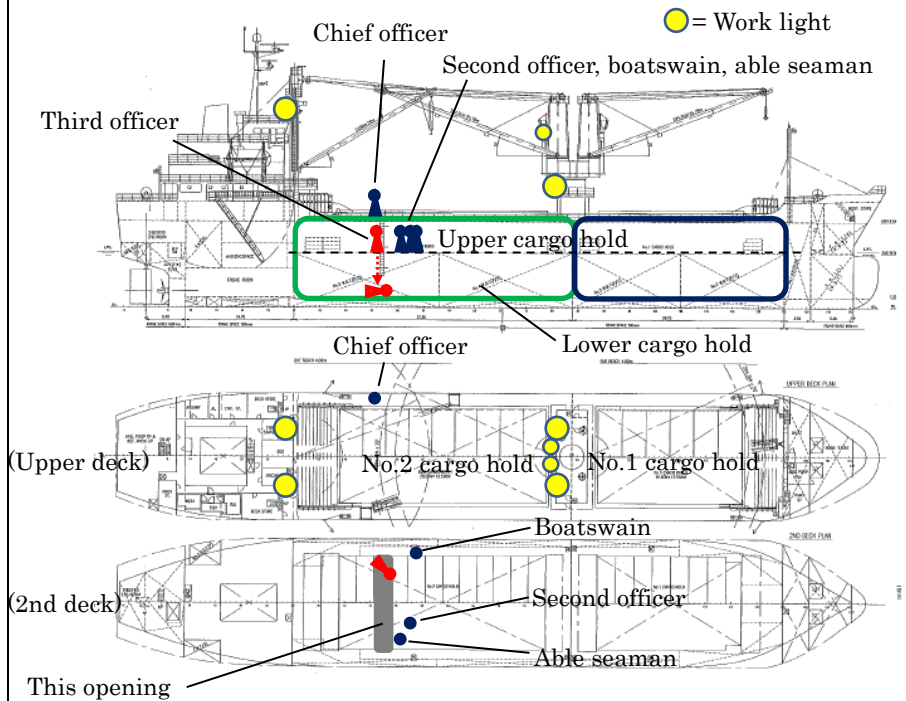
Figure.1 Positions of crew members (general arrangement)

The second officer and the able seaman were engaged in removing dirt from the upper cargo hold by using high-pressure cleaning equipment to spray clean water near the starboard bow side of this opening.

The third officer and the boatswain were both engaged in using water mop implements (squeegees) to mop away the water remainder, the former on the 2nd deck near the port side of this opening and the latter near the ladder on the port side, respectively.

The third officer and the boatswain were not visible to the chief officer.

Although the fallen helmet and squeegee were found in the location where the third officer fell, no crew member witnessed the circumstances of the fall.
