MARINE ACCIDENT INVESTIGATION REPORT

December 8th, 2016

Adopted by the Japan Transport Safety Board

Accident Type	Contact (light buoy)
Date and Time	Approx. 13:25, June 6, 2015 (local time: Approx. 12:25, June 6, 2015)
Location	EASTERN BUOY in the Port of Singapore in the Republic of Singapore Around 289° true bearing, 4.1 M from Changi Lighthouse (Approximate position: 01°17.8' north latitude, 104°05.9' east longitude)
Summary of the Accident	Bulk cargo carrier SHIN HEIRYU contacted with a light buoy while sailing. SHIN HEIRYU suffered abrasions to its portside stern shell. The light buoy suffered dents to the body.
Process and Progress of the Investigation	The Japan Transport Safety Board appointed an investigator-in-charge from the Kobe Office to investigate this accident on June 10, 2015. One other local investigator was appointed at a later date. Comments on the report were invited from parties relevant to the cause of the accident. Comments on the report were requested from countries with substantial interest in the SHIN HEIRYU.

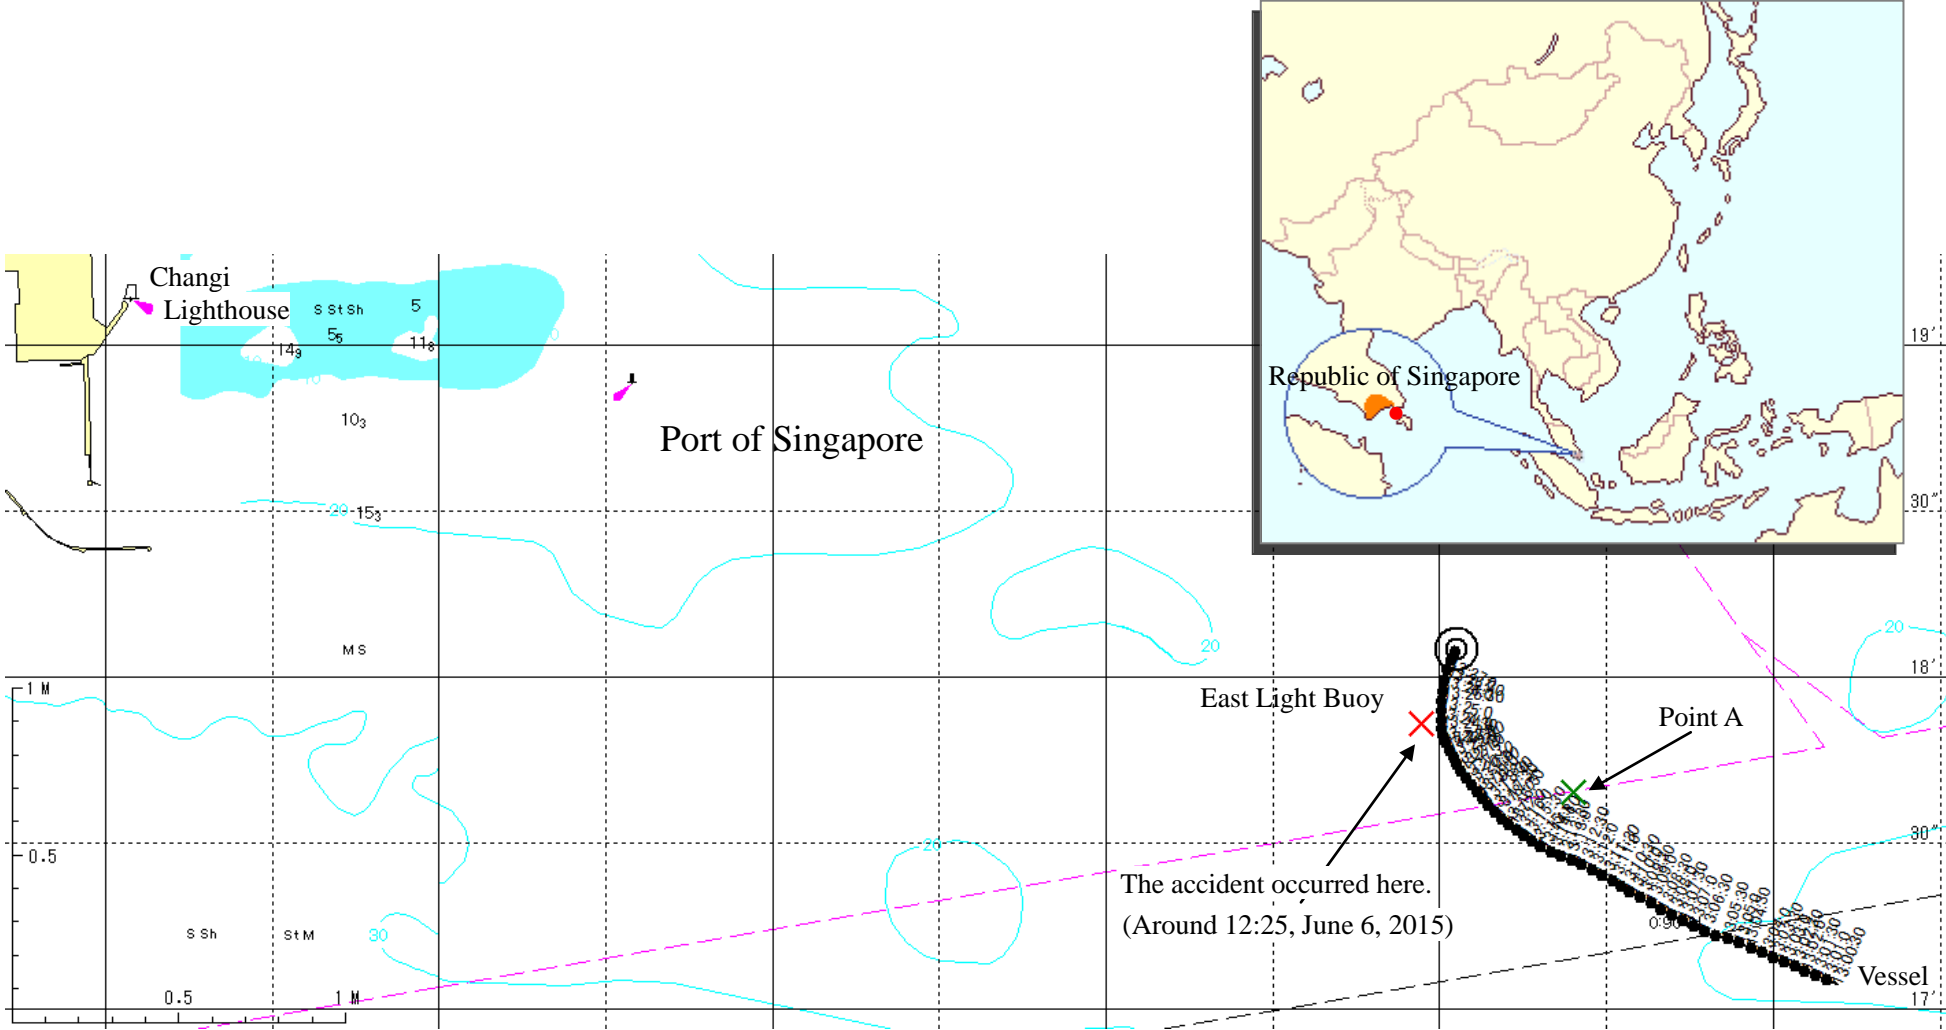
Attached Figure 1 Track

* Times indicated beside the track are Japan Standard Time. There is a difference of one hour between local time and Japan Standard Time.
The track indicated is for the period between 13:00 and 13:27 (local time: 12:00 to 12:27).

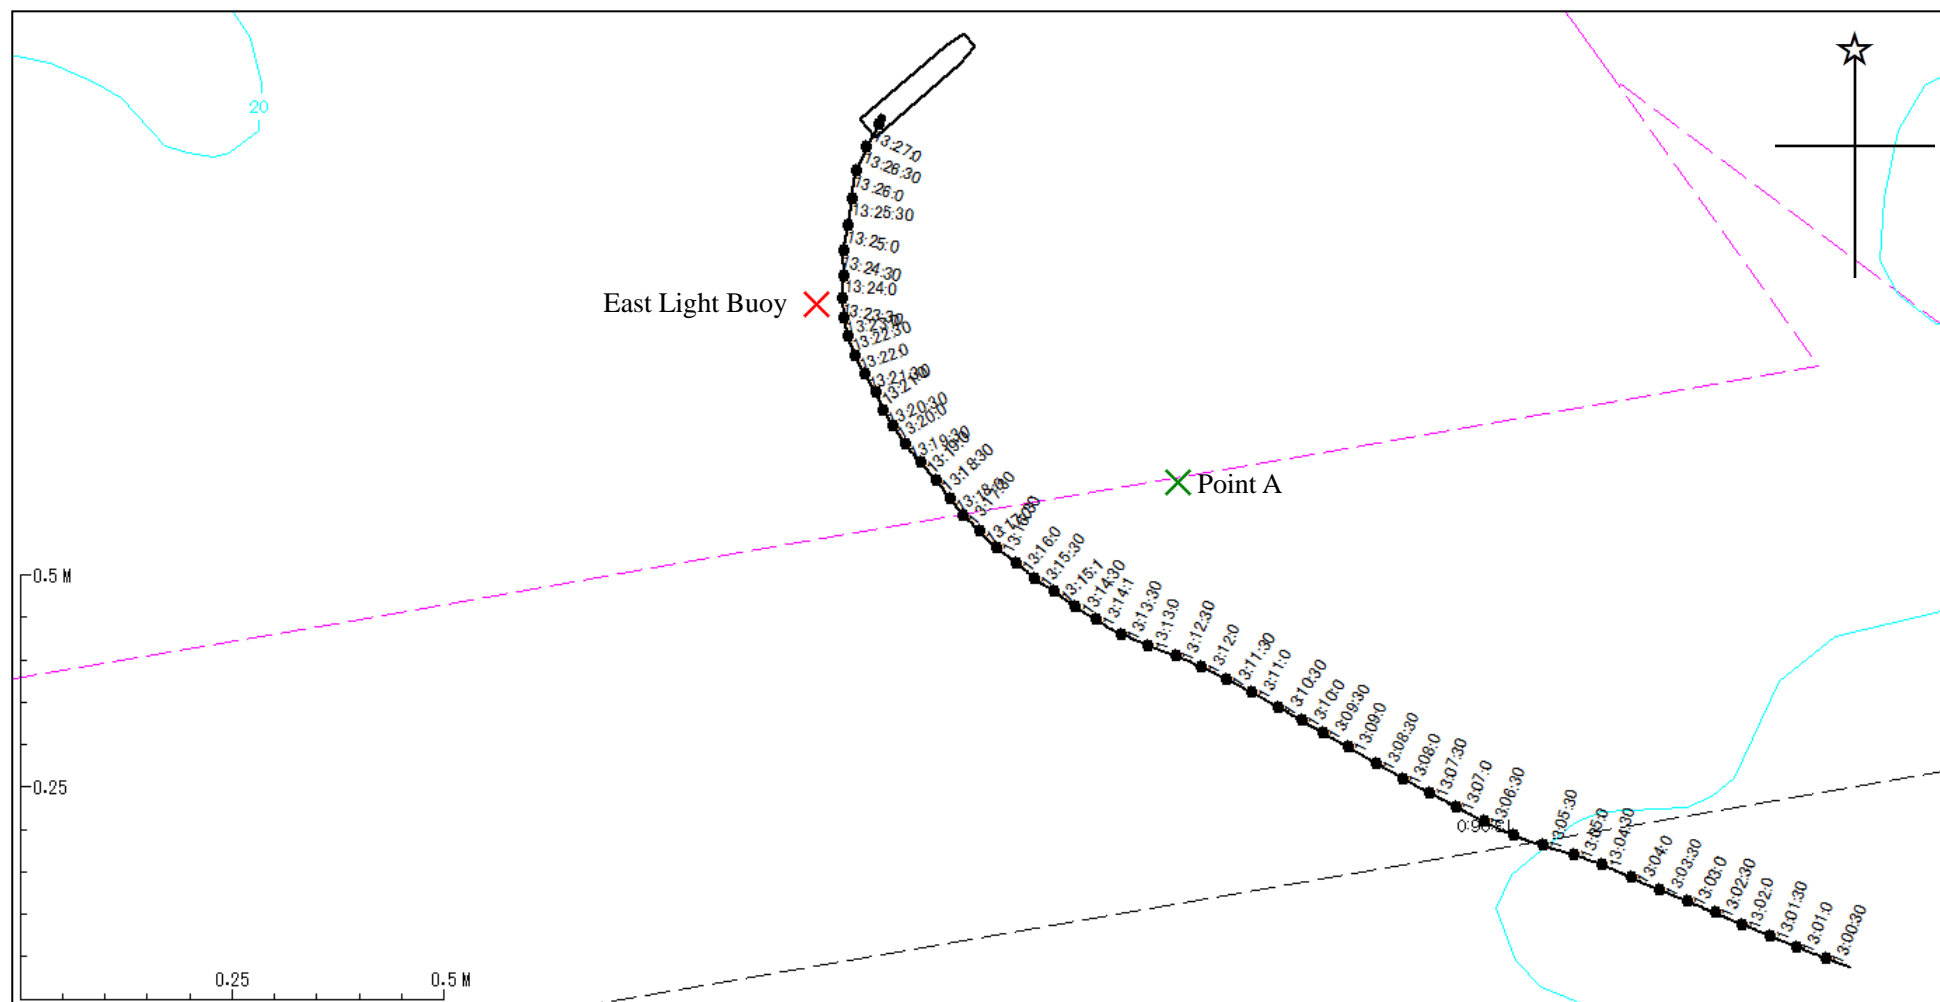
Attached Figure 2 Track (Magnified)

* Times indicated beside the track are Japan Standard Time. There is a difference of one hour between local time and Japan Standard Time.
 The track indicated is for the period between 13:00 and 13:27 (local time: 12:00 to 12:27).
