MA2017-7

**MARINE ACCIDENT
INVESTIGATION REPORT**

Vessel type and name: Passenger Ship "BEETLE"

Accident type: Collision

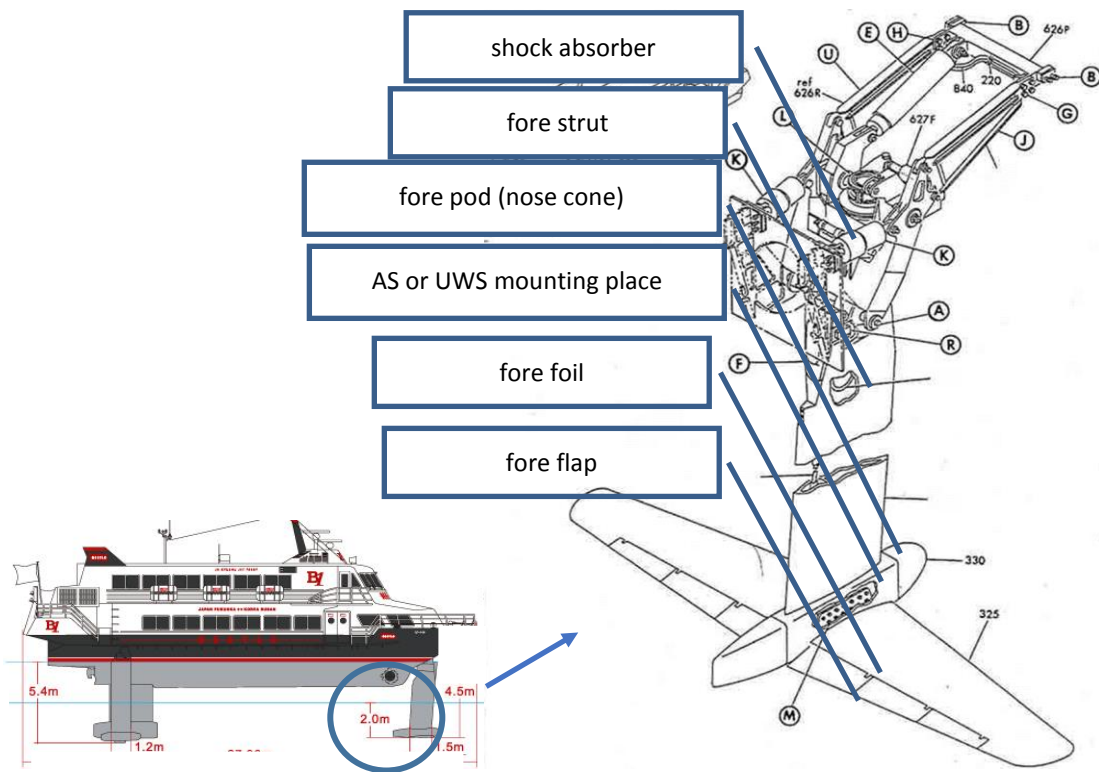
Attached Figure 4 Hydrofoil Device on the Bow

The 1/E checked the hydrofoil device on the bow from the foredeck and found that two shock absorbers (hereinafter, referred to as "the shock absorbers") equipped on the upper part of the fore strut which was a support pillar made of stainless steel constituting the hydrofoil device on the bow operated and had extended in order to absorb impact of the contact with obstacles under the sea and that the hydrofoil device on the bow had greatly been inclined toward the stern, he thought that traveling in foilborne mode is not possible, and reported the condition to the captain.

The hydrofoil device on the bow stretches for approximately 3.1 m from the base line^{*4} to the lower end of the foil in foilborne mode to support the bow part, and consists of a trapezoid foil made of stainless steel (hereinafter, referred to as “the front foil”), a front strut capable of remote controlling while supporting the front foil, and a streamlined member called a pod connected to a lower end of the front strut in the central part, and others.

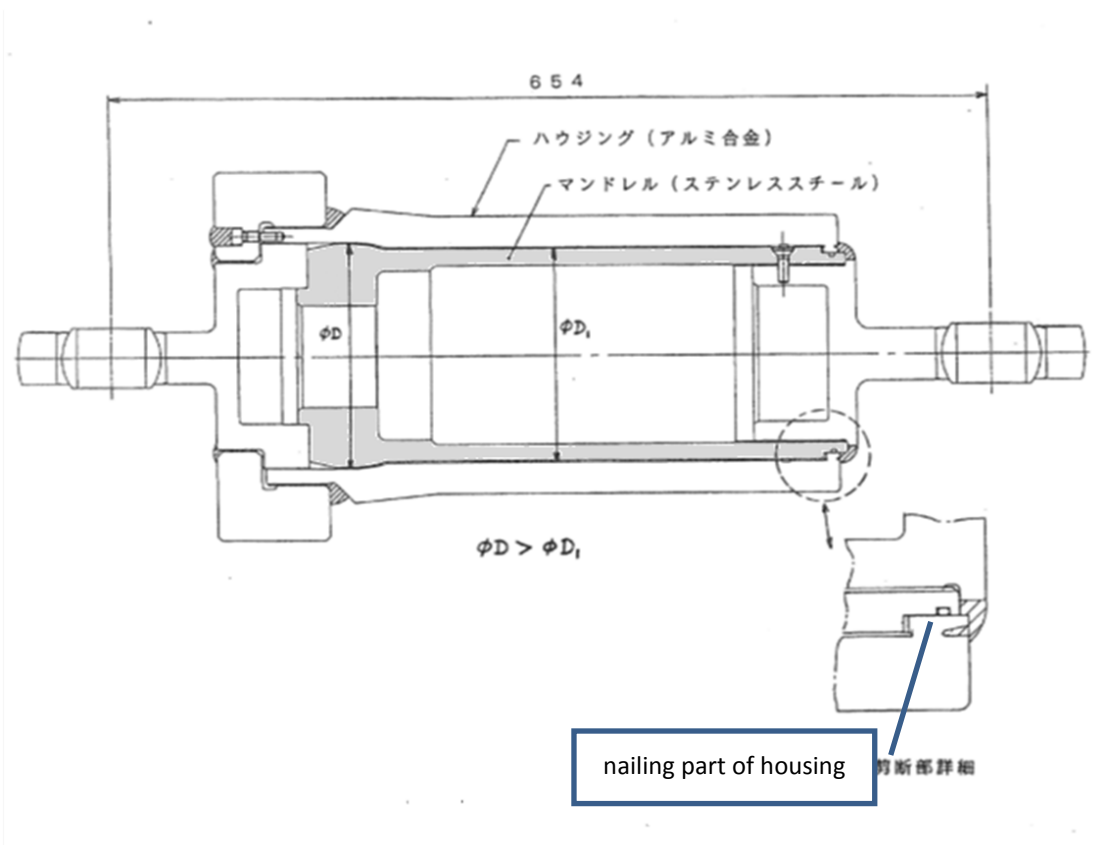
Attached Figure 5 Shock Absorber

The shock absorber consists of an external cylinder called a housing, a spindle called a mandrel, hull mounting brackets and others, and has a structure in which: a load is normally borne by a pawl part of the housing, but when a static load over approximately 700 kN which is an operation start load is added by the hydrofoil on the bow coming in contact with undersea obstacle, the pawl part undergoes shear fracture and the mandrel is pulled out from the housing, and in this instance, the mandrel with a diameter longer than an inner diameter of the housing distorts the aluminum alloy housing and thereby the collision energy will be absorbed.

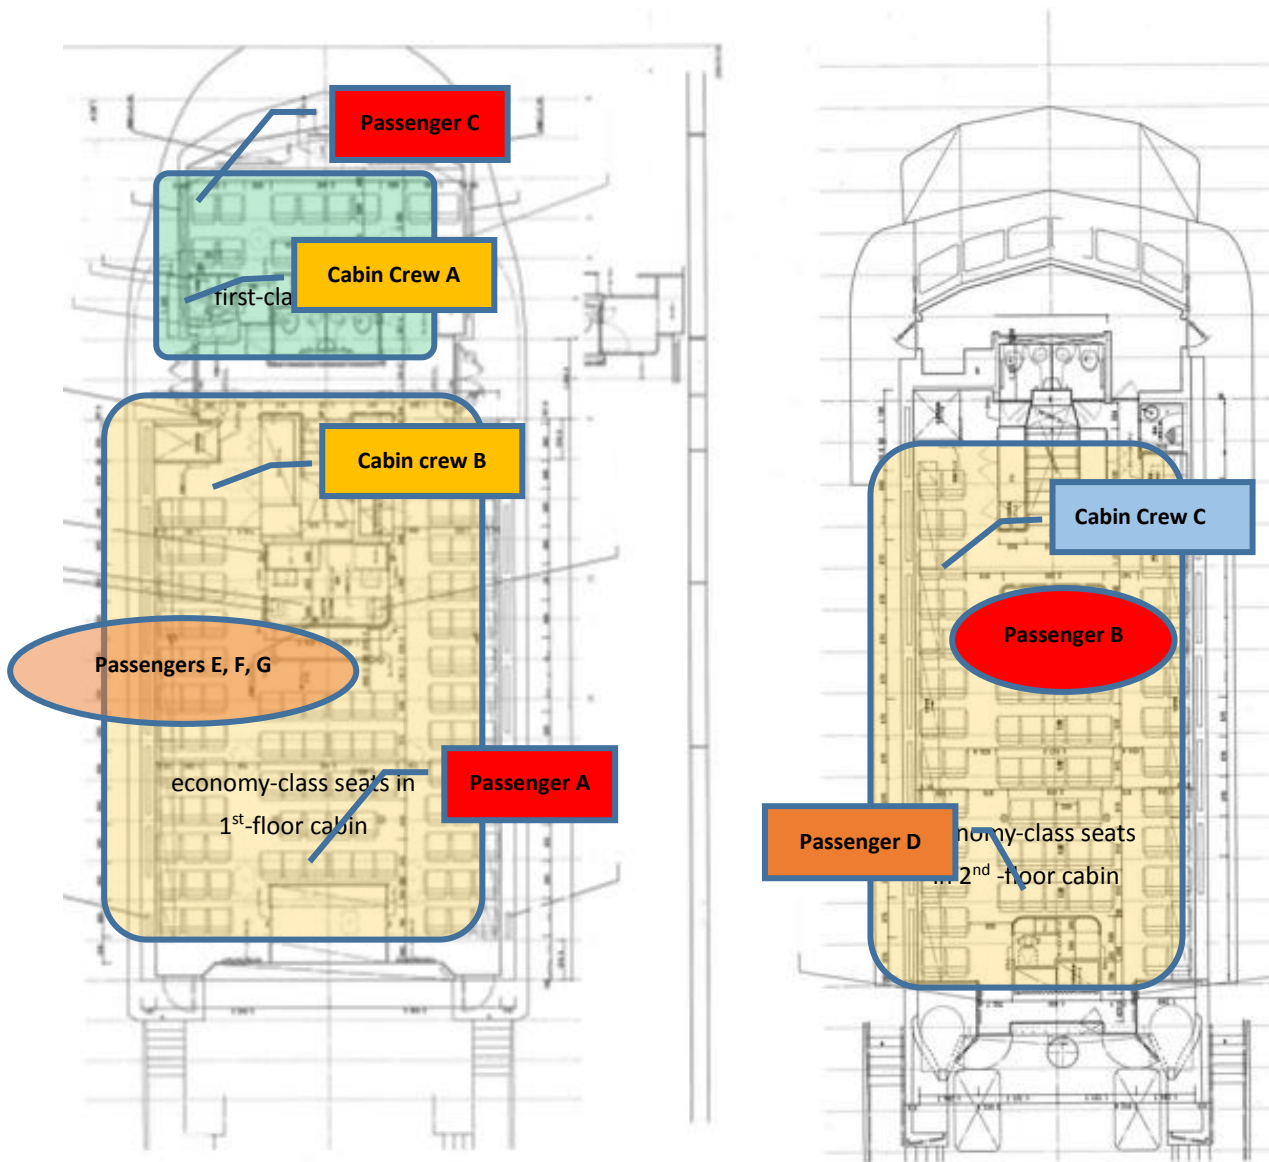
Attached Figure 6 Seating Arrangements

Passenger B was sitting on the seat located in the center block closer to the starboard in the second-floor cabin with the seat belt fastened, and although he had had a check of the seat belt fastening state by a cabin crew, at the time of the accident, he had the backrest of his seat fallen down, was sitting on the front of the seat in a posture of leaning against the backrest with the seat belt loosen and was not using the table.

Seating locations of Passenger B, Passenger E, Passenger F, and Passenger G are unknown.

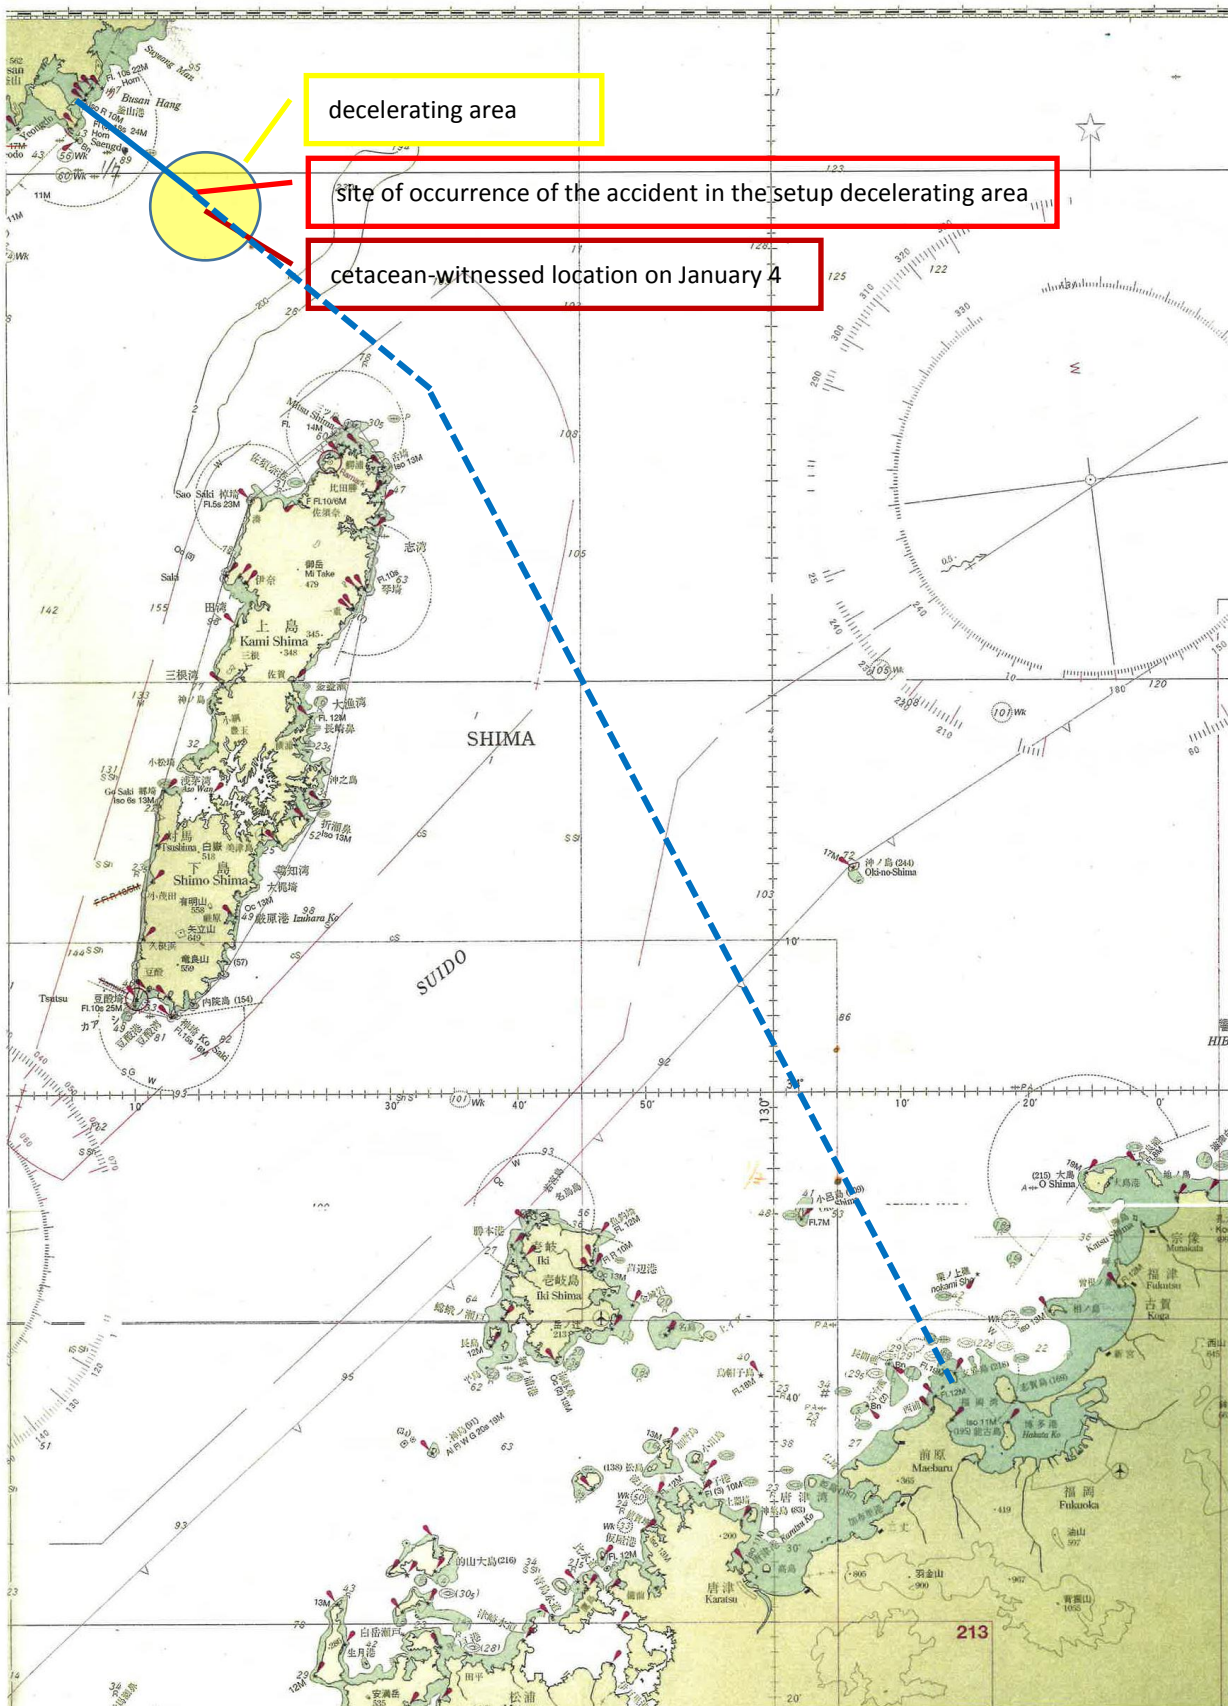
Attached Figure 7 Setting Condition Map of the Decelerating Area

On January 4, 2016, a 17-meter-long whale (hereinafter, referred to as “the eyewitness information”) had been witnessed in the location at 34°57.6’N, 129°15.4’E.
(See Attached Figure 7 Setting Condition Map of the Decelerating Area)

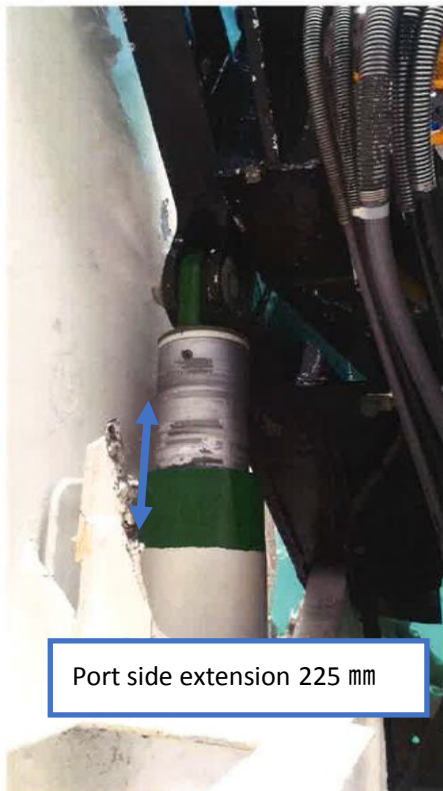
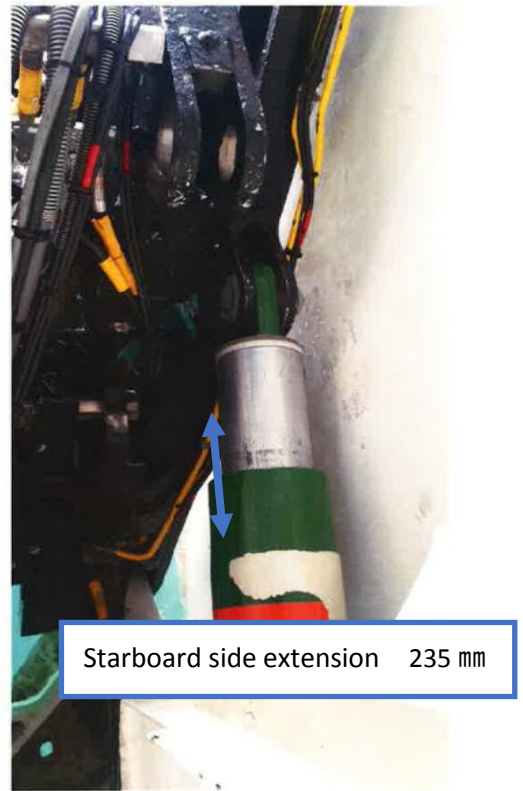
Photo 1 Shock Absorber

Three of the passengers were seriously injured by a lumbar vertebra compressed fracture etc., and four of the passengers and two of the cabin crews suffered minor injuries. Two shock absorbers on the bow stretched out, and then BEETLE returned to the Port of Busan in hullborne mode.

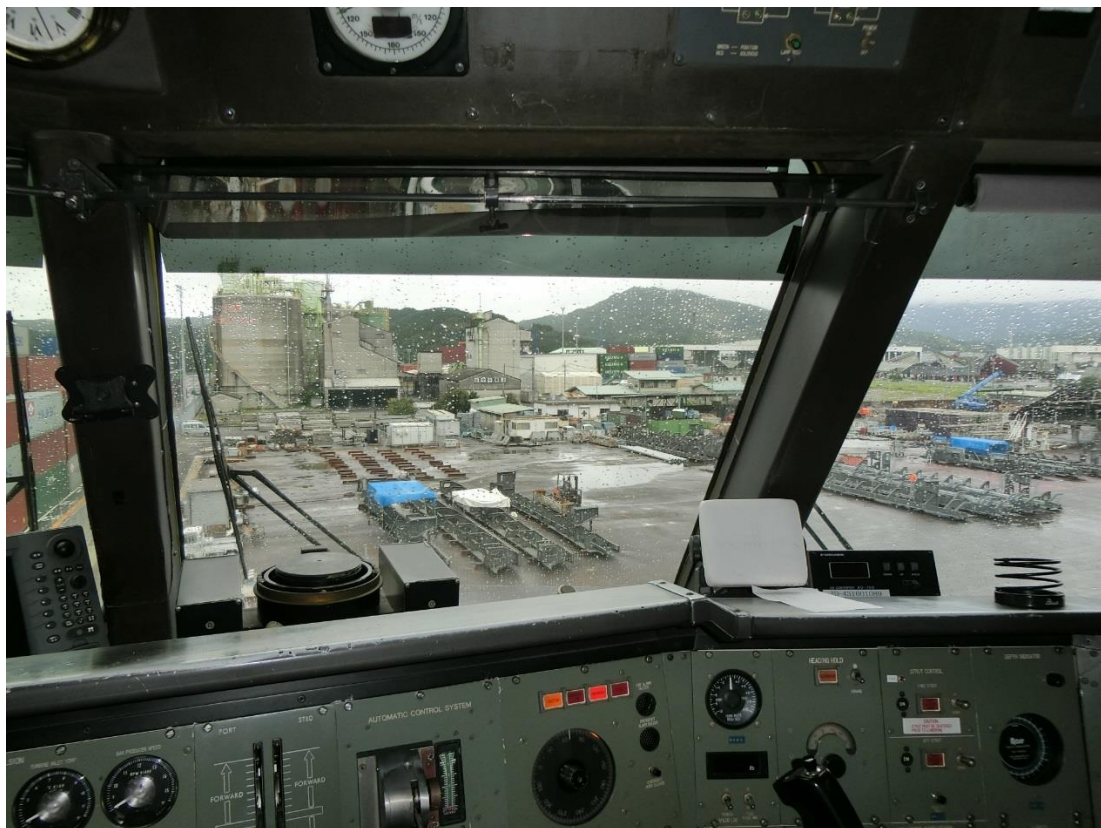
Photo 2 Outlook Condition from the Wheelhouse

The captain and the 1/A were wearing sunglasses since it was hard to see the condition of the sea surface due to sea surface reflection of the sun.

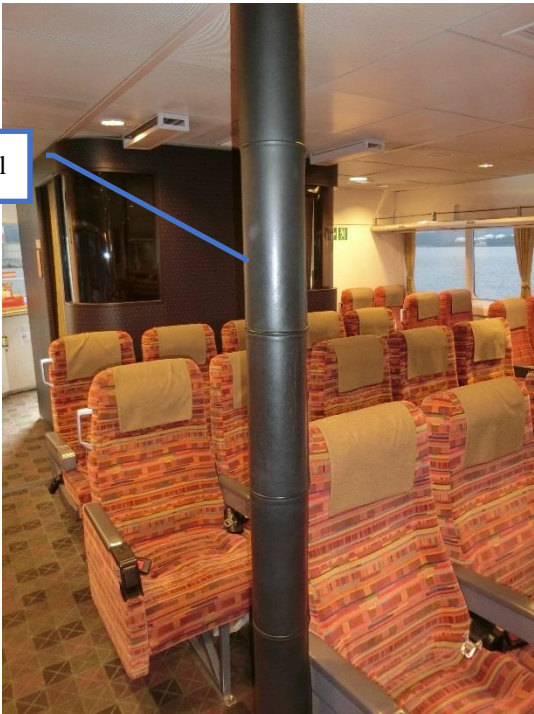
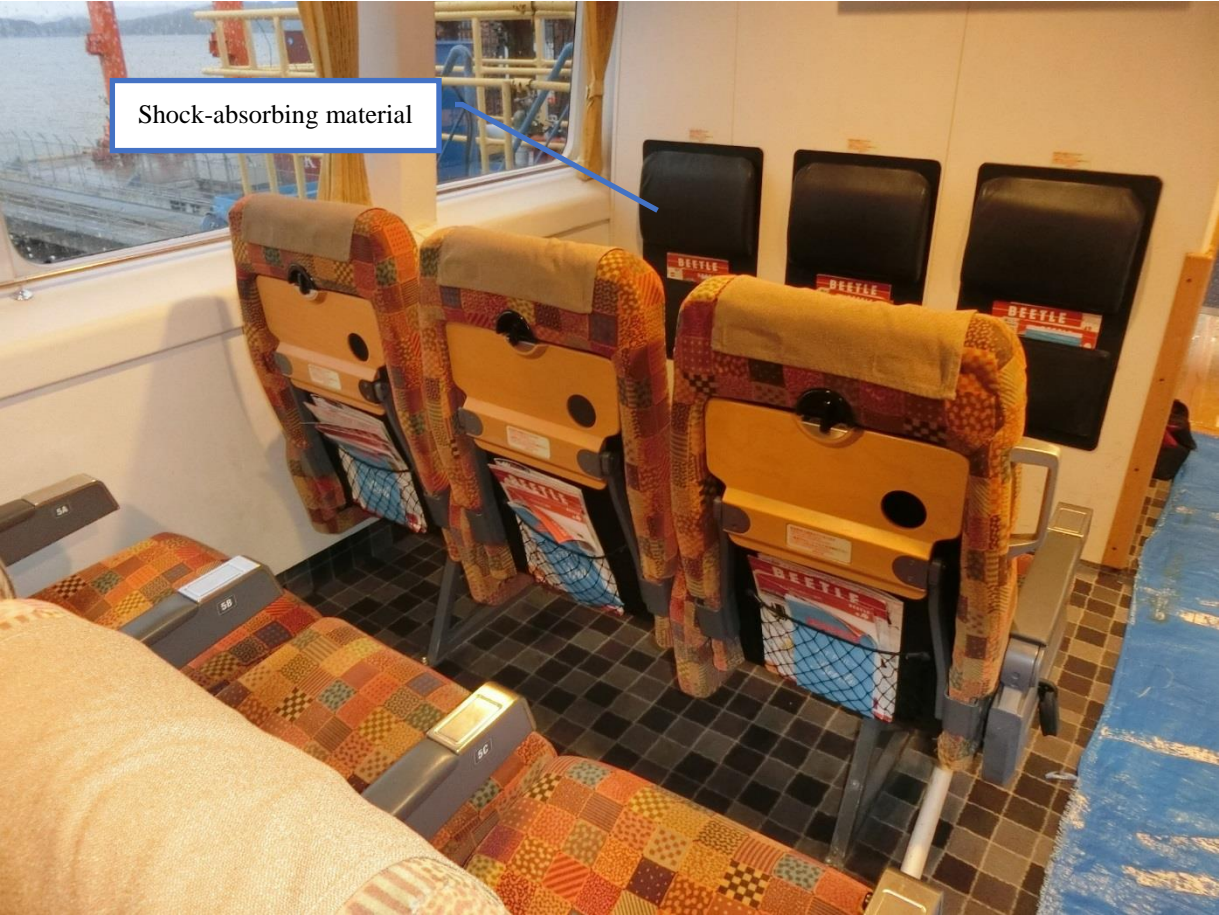
Photo 7 Shock-absorbing Material

Company A equipped passenger ships of the company with seats that met technical criteria of a seat belt in order to reduce damage in instances of collision, had established an obligation to wear a seat belt in its transportation agreement, and had installed a shock-absorbing material inboard just in case.

- (8) For this reason, it is considered effective to thoroughly disseminate appropriate seat belt wearing to passengers, provide a shock-absorbing material on the armrest, store the table during the cetacean-cautious maneuver, suspend inboard sales by cart, and have cabin crews seated are effective for reducing the number of injured and mitigating the degree of injury when an accident occurs.
