**MARINE ACCIDENT  
INVESTIGATION REPORT**

Vessel type and name: Chemical Tanker EASTERN PHOENIX

Vessel type and name: Oil Tanker KEIHIN MARU No. 8

Accident type: Collision

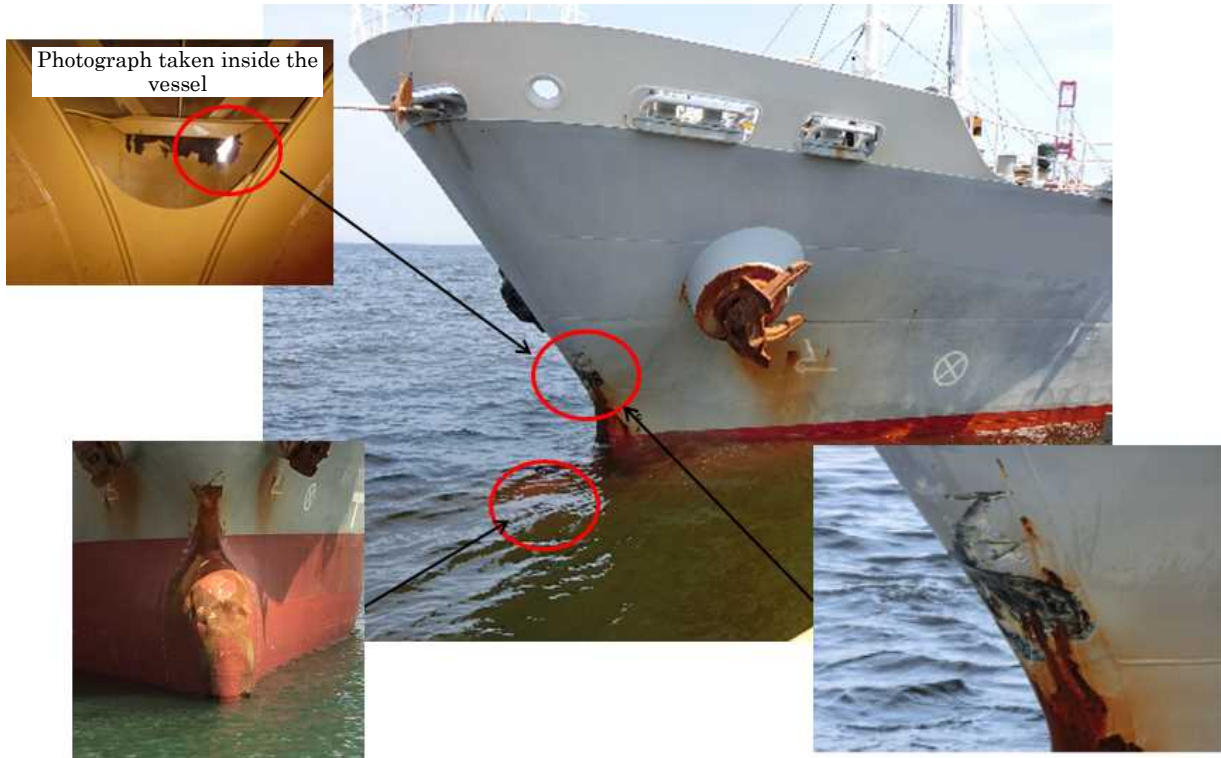
Vessel A had a dent and breach in her bow shell plating and a dent and other damage in her starboard midship shell plating. Additionally, according to the reply to the questionnaire by Company A, there was a dent and other damage to Vessel A's bulbous bow. (See Photo 2.3-1 and Photo 2.3-2)

Photo 2.3-1 Damage to the bow (Vessel A)

- (1) It is probable that Vessel A had a dent and breach in her bow shell plating and dents and other damage in her bulbous bow and starboard midship shell plating.
- (2) Vessel B had dents and breaches in her port bow's fender and bottom and a dent and other damage to her port stern fender.

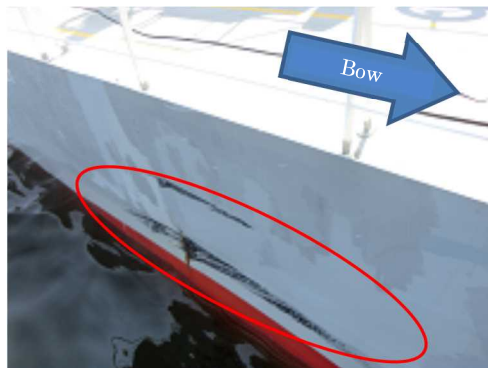
Photo 2.3-2 Damage to the starboard midship (Vessel A)

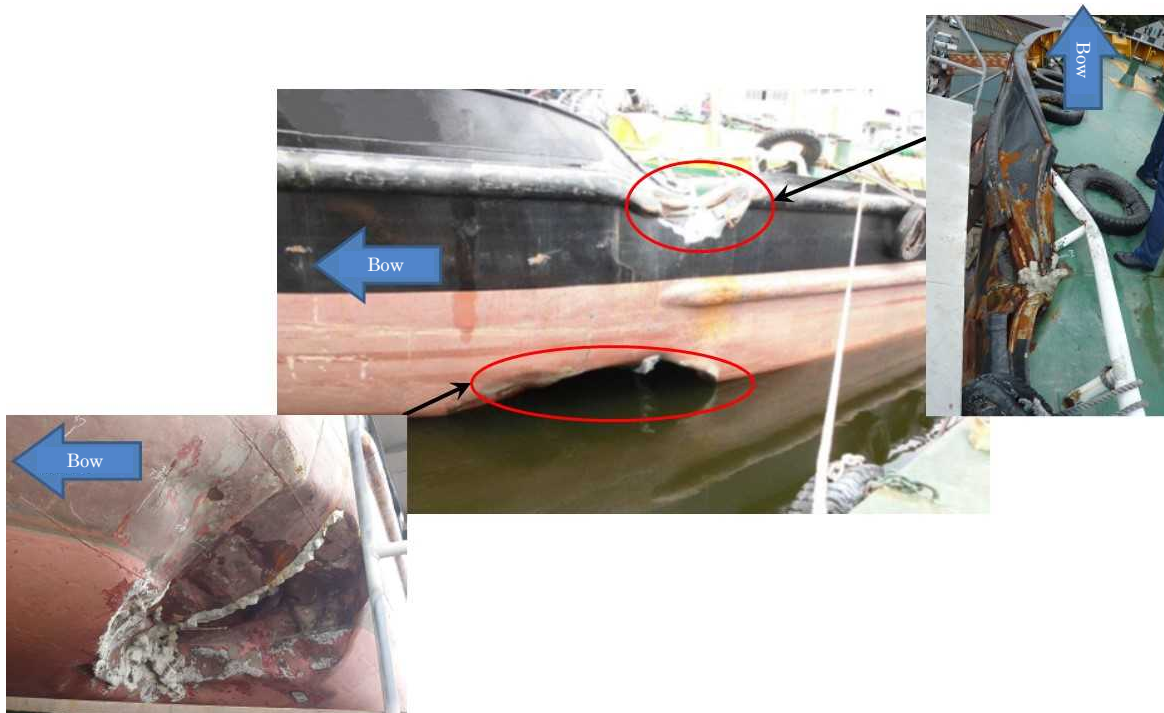
Vessel B had dents and breaches in her port bow's fender and bottom and a dent and other damage to her port stern fender. (See Photo 2.3-3 and Photo 2.3-4)

Photo 2.3-3 Damage to the port bow (Vessel B)

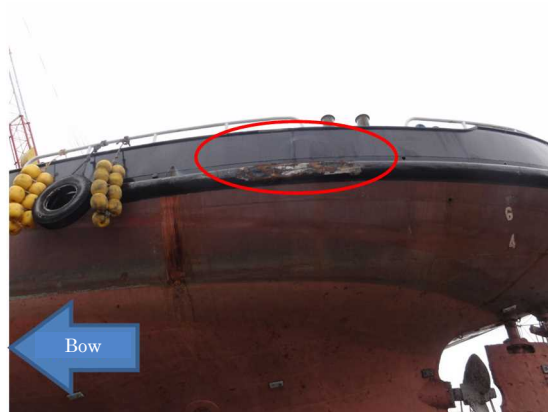
Photo 2.3-4 Damage to the port stern (Vessel B)
