**MARINE INCIDENT
INVESTIGATION REPORT**

January 25, 2018

MARINE INCIDENT INVESTIGATION REPORT

Incident type	Unnavigable state (hull list)
Date and time	Around 12:00 on January 11, 2017 (local time, UTC+9 hours)
Location	Off the north of Oshima Island, Munakata City, Fukuoka Prefecture (approximately 33°56.3'N, 130°25.3'E)
Summary of the Incident	While cargo ship TONG DA was proceeding east-northeast in Genkai-nada, with a master and 13 other crew members onboard, her hull listed to port and she was intentionally run aground. TONG DA had seawater damage to her engine, cargo, etc.
Process and Progress of the Incident Investigation	The Japan Transport Safety Board (hereinafter referred to as "JTSB") appointed an investigator-in-charge and two other investigators to investigate this incident on January 13, 2017. January 13, 14 and May 22, 2017: Interviews January 15, 17, 18 and April 25, 2017: On-site investigations April 10, 21 and May 26, 2017: Collection of questionnaire Comments on the draft report were invited from parties relevant to the cause of incident.

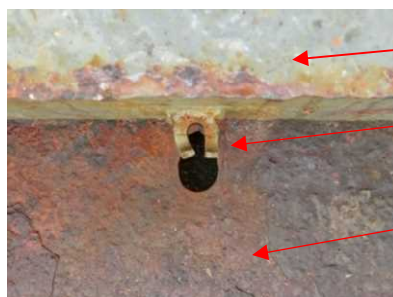
Photo 3 Snug (Photographic View
from Above)

a Places missing the cleats used to preserve the weathertightness of the cargo holds' hatch covers and places where cleats could not be securely attached due to deformation of the snug that receives the cleat were found. (See Photo 3 and Figure 2)

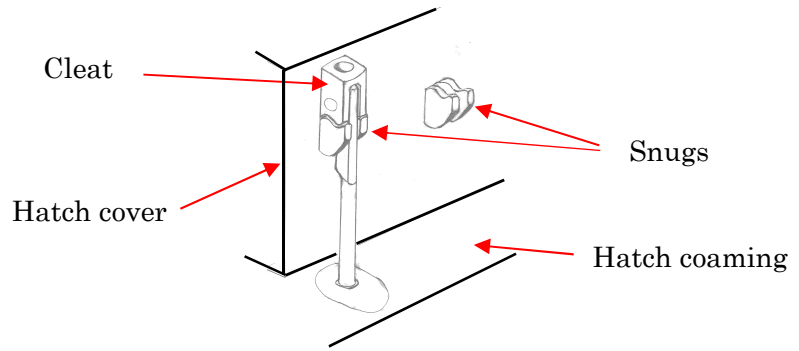
Figure 2 Snug and Cleat

- d The cleats on the Vessel’s hatch covers were arranged into two locations, on the fore side and aft side, on both sides of a hatch cover. The center-to-center space between the two locations exceeded 600 mm.

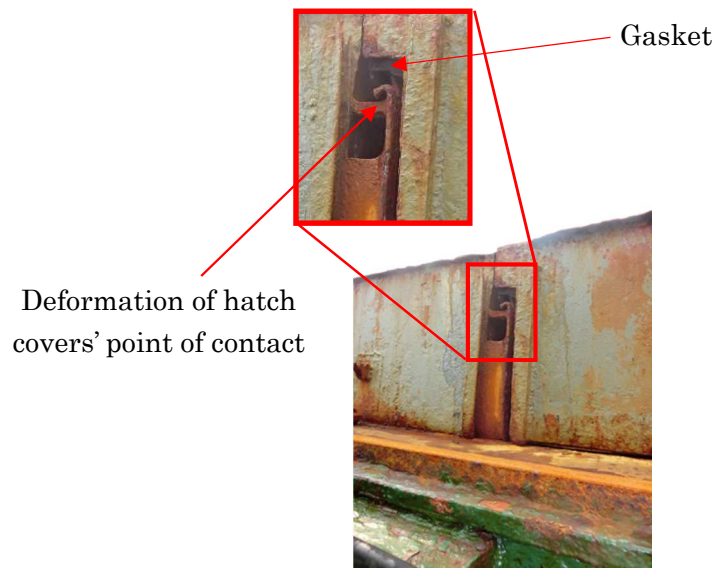
Photo 4 Hatch Covers

b Although gaskets (rubber fixtures for preventing leaks that are used on stationary parts) were installed on the hatch covers of the cargo holds, unevenness was observed in places where adjoining hatch covers came into contact. (See Photo 4)

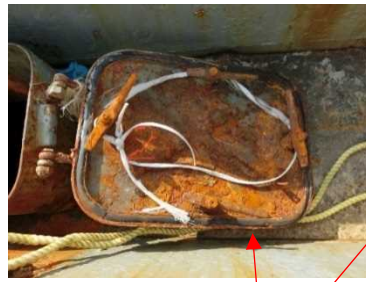
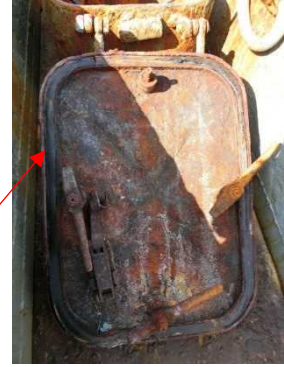
Photo 5 Hatchways

c The hatchways to both cargo holds that were located between the No. 1 cargo hold and No. 2 cargo hold were in a state that did not permit them to preserve weathertightness with the gasket due to unevenness occurring in the upper part of the hatch coaming and deformation of the hatch cover. (See Photo 5)

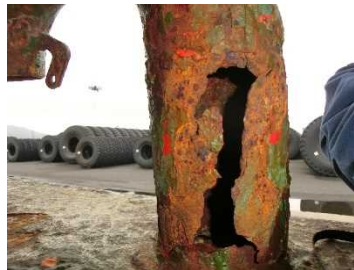
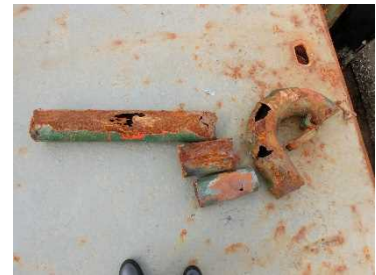
Photo 6 Air Vent Pipe

d The air vent pipe installed on the starboard side of the No. 2 cargo hold's upper-deck hatch was observed to have several corrosion-caused holes in it. (See Photo 6)

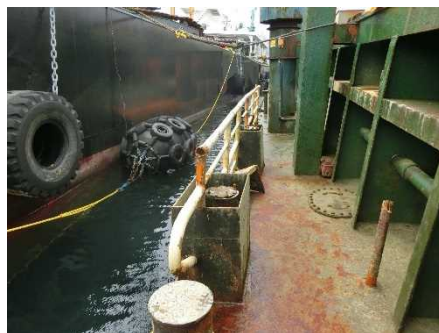
Photo 7 Sounding Tubes

e Sounding tubes located in the port aft area of the upper deck had cracks and were missing a cap needed to preserve weathertightness. (See Photo 7)

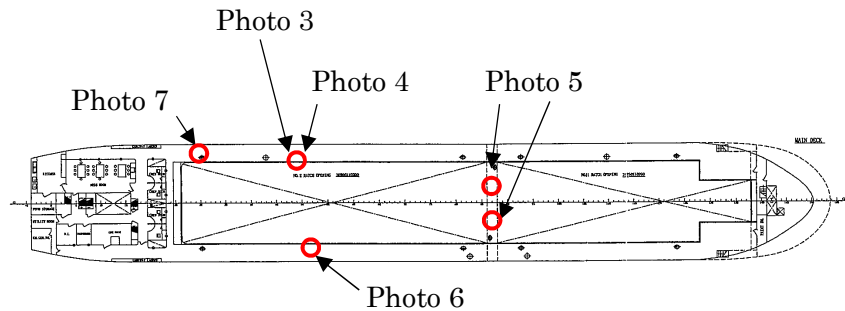
Figure 3 Damaged Locations of the Upper Deck

4) Information concerning the weathertightness of the cargo holds, hatchways, ballast tanks, etc. (See Figure 3)

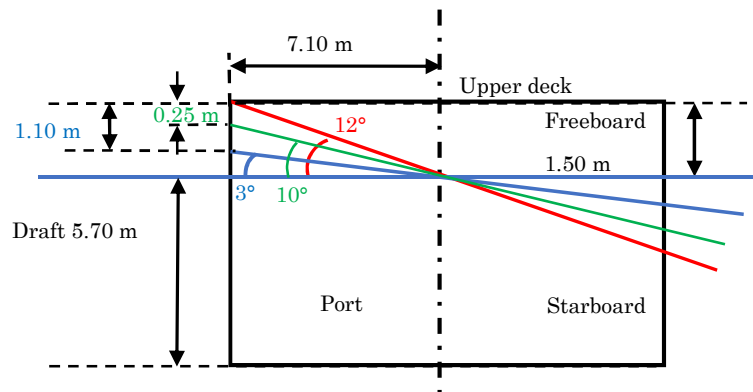
Figure 3 Circumstances of the Water Line when the Vessel Listed (Conceptual Image)

From the Vessel's draft at the time that she left Weifang Port and her beam, it is probable that the situation concerning the washing up of waves with the hull's list was as follows. (See Figure 3)

- a Given that, while the Vessel was proceeding east off to the southwest of Jeju Island, the freeboard near the hull's midship was approximately 1.10 meters in state in which the hull was listing approximately 3° to port, and that the wave height was between approximately 1.00 and 1.50 meters, waves were washing onto the upper deck.
- b Given that, as the Vessel was proceeding east-northeast in Genkai-nada, the freeboard near the hull's midship was approximately 0.25 meters in a state in which the hull was

listing approximately 10° to port, that the wave height was between approximately 1.51 and 1.85 meters, and that the master observed seawater washing onto the upper deck, the area near the port edge of the upper deck became submerged at times.

- c The angle of list at which the area near the port edge of the Vessel's upper deck near the hull's midship would become submerged was approximately 12° .
