**MARINE ACCIDENT
INVESTIGATION REPORT**

Vessel type and name: Cargo Ship REAL

Accident type: Grounding

Date and time: Around 00:15, October 23, 2017 (local time, UTC+9 hours)

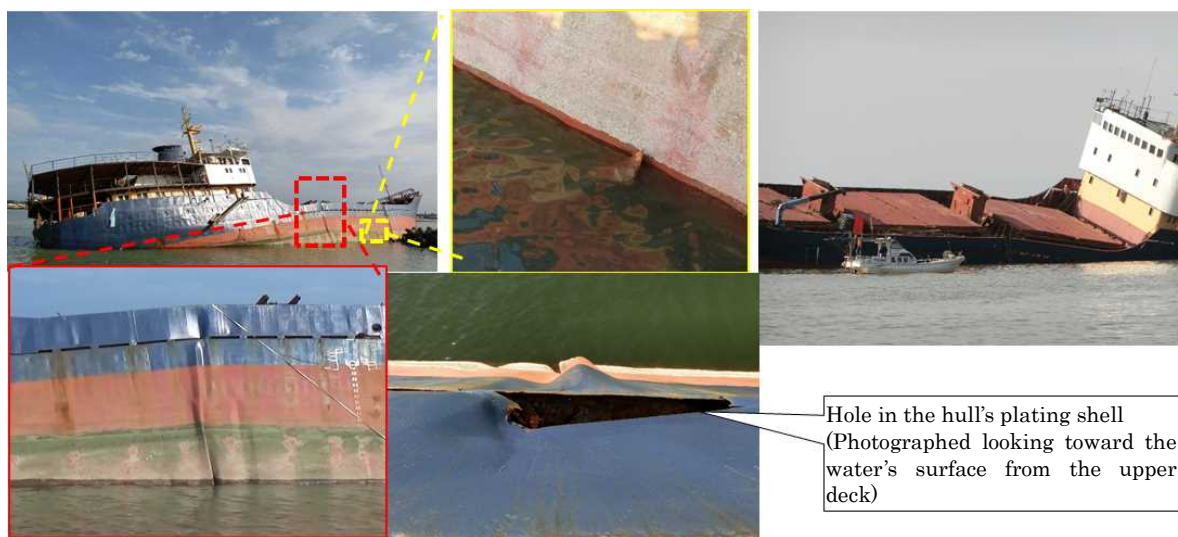
Photo 2.3 Hull Damage

According to the onsite investigations and statement of the person in charge at the salvage company, the Vessel was a total loss, as the area near the Vessel's midship was fractured to a large extent and there were breaches, cracks, and dents in all parts of the hull. The Vessel was removed from the Breakwater by the salvage company on January 7, 2018.

near her midship was fractured to a large extent and there were breaches, cracks, and dents in all parts of the hull.

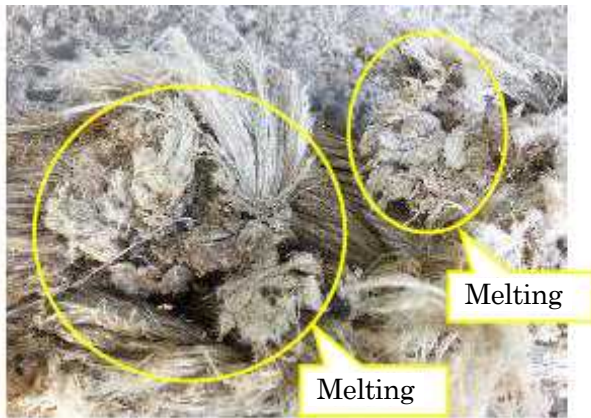
Photo 2.9-3 Traces of Melting

- (5) Two ropes had traces of melting.
 - (6) Two ropes had breaks in the strands themselves.
- (See Photos 2.9-1, 2.9-2, 2.9-3, and 2.9-4)
