MA2019-8

MARINE ACCIDENT INVESTIGATION REPORT

Vessel type and name: Container ship ACX CRYSTAL

Vessel type and name: Missile destroyer warship USS FITZGERALD

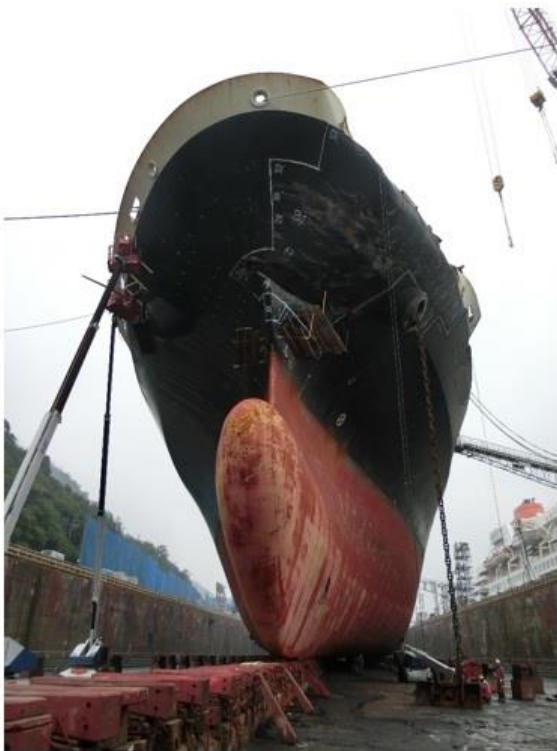
State in dock

Figure 3: Damage of Vessel A (bottom section and anchor)

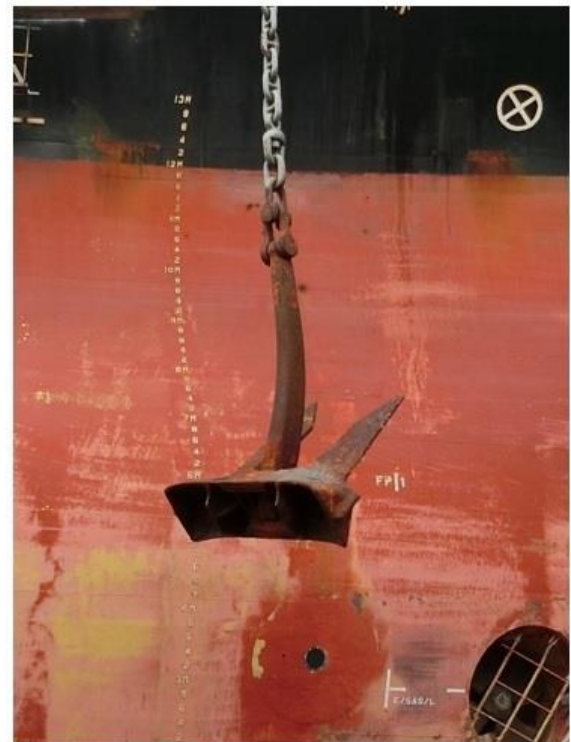
Damaged recessed port anchor shank

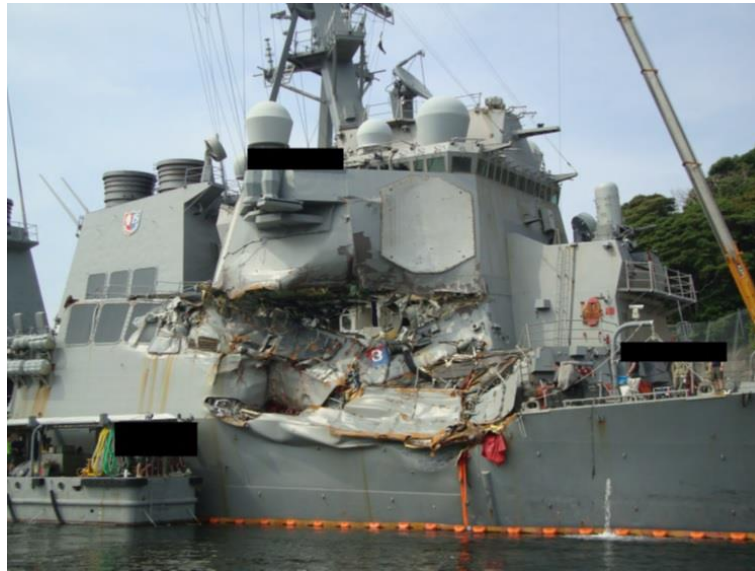
Figure 4: Damage of Vessel B (near the starboard midship front section)
(provided by US Coast Guard)

Damaged recessed part and broken holes in the starboard midship front shell and in a second accommodation space of the starboard bow under water surface (Refer to Figure 4, Figure 5 and Attached figure 4: Damaged part of Vessel B (side view))

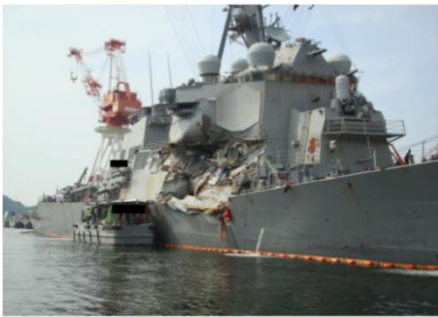
Outside damage ①

Figure 5: Damage of Vessel B (provided by US Coast Guard)
