MA2019-7

**MARINE ACCIDENT
INVESTIGATION REPORT**

MARINE ACCIDENT INVESTIGATION REPORT

Accident type	Fatality of a stevedore
Date and time	Around 11:14 on January 6, 2019 (local time, UTC+9 hours)
Location	T1 berth of Nabeta wharf, Yatomi city, Aichi Prefecture On a true bearing of approximately 283° and at a distance of 1,400 meters from Nagoya port west passage No.8 light beacon (approximately 35° 01.5' N, 136° 47.8' E)
Summary of the Accident	At around 11:14 on January 6, 2019, while the container vessel HARRIER was moored at the Nabeta wharf, with the master and 17 crew members on board, 7 stevedores were loading containers to the vessel, and a stevedore who was serving as assistant wireless signal person and communicating the conditions of unloading and loading containers by radio apparatus got caught between two containers, then the stevedore was pronounced dead by a doctor.
Process and Progress of the Investigation	<p>(1) Set up of the Investigation The Japan Transport Safety Board appointed an investigator-in-charge and a marine accident investigator to investigate this accident on February 27, 2019, and later appointed a marine accident investigator in addition.</p> <p>

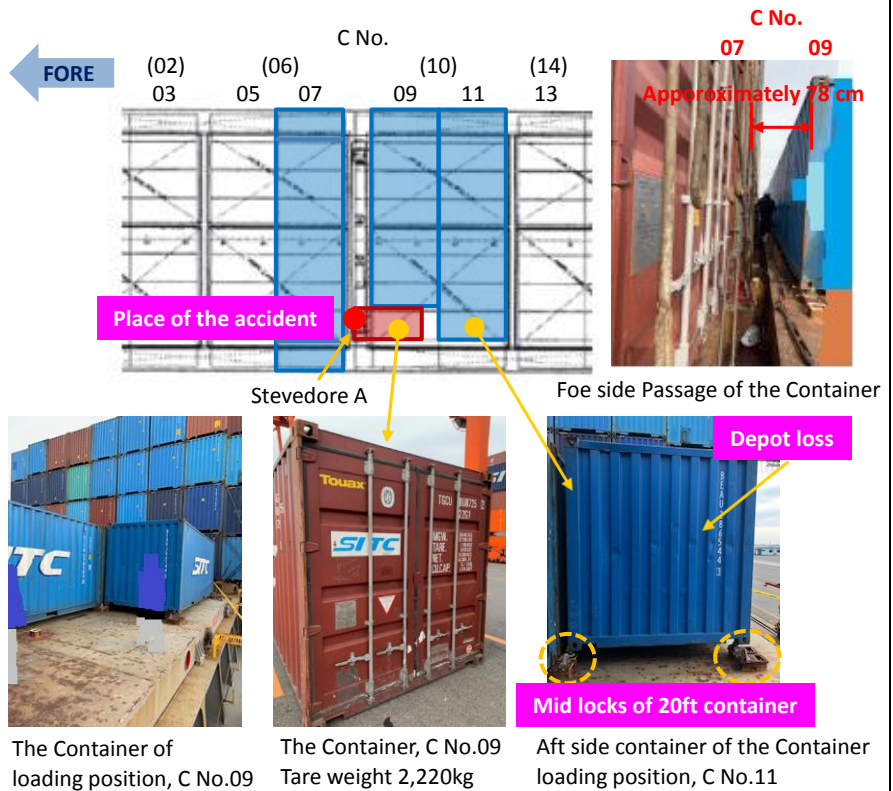
Figure 4 Stevedore accident occurrence place

The Container was suddenly pulled from the mid locks and was lifted up, then was swung to aft side by the impact of being pulled and lifted by the GC and bumped to the aft side container (C No. 11) which had already been loaded and the container (C No.11) was damaged recessed part. By the repercussion of the bumping, the Container was swung to the fore side and bumped into the fore side container (C No. 07), which had also already been loaded.

After this, other stevedores on board found out Stevedore A which had been caught between the Container and the loaded container (C No. 07), then he leaned to the fore side container, stood and faced the aft side, was injured when leaving the Container. However, nobody saw the precise moment when the accident occurred.

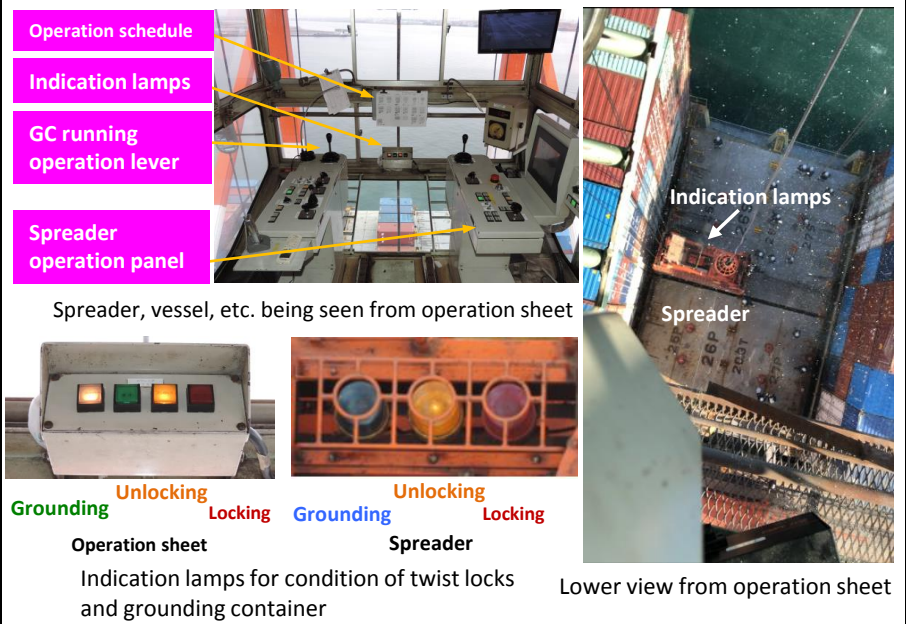
Figure 5 The operation sheet of the GC

In the on-site investigation it was found out that the indication lamps were set to the sea side of the spreader of the GC and adopted common lamp lights, so it was difficult to see the light condition due to the incidence of daylight.

<p>communication when there is no relevant information for loading containers and emergency information while the GC is grounding a container, hoisting a container or releasing the spreader from a container on board level</p> <ul style="list-style-type: none">• It is desirable that the indication lamps of the GC spreader are positioned where they can be easily seen from GC operation sheet. Rotary lamp light, etc. should be installed as well. <p>Based on the results of the investigation of this fatal marine accident, the Japan Transport Safety Board will widely disseminate this marine accident investigation report to contribute to the prevention of recurrence of the similar maritime accidents and reduction of damages, with the cooperation of Ports and Harbours Bureau of Ministry of Land, Infrastructure, Transport and Tourism, Japan Port Transportation Industry Safety & Health Association, Japan Association of Cargo-handling Machinery System, etc.</p>

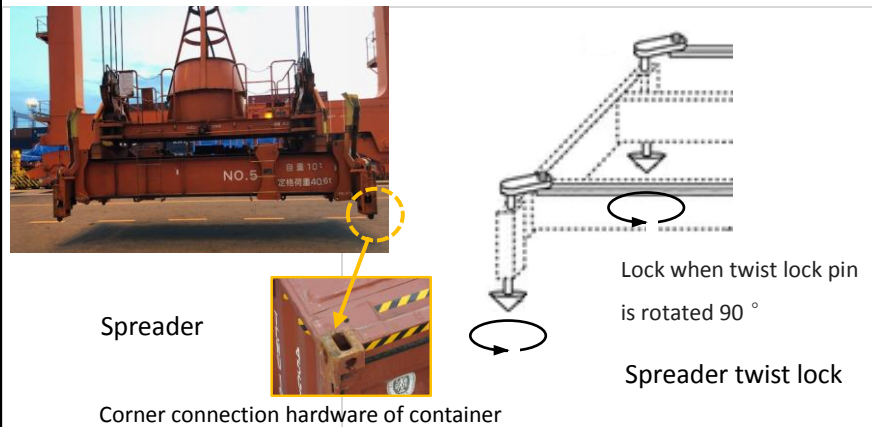
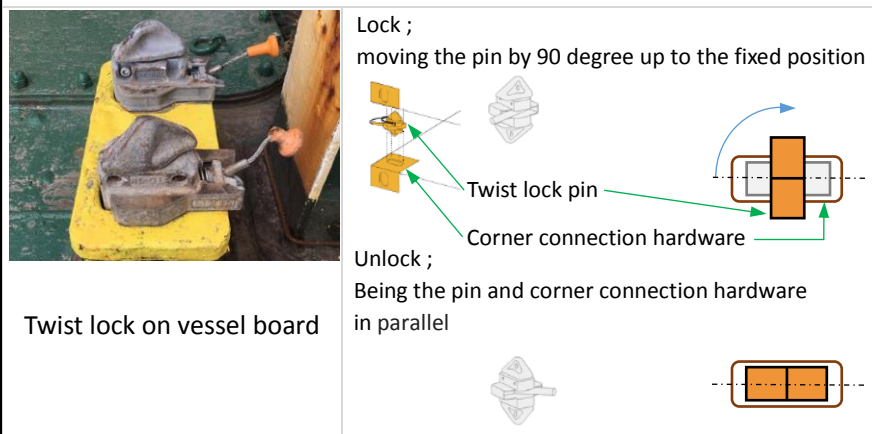
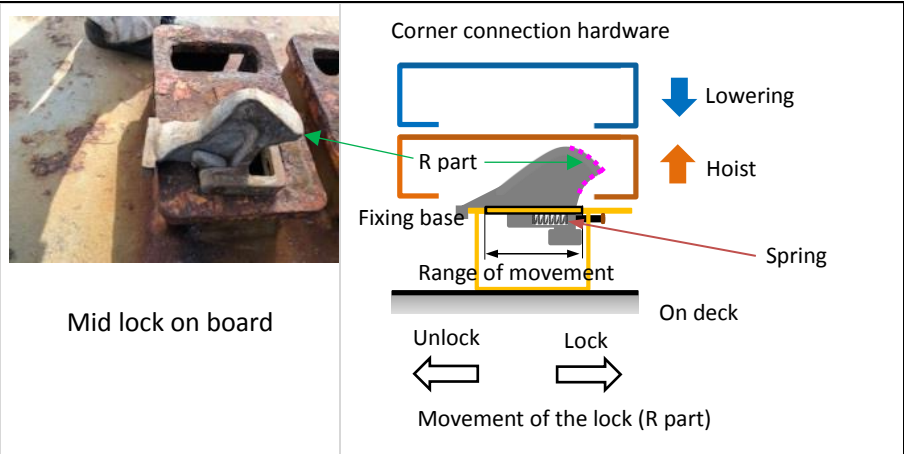
Figure 7 Container loading facility

- ❖ The mid lock was unlocked by moving it to the left side due to the corner connection hardware of container contacting to R part of the mid lock (indicated by dotted line) downward from upper when lowering container, and the hardware contacting to R part upward from below when hoisting container.
- ❖ After that, the mid lock was locked by moving it to the right side automatically.
