MA2020-7

**MARINE ACCIDENT
INVESTIGATION REPORT**

Vessel type and name: Container vessel OOCL NAGOYA

Accident type: Collision

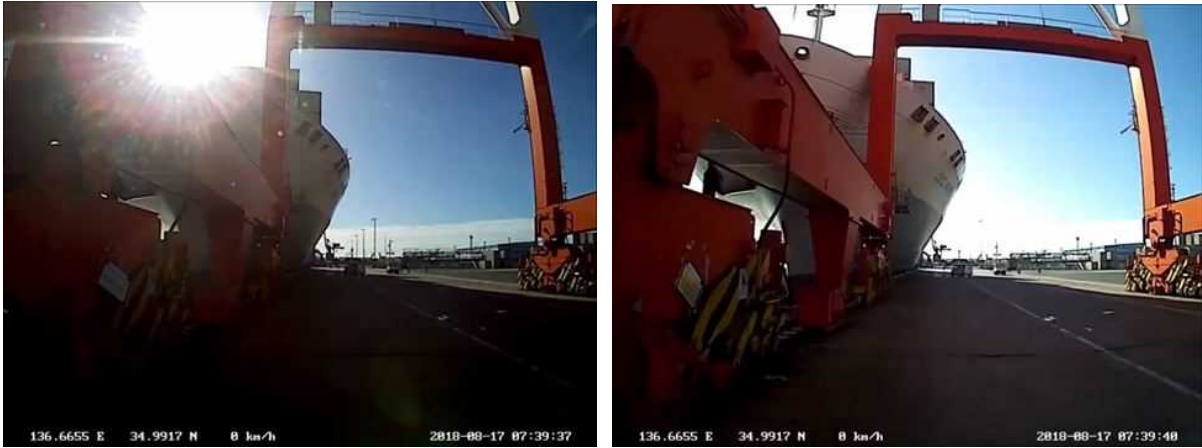
Figure 3 Record from Recorder A (excerpt)

(hereinafter referred to as “GC S2”), and that the bulwark of the Vessel’s fore port part that contacted the gantry crane and the gantry leg part of GC S2 were moving in front of the screen. (See Figure 3)

Left: 07:39:37, Right: 07:39:40

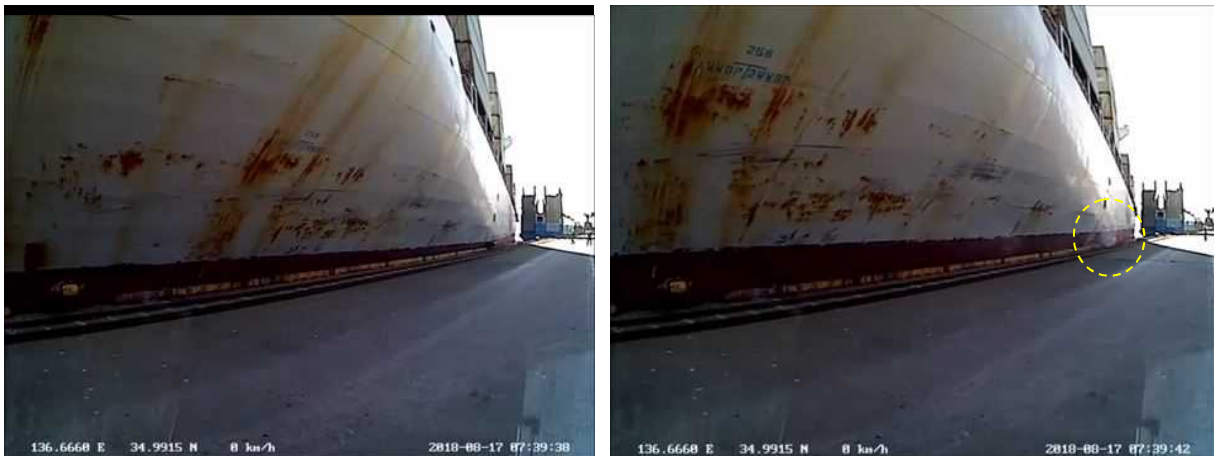
Figure 4 Record from Recorder B (excerpt)

Recorder B recorded the impact sound heard from around 07:39:39 for more than 10 seconds, the contact between hull plate of the Vessel’s port side and the Berth, and the concrete flakes blowing upwards. (See Figure 4)

Left: 07:39:38, Right: 07:39:42

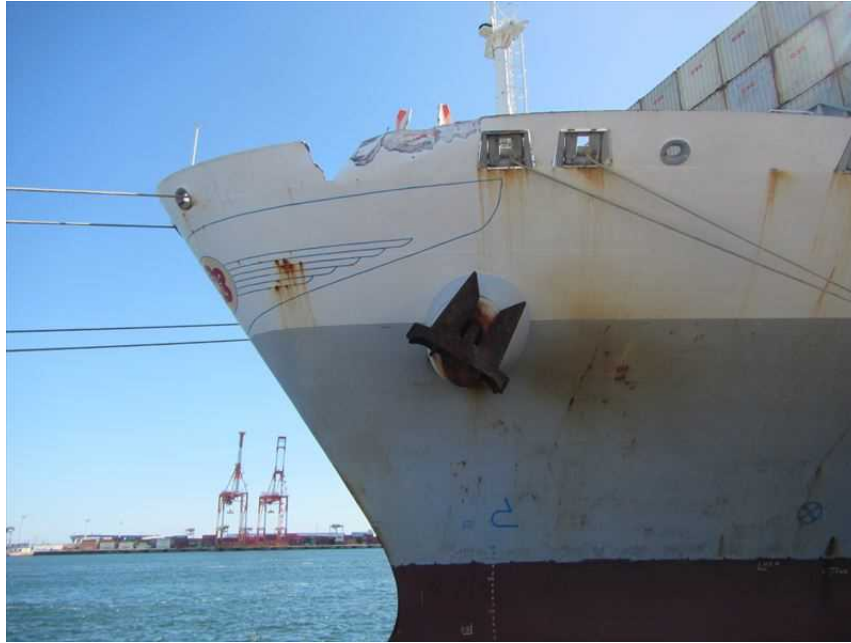
- (1) The port bulwark plate was cut and buckled, and the remote control stand of the mooring equipment was deformed on the forecastle deck
- (2) The port fore part of the shell plate was dented.

Figure 5 State of damage to the Vessel (Bulwark on the port fore part)

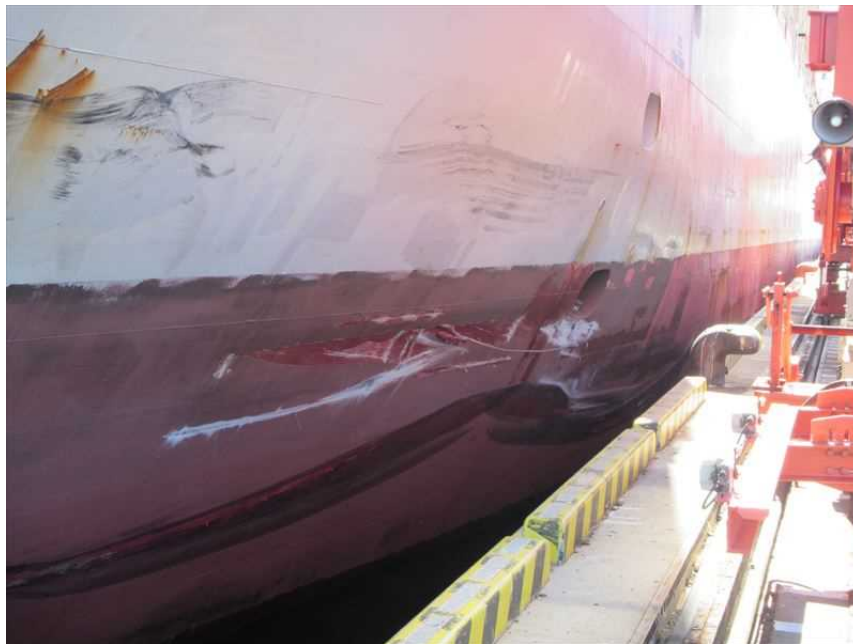
Figure 6 State of damage to the Vessel (Port fore part shell plate)

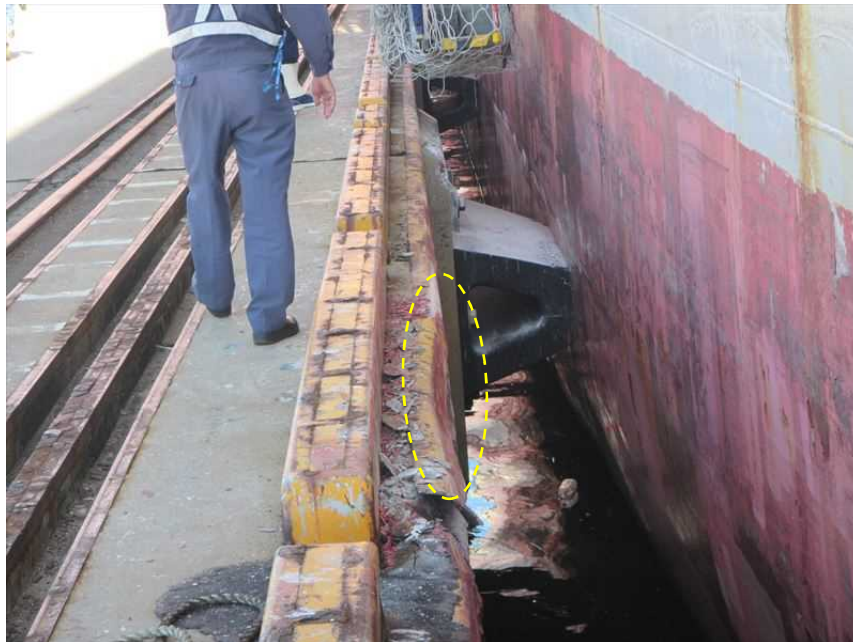
The fenders' body was cracked, etc., and concrete parts such as the upper surface of the Berth and the pedestal part of the fenders, were damaged in the form of delamination, etc., and the corner metallic fittings at the front edge, etc. of the Berth were bent.

Figure 7 Damage to the quay

The fenders' body was cracked, etc, concrete parts such as the upper surface of the Berth and the pedestal of the fenders were damaged in the form of exfoliation, etc. and the metal fittings at the front edge of the Berth were damaged.

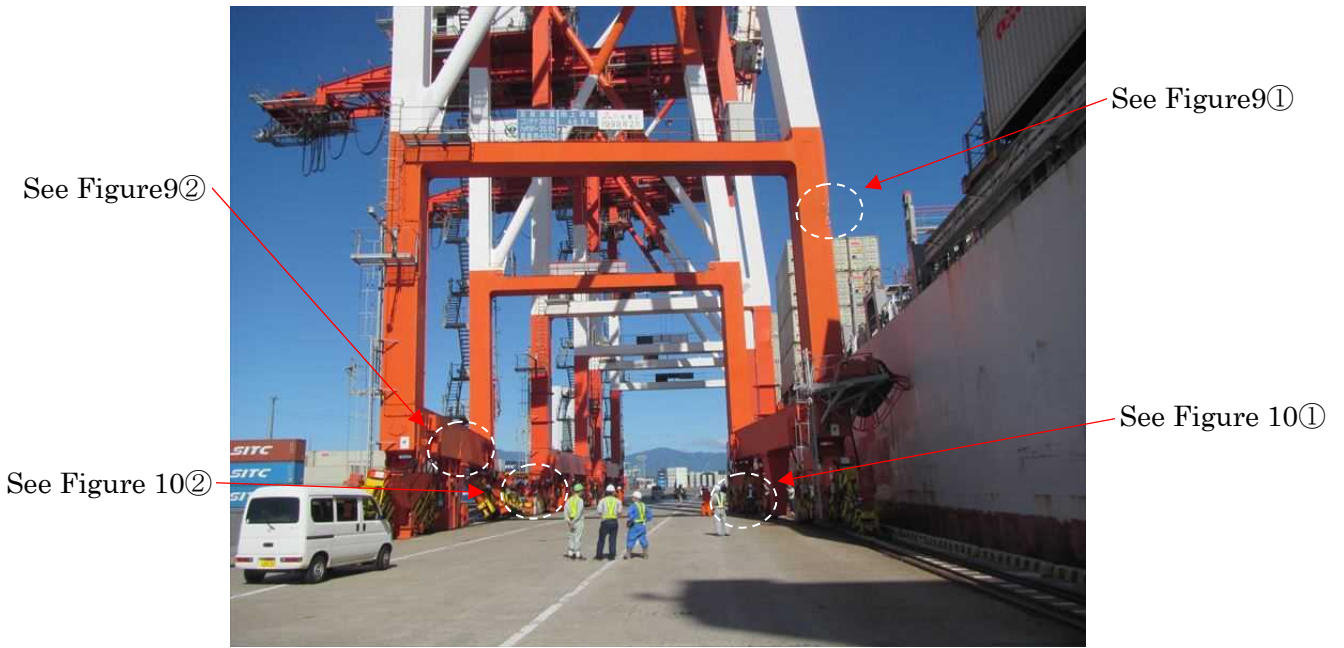
The gantry cranes were in the order of GC S2, Unit S3 and Unit S1 from the east side of the Berth, and were not in operation but were on standby condition. They were all moved due to the accident. The Unit 3 was damaged at the traveling motor, and the gantry leg part structure of Unit S3 was deformed. GC S2 was derailed and the traveling equipment was bent, was broken, etc., and the gantry leg part structure of GC S2 was deformed, furthermore a part of fixing component of traveling rail was damaged, respectively, and thereby GC S2 and Unit S3 were caused to be inoperable. Still, Unit S1 was not damaged.

GC S2, Unit S3 and Unit S1 from the front of the photo

Figure 8 Damage to gantry cranes

All of the gantry cranes on the Berth were moved, the traveling device of Unit S3 was the damaged and the leg part structure was cracked, deformed, etc. GC S2 was derailed and the traveling device was bent, was broken, etc., this leg part structure was deformed, and furthermore a part of fixing component of traveling rail was damaged, etc. As a result, GC S2 and Unit S3 were in an inoperable condition. Still,

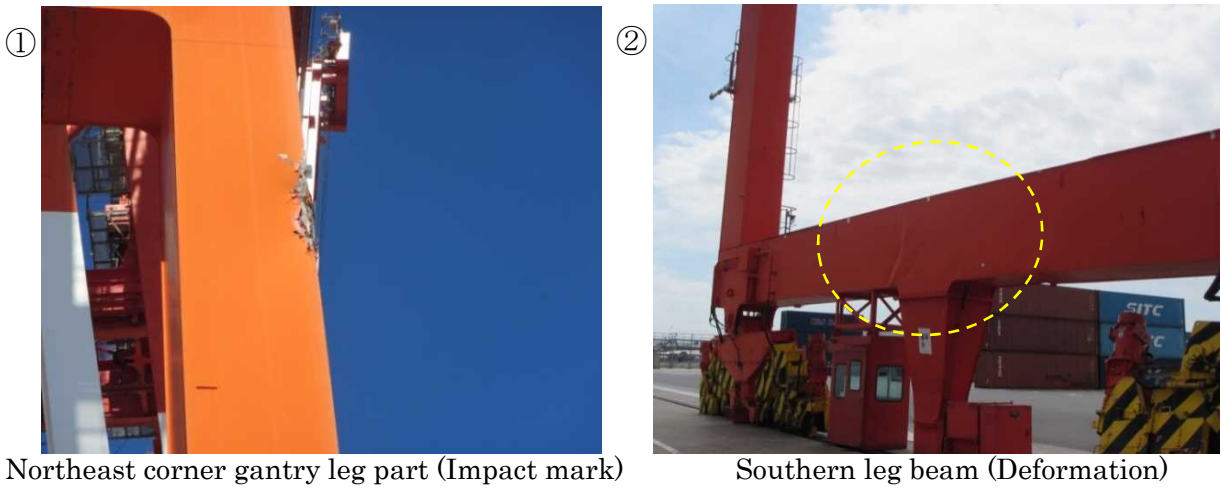
Figure 9 Damage 1 to GC S2

The collision part of GC S2 was the northeast corner of the gantry leg, with a horizontal distance of approximately 2 meters from the front of the fender installed at the Berth front edge and a height of approximately 10 meters from the surface of the Berth.

① Northeast corner gantry leg part (Impact mark)

② Southern leg beam (Deformation)

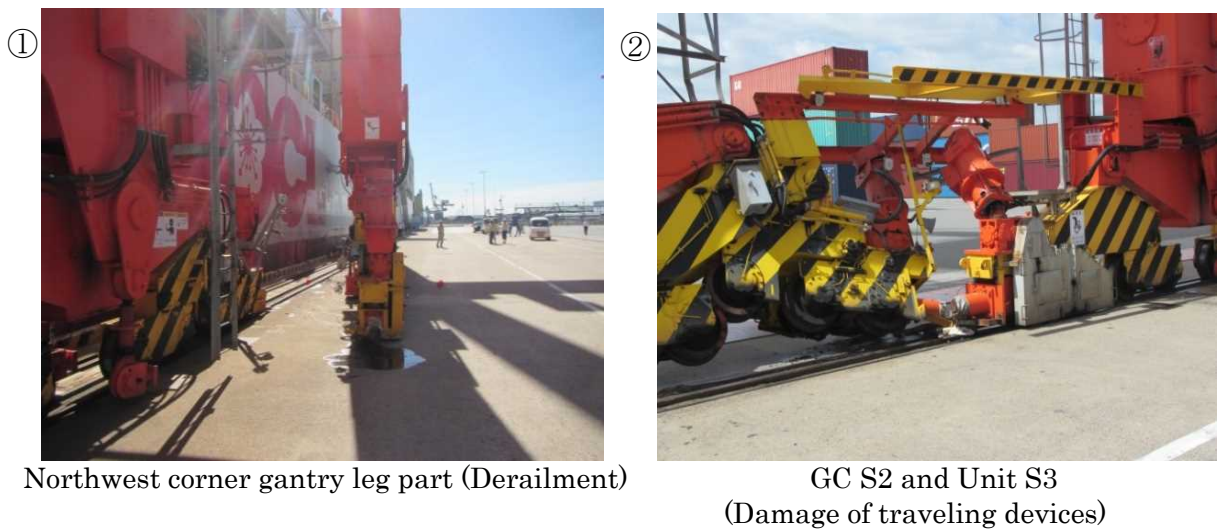
Figure 10 Damage 2 to GC S2

① Northwest corner gantry leg part (Derailment)

② GC S2 and Unit S3
(Damage of traveling devices)
