MA2021-2

**MARINE ACCIDENT
INVESTIGATION REPORT**

Vessel type and name: Cargo vessel JIA DE

Accident/Incident type: Foundering

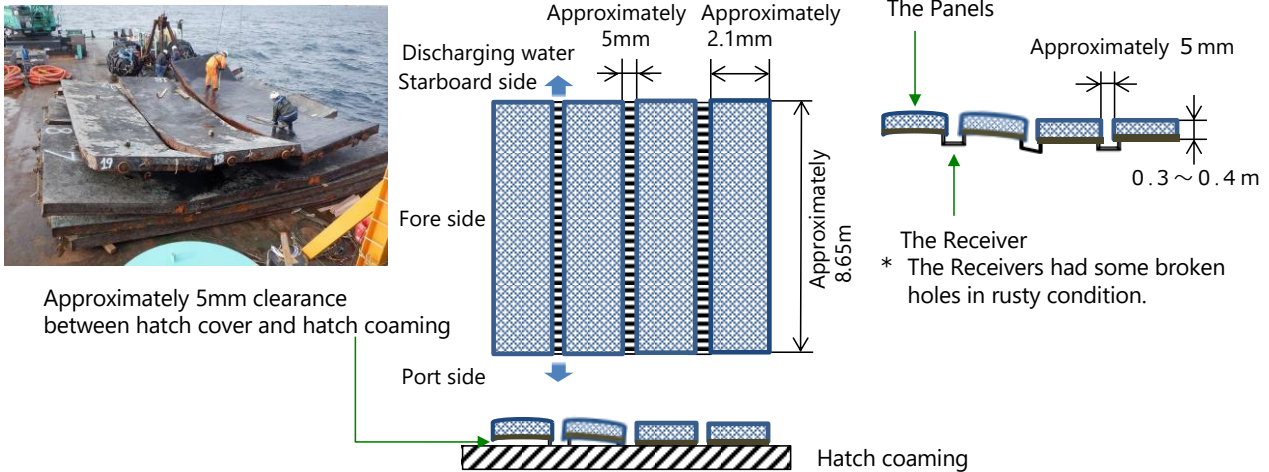
Figure 5 Construction and Condition of the Panels

The Panels after recovery

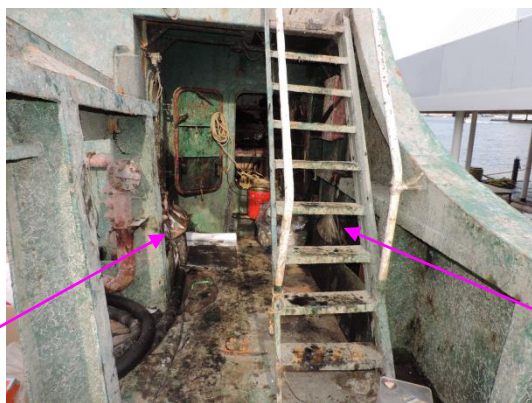
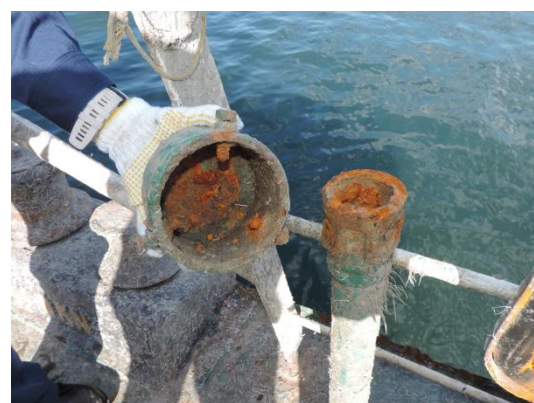
① Arranged position, port-stern part on upper deck ② Construction of air vents for similar air vents

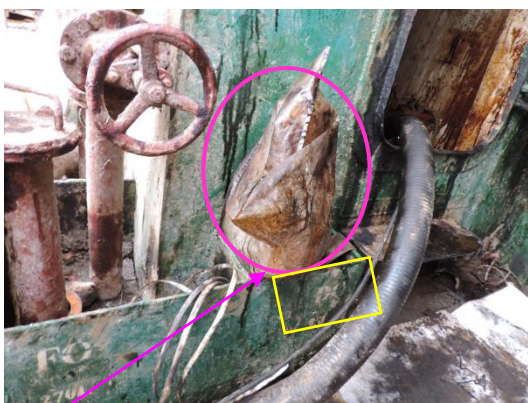
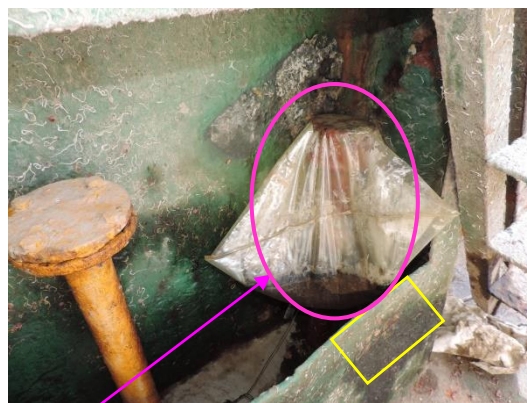
① Deck house side of port-stern part ② Bulwark side of port-stern part

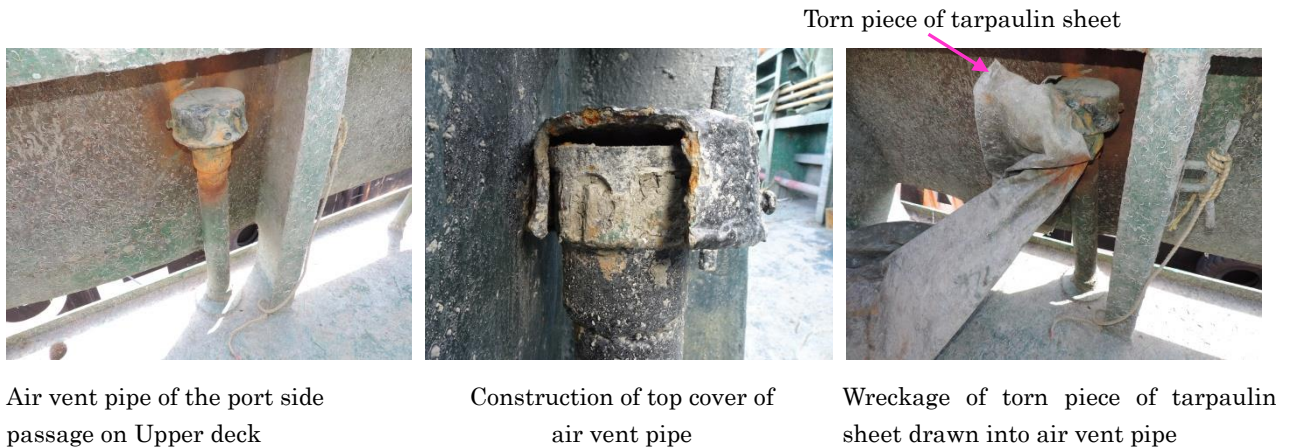
Figure 7 Condition of Air Vent Pipe of Ballast Water Tank

were drawn with ingress water into the ballast tanks when the accident occurred. (See Figure 7)

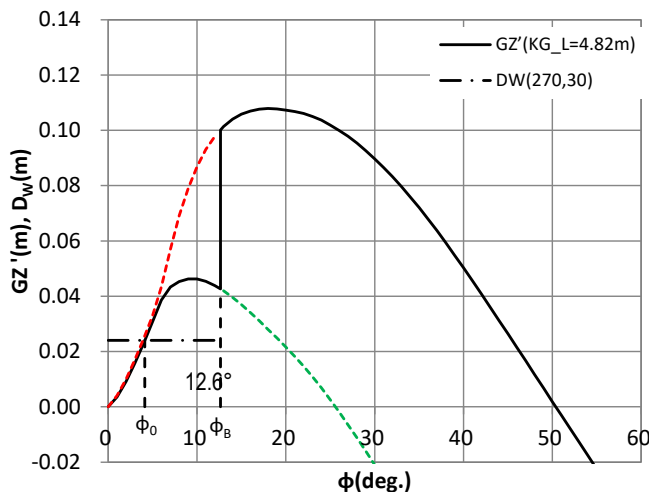
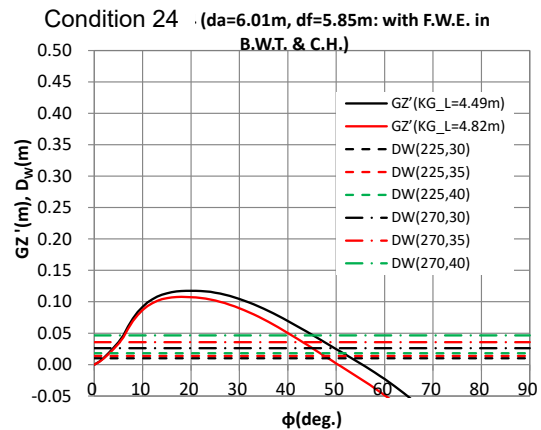
Stability Curve in Condition 24
RW ratio 0% + IW ratio 8%

In Figure 16, the red dotted line is the stability curve of Condition 24 in the case of $0 \leq \phi \leq \phi_B$, and the green dotted line is the stability curve of Condition 14 (a Retained Water ratio of 75%) in the case of $\phi_B \leq \phi$.

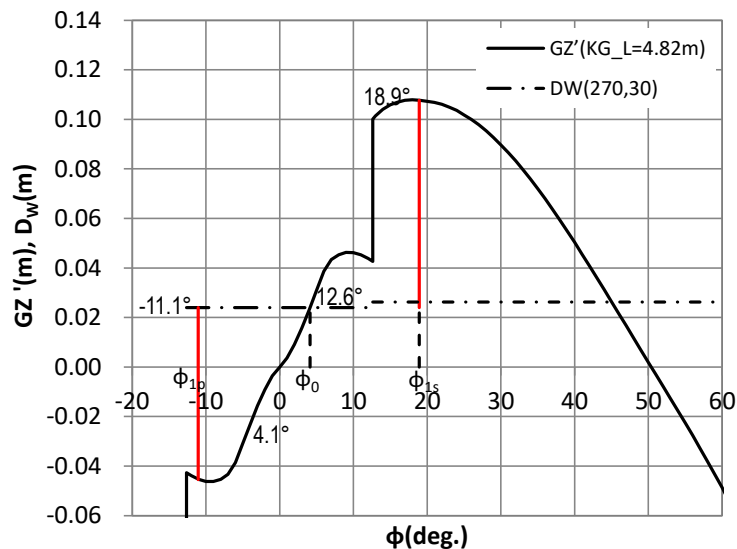
Figure 17 Calculation of Rolling in Steady-state Heeling Condition
 Condition 14, Condition 24: $KG_L=4.82$ m
 Middle of heeling ϕ_0 : 4.1° , Amplitude of heeling due to waves: 15°

However, in case that the lateral heeling angle exceeds the submerged angle 12.6° of the top of the bulwark, the stability transits to the condition of ingress water being in the cargo holds without the Retained Water (Condition 24), and furthermore it is assumed that the heeling couple of force due to winds also transits to the couple of force of Condition 24.
