MA2021-2

**MARINE ACCIDENT
INVESTIGATION REPORT**

MARINE ACCIDENT INVESTIGATION REPORT

Accident type	Fatality of a crew member
Date and time	Around 11:20 on November 16, 2019 (local time, UTC+9 hours)
Location	Wakayama Shimotsu Port, Wakayama Prefecture Around 252 true bearing, 1.6 nautical miles (M) from Wakayama Hokko West Breakwater Lighthouse (approximately 34°13.6'N, 135°05.3'E)
Summary of the Accident	While the cargo ship ORANGE PHOENIX with the master and 20 crew members aboard was anchoring at Wakayama Shimotsu Port, Wakayama Prefecture, a crew member died of a fall from a lifeboat to the deck when engaging in the lifting and recovery of the lifeboat in an abandon ship drill.
Process and Progress of the Investigation	(1) Set up of the Investigation The Japan Transport Safety Board appointed an investigator-in-charge and one other investigator to investigate this accident on November 18, 2019. (2) Collection of Evidence November 19, 2019: On-site investigations and interviews November 28, December 16, 2019, March 2, 5, 6 and 26, August 5, 12 and 18, 2020: Collection of questionnaires (3) Comments from Parties Relevant to the Cause Comments on the draft report were invited

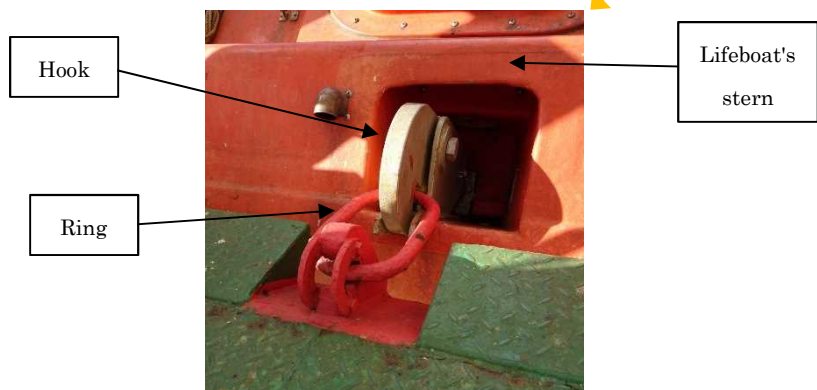
the stern deck of the Vessel in an empty state to the sea surface while hanging it with a hoisting wire. After that, they hoisted the lifeboat up to the original lifting and recovery position and hooked the hook of the release system installed at the stern of the lifeboat on the ring of the boat davit. (See Figures 2 and 3.)

Figure 3 Hook of the release system and ring of the boat davit

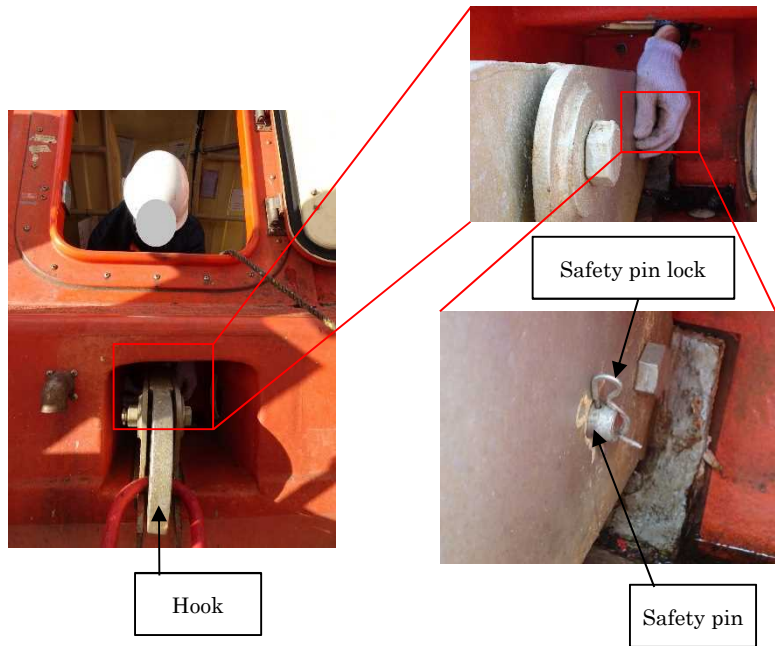
After that, Navigation Officer A entered the lifeboat from the doorway on the stern side of the lifeboat for the purpose of conducting operation to restore the release system that fixes the hook hooked on the ring. Navigation Officer B was taking photographs near the doorway in the bent-over posture to keep the photographs as a record of the drill. (See Figures 4 and 5.)

Figure 4 Status of Navigation Officer A's work (re-enactment)

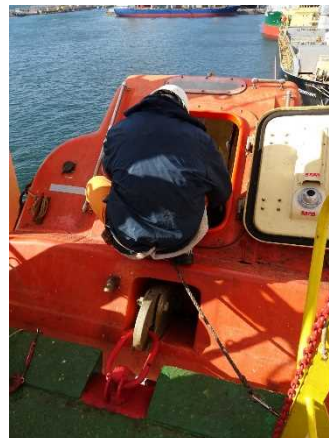
Figure 5 Conditions of Navigation Officer B before the fall (re-enactment)

According to the statement of Navigation Officer A and the reply to the questionnaire by Company A, Navigation Officer B was wearing a workwear, safety shoes, and helmet at the time of the accident, and at the beginning of the launching of a lifeboat, he was also wearing a safety belt and hooking the hook of the belt. However, when he got onto the doorway at the stern of the

<p>lifeboat, he removed the safety belt itself as the rope of the belt was not long enough to reach the position on which the hook of the belt was hooked.</p> <p>According to the reply to the questionnaire by Company A, before getting onto the lifeboat, Navigation Officer B confirmed that the lifeboat was connected to the hoisting wire. However, he did not notify anyone that he would get onto the lifeboat.</p> <p>According to the reply to the questionnaire by Company A, Navigation Officer A had known that Navigation Officer B removed the safety belt itself, but said nothing special to Navigation Officer B.</p> <p>According to the statement of the master, the Vessel was not being shaken by waves, etc. at the time of the accident.</p> <p>(4) Taking the photographs of the abandon ship drill</p> <p>The purpose of taking the photographs of the abandon ship drill was to keep a record of implementation of the drill on paper and present a port state control officer with the fact that the drill was implemented without fail at the time of receiving a port state control.</p> <p>For the Vessel, no person in charge of taking photographs had been decided in advance, and Navigation Officer B was taking photographs at the time of the accident.</p>

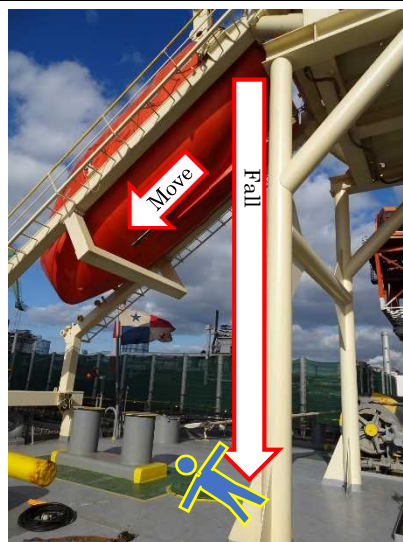
Around 11:20, when Navigation Officer A operated the release system and slightly inserted the safety pin, the hook was suddenly released and the lifeboat moved approx. 1.5 to 2.5 m downward on the guide rail. Thereby, Navigation Officer B lost his physical balance and fell head-first to the deck that was approx. 6 m below. (See Figure 6.)

Figure 6 Status of Navigation Officer B's fall (image)

Navigation Officer B was transferred to Japan Coast Guard's helicopter that came to assist upon receipt of the notification, and was then taken by ambulance to a hospital in Osaka Prefecture. However, he was pronounced dead by a doctor, and the cause of death was confirmed as brain contusion.

<p>Probable Causes</p>	<p>It is considered probable that the accident occurred in a manner that, when the Vessel was doing the lifting and recovery work of the lifeboat in the abandon ship drill while anchoring at Wakayama Shimotsu Port, Navigation Officer B lost his balance and fell to the deck because he was taking photographs in a bent-over posture at the doorway at the stern of the lifeboat without wearing the safety belt, and the hook of the release system was released from the ring of the boat davit and the lifeboat moved downward along the guide rail.</p> <p>It is considered probable that the hook of the release system was released from the ring of the boat davit because it is likely that the lock piece was not hooked in the appropriate place.</p>
<p>Safety Actions</p>	<p>Company A issued a document concerning the accident to gain the attention of all the vessels it manages and also implemented the following measures following the accident.</p> <ul style="list-style-type: none"> - The master and the chief officer provide the crew members with on-site education concerning the release system restoration procedures using an actual lifeboat on a regular basis. - The master provides the crew members with on-site education concerning appropriate equipment, such as a safety belt, for work in a high place. - The master holds a meeting before an abandon ship drill and provides explanation to the crew members concerning the prediction of danger, thereby having each crew member become aware of safe work. - Before conducting a lifeboat lifting and recovery work, the chief officer confirms and thoroughly ensures the following key points

<p>of the work: the hook of the release system is hooked on the ring of the boat davit; the hoisting wire is not released until the hook is completely fixed; the reset position of the hook is confirmed by the green paint of the lock piece; the hook is surely fixed with the safety pin lock by inserting the safety pin.</p> <ul style="list-style-type: none">- Each vessel holds an onboard safety meeting and gives explanation about the details of the accident, and reports the record of implementation of on-site education to Company A.- Company A's supervisor visits the vessels Company A manages and confirms that the release system is actually operated in an appropriate manner. <p>It is probable that the following actions will be useful in preventing the reoccurrence of a similar accident and reducing damage.</p> <ul style="list-style-type: none">- When lifting and recovering a lifeboat, crew members make sure to do the next work after confirming that the lifeboat was fixed by surely conducting the lifeboat release system restoration operation.- When doing work at a place involving the risk of a fall, crew members appropriately use a safety belt.

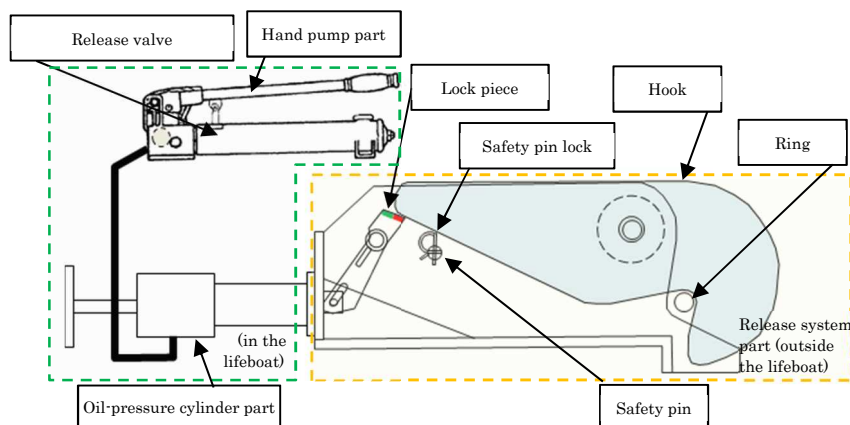
Figure 7 Structure of the release system

The release system comprises a release system part, a hand pump part, and an oil-pressure cylinder part. (See Figure 7.)

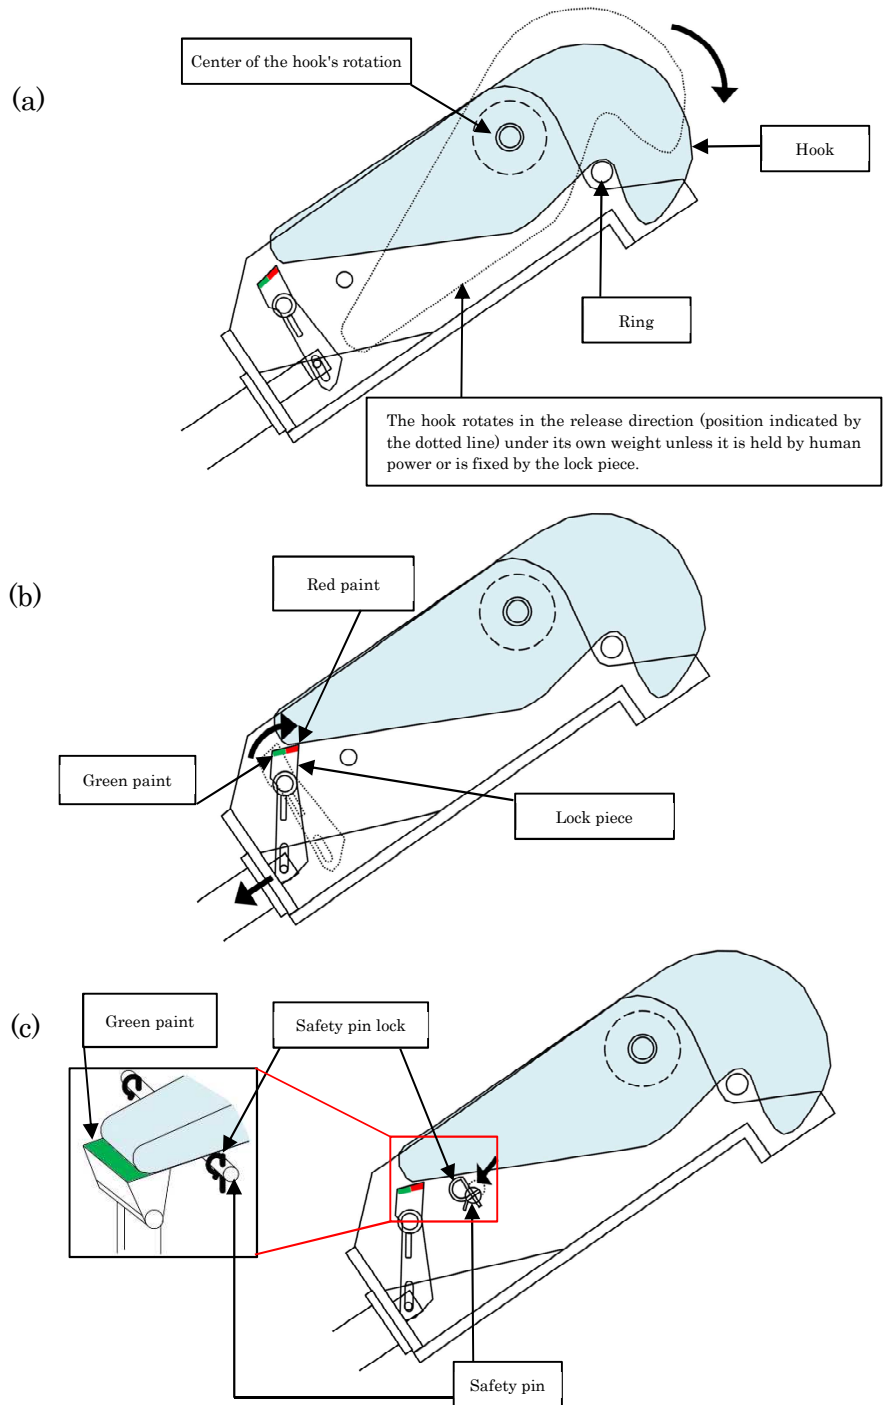
Figure 8 Operation to restore the release system

- Hook the hook of the release system on the ring of the boat davit and hold the hook as it is. (See Figure 8 (a).)
- The lock piece is hooked on the hook (rear underside) when the release valve of the hand pump is relaxed in the state of

holding the hook. At this time, if the end of the hook is normally hooked on the lock piece, only the green paint of the lock piece is seen from the position of the operator in the lifeboat and the red paint thereof cannot be confirmed. (See Figure 8(b).)

- Insert the safety pin, and put in the safety pin lock. (See Figure 8(c).)

- Navigation Officer A could see only the green paint of the lock piece before he tried to insert the safety pin.
- Navigation Officer A tried to insert the safety pin but could not insert it as the safety pin was blocked by the hook.

- The fact that Navigation Officer A could see only the green paint of the lock piece and the fact that the safety pin was blocked by the hook are incompatible for the structural reason as stated below.

① If only the green paint of the lock piece can be seen, the hook is in the reset position (the state where the lock piece is normally hooked on the end of the hook) and the safety pin can be inserted.

② The fact that the safety pin was blocked by the hook indicates that the lock piece was not hooked on the hook and that the hook was not in the reset position.
