**MARINE ACCIDENT
INVESTIGATION REPORT**

Vessel Type and Name : Cargo Ship, GUO XING 1

Vessel Type and Name : Fishing Vessel, TOMI MARU No.8

Accident Type : Collision

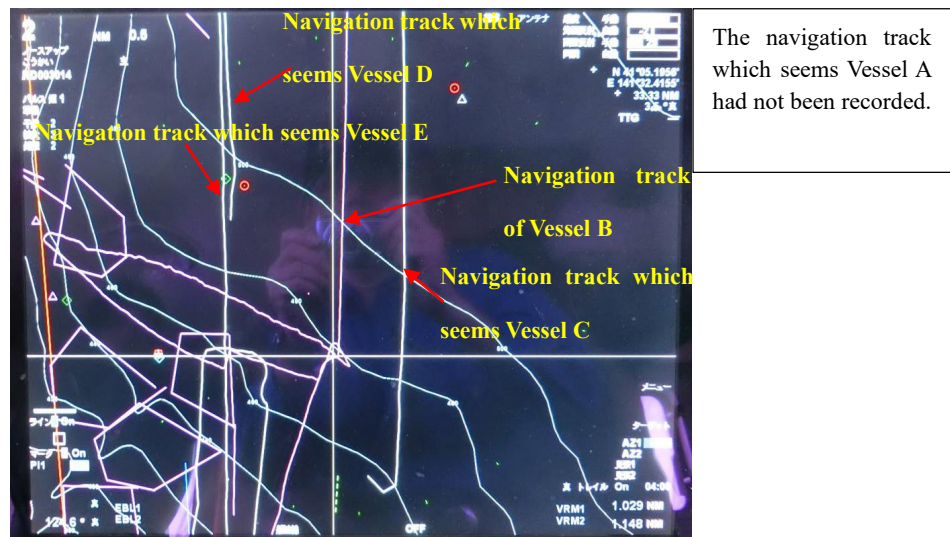
Figure 1 Navigation track recorded on the radar plotter of Vessel B

The Chief fisherman B did not expect that Vessel A heading toward Vessel B after heading east of Vessel B's course extension.

Although Chief fisherman B normally used the ARPA function of the radar when he felt that dangerous vessel heading toward vessel B, the ARPA function was not used for Vessel A at that time of this accident. (See Figure 1)

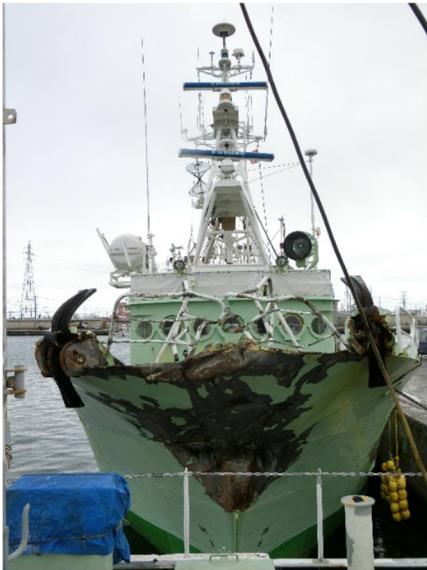
Vessel B was suffered and dented with holes on the bow, and dented and scratched on the bulbous bow and shell plating of port side bow. (See Figure 3).

Damage of Bow

As described in 2.3(2), Vessel B was damaged that the bow was dented with holes and scratched, and the shell plate of portside bow was scratched.

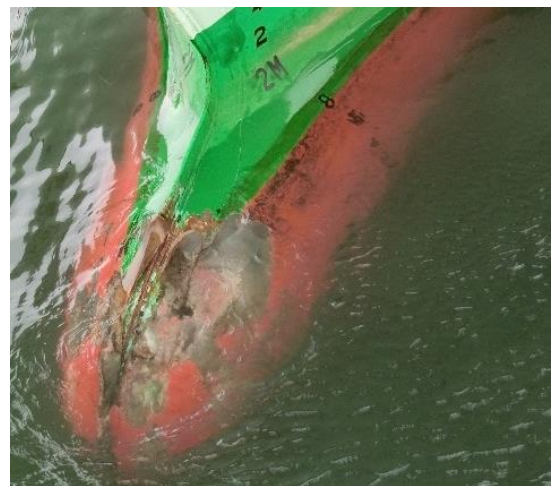
Damage of Bulbous Bow

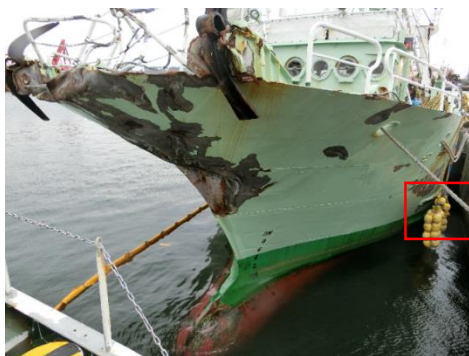
Damage of port side bow (1)

- (2) According to the following statements, it was likely that Vessel B was damaged that the shell plate of port side bow was scratched, because port side bow of vessel B was in close contact with the starboard side hull of vessel A which was sailing from collision to around 22:13.

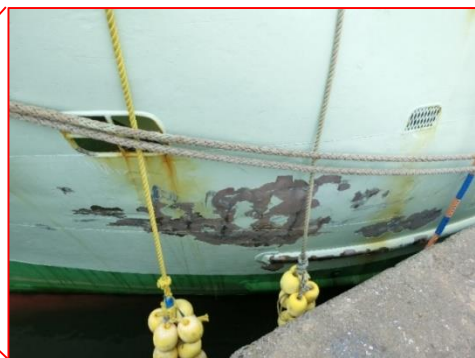
Damage of port side bow (2)

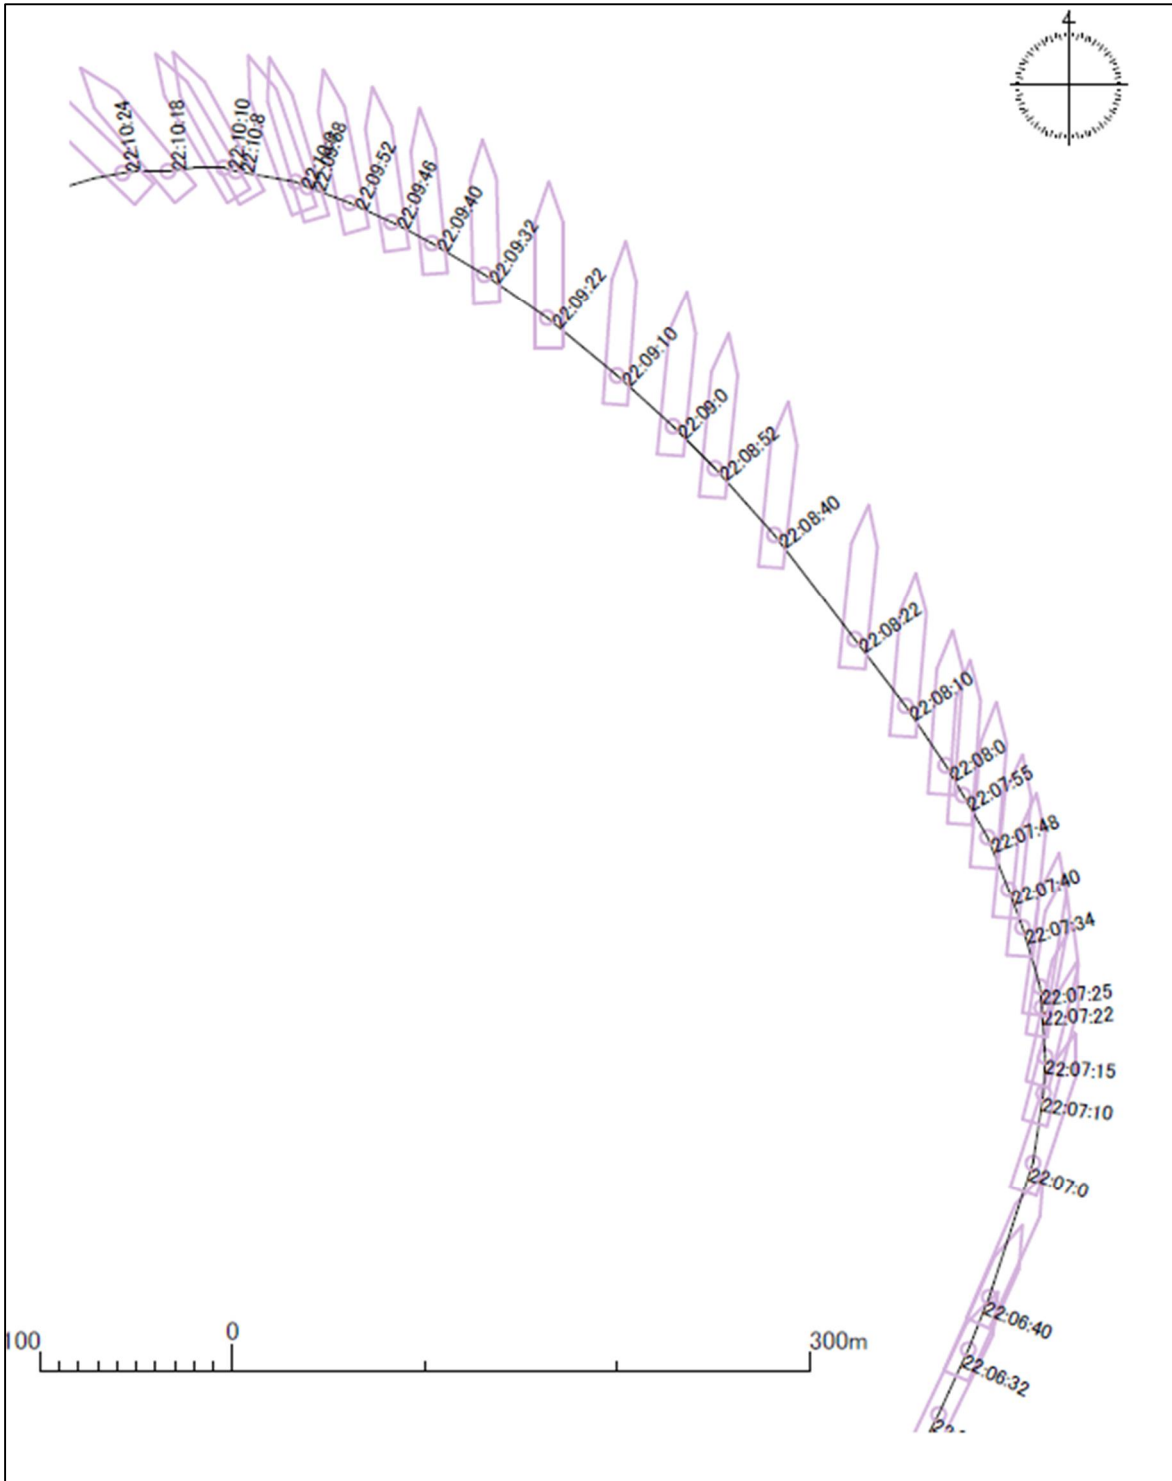
Figure 1 Ship track of Vessel A from 22:06:32 to 22:10:24 on 20200229 according to AIS record of Vessel A

Regarding the verification based on AIS record of Vessel A shown in Table 1 of 2.1.1, the vessel was kept the heading from north-north-east to west-north-west after 22:07:10, and it is shown that Vessel A was moving from north-north-west to north-west at a speed of around 7kn. This ship track is extremely unnatural for the cargo ship with one fixed pitch propeller as a propulsion system (2.5.1(1)) which sailed on the open sea area under the weather and sea condition (2.6) at that time of the accident.

Vessel A had sunk and JTSCB could not investigate the navigation equipment of this vessel. However, in view of the above, it is probable that the heading of vessel A after 22:7:10 on AIS record were not recorded correctly.
