**MARINE ACCIDENT  
INVESTIGATION REPORT**

Vessel type and name: Container Ship ONE APUS  
Vessel No. 143426 (IMO No. 9806079)  
Gross tonnage: 146,694 tons

Accident/Incident type : Damage to container hatchcover,etc.

Date and time : November 30, 2020, around 23:22(ship time)(First heavy rolling) -  
December 1, 2020, around 00:59 (ship time)(Second heavy rolling)

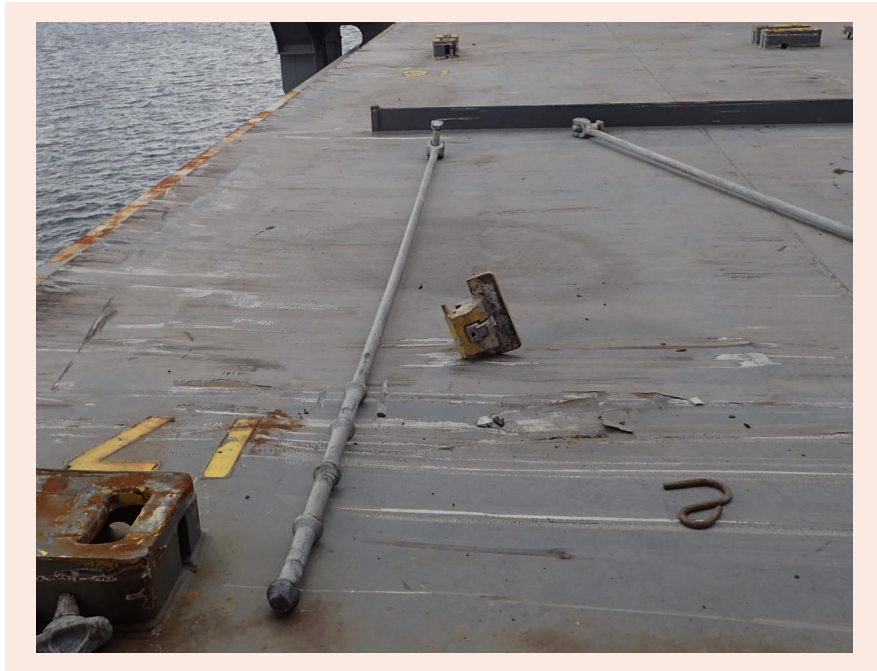
Photo 1 Container hatch cover

According to the on-site investigation and Company A's collection of questionnaires, The vessel had a hole in the container hatch cover abrasions on the bow and center shells, bent handrails on the upper deck, fire hydrants from the fire extinguishing seawater pipes, etc., and compressed air and fresh water. The damage caused included damage to system pipes, damage to power receiving equipment from land, damage to the handrail of the lashing bridge (a bridge for attaching devices for Securing containers), and loss to the pilot ladder. (See photos 1 to 4)

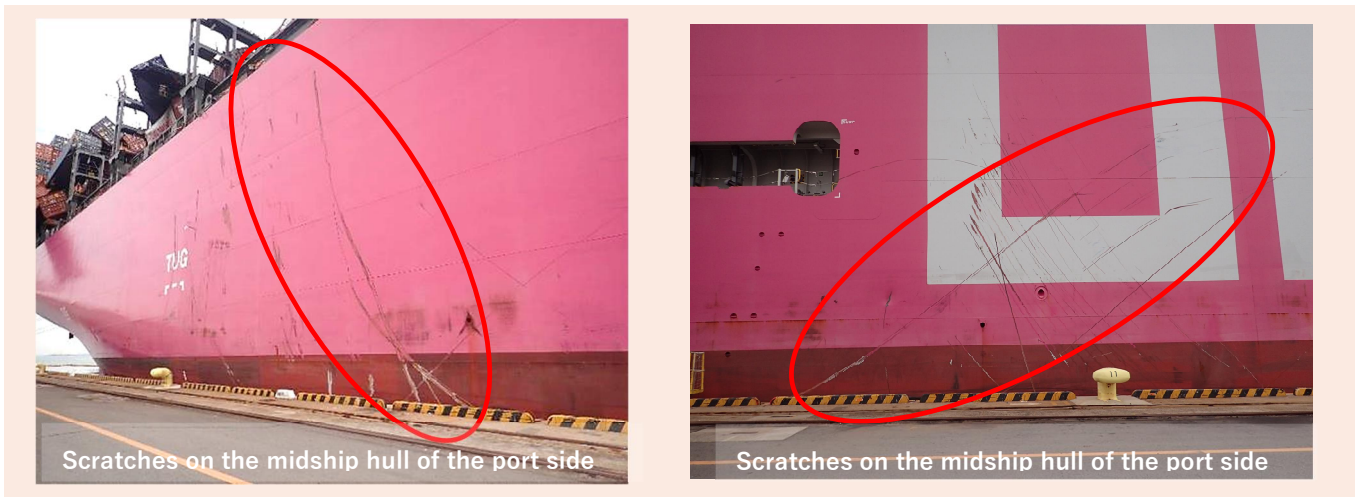
Photo 2 Damage to the hull

Scratches on the midship hull of the port side

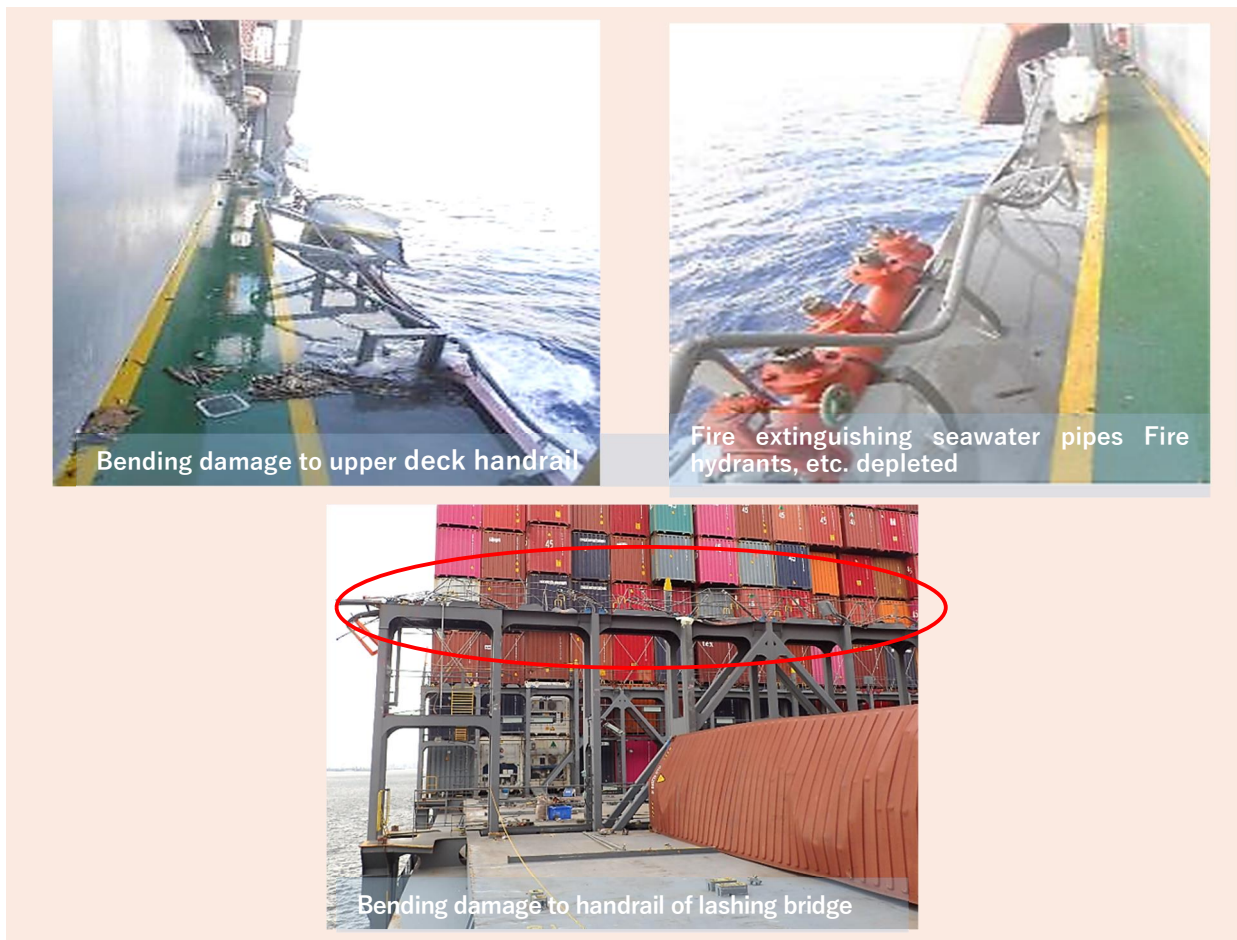
Photo 3 Damage to equipment on deck

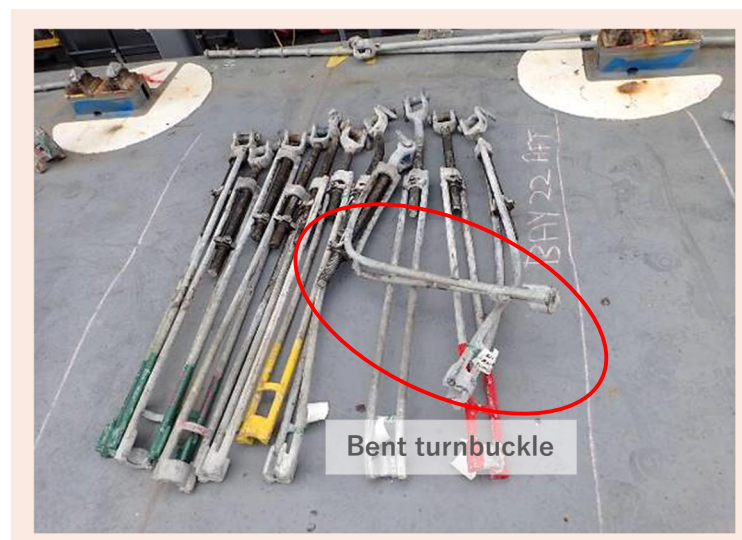
Photo 4 Damage to lashing equipment

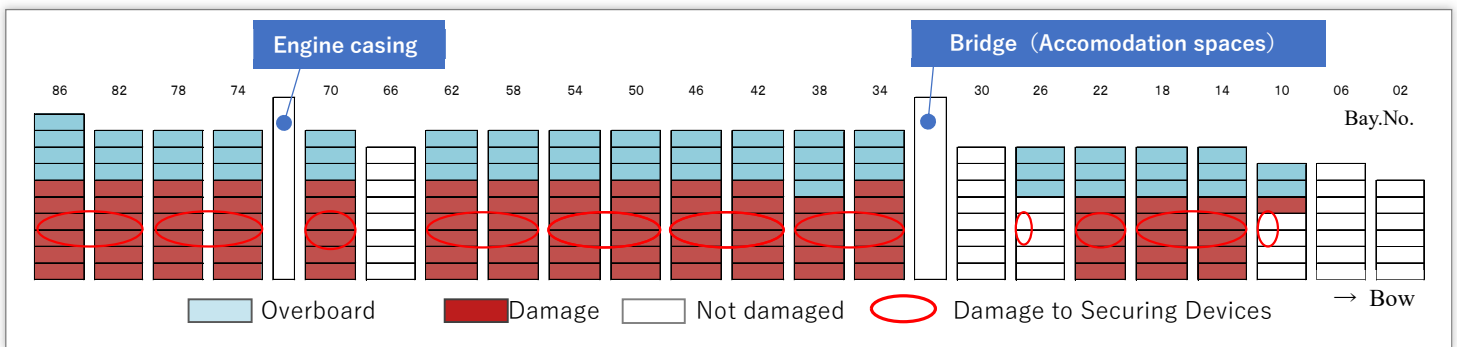
Figure 6 Approximation of damaged arrangement Upper deck loading containers and Securing Devices

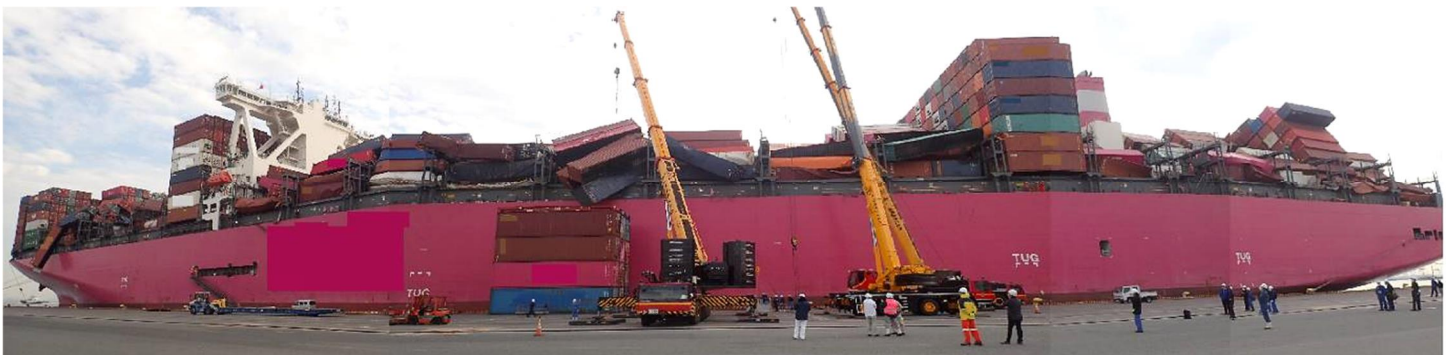
Photo 5 The collapsed container seen from the port side

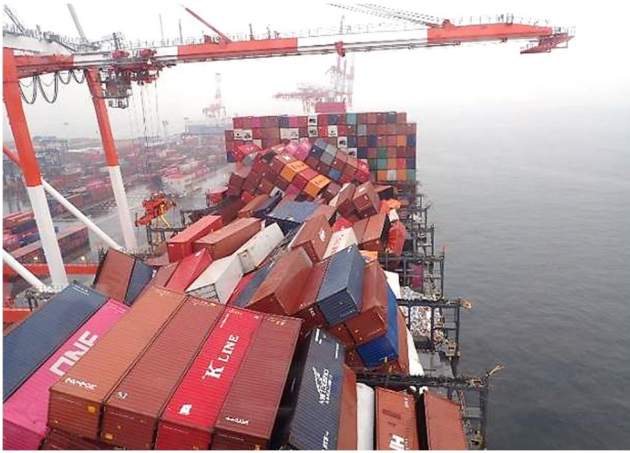
Photo 6 Collapsed containers on upper deck

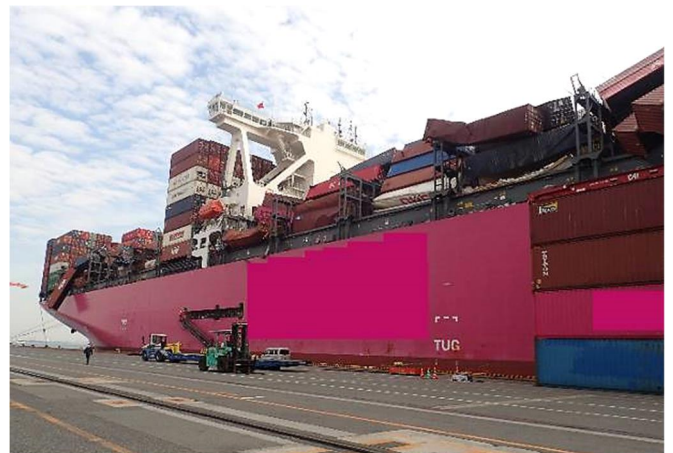
Photo 7 Collapsed containers on port bow

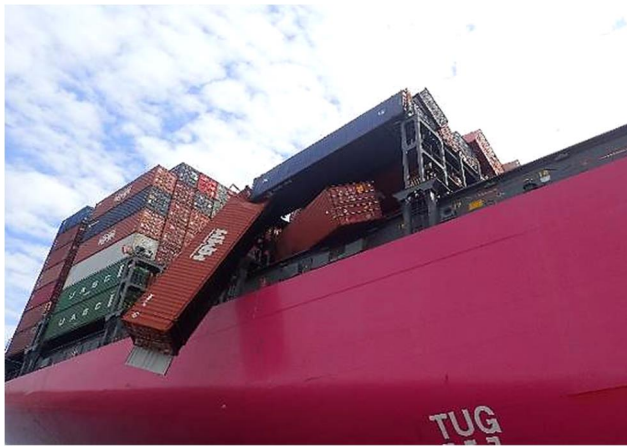
Photo 8 Containers on the verge of falling

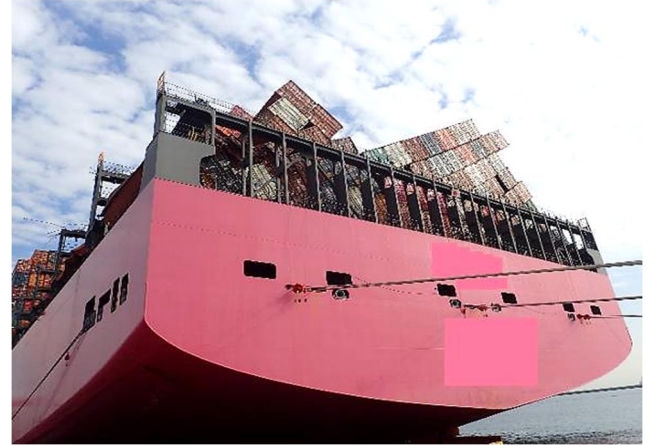
Photo 9 Collapsed containers at stern

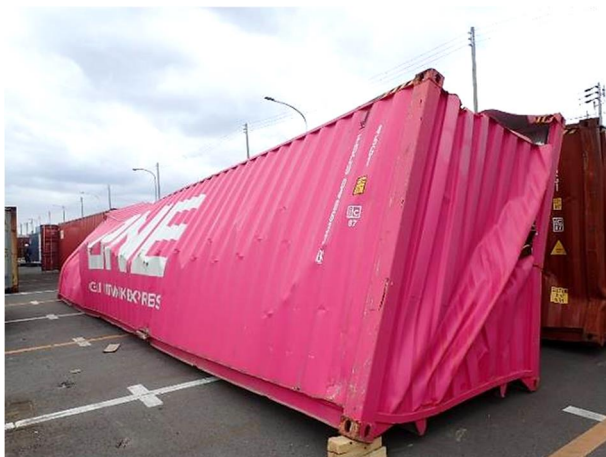
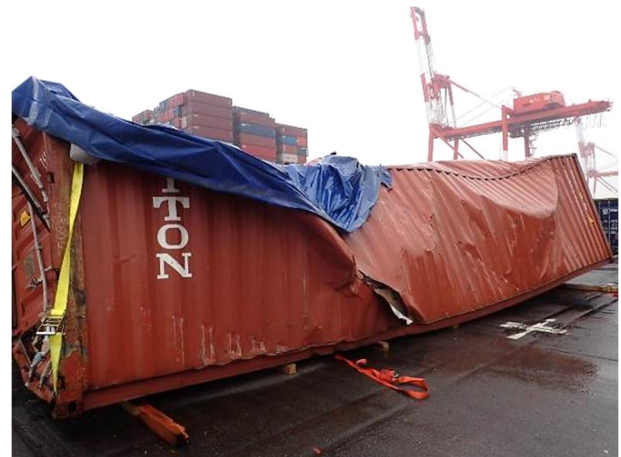
According to the on-site investigation, the damaged container was pressed down by the adjacent container, causing pressure loss on the top and sides, and deformation of the container bottom member. (See Photos 10-11).

Photo 10 Container pressure loss situation

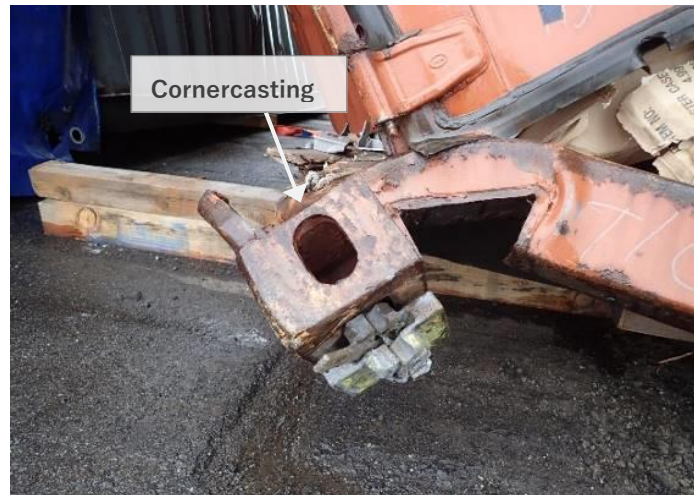
Photo 11 Deformation of the container bottom member
