"The train derailment accident due to the collision of the train and the standard sized automobile, occurred at the class 1 level crossing"

Railway operator : Odakyu Electric Railway Co., Ltd.
 Accident type : Train derailment accompanied by the level crossing accident
 Date and time : About 14:52, June 19, 2019
 Location : Hon-Atsugi No.13 level crossing, the class 1 level crossing equipped with crossing gate and road warning device, at about 47,340 m from the origin in Shinjuku station, between Hon-Atsugi station and Aiko-Ishida station, double track, Odawara Line, Atsugi City, Kanagawa Prefecture

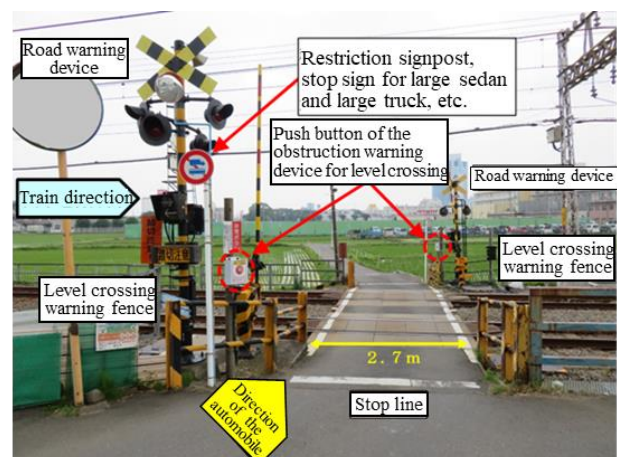
<Status of Hon-Atsugi No.13 level crossing viewed from the entered side of the automobile>

As for that the driver of the concerned automobile entered the concerned level crossing in the status as the road warning device of the concerned level crossing was operating, it is somewhat likely that it was the first time for the driver of the concerned automobile to pass the concerned level crossing by driving the concerned automobile, and his consciousness was not paid toward the on and off red flash lamps and the alarm sound of the road warning device in the concerned level crossing because his consciousness had been concentrated to drive the automobile carefully as the obstacle detection system of the concerned automobile uttered the warning sound when moved the concerned automobile into the concerned level crossing. In addition, as for that the concerned automobile stopped in the concerned level crossing, it is certain that the driver of the concerned automobile stopped the concerned automobile in the concerned level crossing because the driver of the concerned automobile did not know that the automobile can get out of the concerned level crossing as the crossing rod would be raised by pushing the cross rod by the automobile.

Furthermore, as for Hon-Atsugi No.13 level crossing, it is desirable to study the installation of the "omnidirectional flash lamps" which improves the visibility of the red flash lamps of the road warning device and the "level crossing obstacle detecting device", among the safety measures against level crossings described in the safety report of Odakyu Electric Railway Co. Ltd.

Odakyu Electric Railway Co., Ltd., responded to the occurrence of the concerned accident, installed the level crossing obstacle detecting device in Hon-Atsugi No.13 level crossing, and attached the hanging banners to the crossing rods of the concerned level crossing indicating as

"wait a moment" for the road side and as "go ahead by pushing the crossing rod" for the track side.
