"The train derailment accident due to collided with automobile halting on the railway track"

Railway operator : East Japan Railway Co. Ltd.
 Accident type : Train derailment
 Date and time : About 00:07, March 26, 2021
 Location : Around 66,689 m from Nippori station, between Tsuchiura station and Kandatsu station, double track, Joban Line, Tsuchiura City, Ibaraki Prefecture

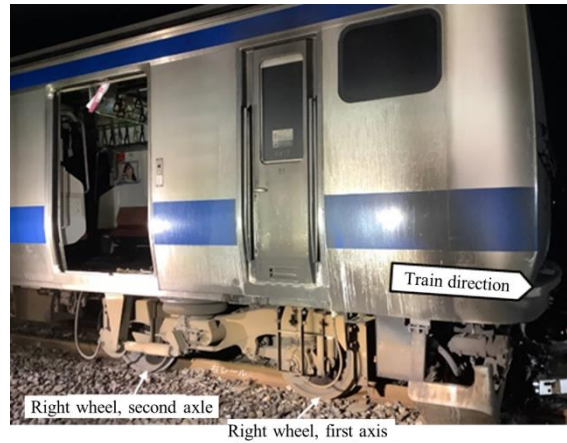
Derailed status of the train

On Friday, March 26, 2021, while the outbound Local 1269M train, started from Shinagawa station bound for Katsuta station of East Japan Railway Co., Ltd., was running between Tsuchiura station and Kandatsu station at the velocity of about 97 km/h, the driver of the train noticed a standard motor vehicle on the down line track halting as crossed. The driver applied the emergency brake immediately but it was too late, the train collided with the standard motor vehicle. The train stopped after ran for about 267 m as dragging the standard motor vehicle. All two axles in the front bogie of the first vehicle derailed to right in this accident.

It is highly probable that the running train collided with the standard motor vehicle which invaded into the track and was halting on the railway track, and right wheels of all two axles of the front bogie of the first vehicle ran onto the rail and derailed to right side of the track, because the standard motor vehicle got into the space between lower left part of the front surface of the first vehicle and the railway track.

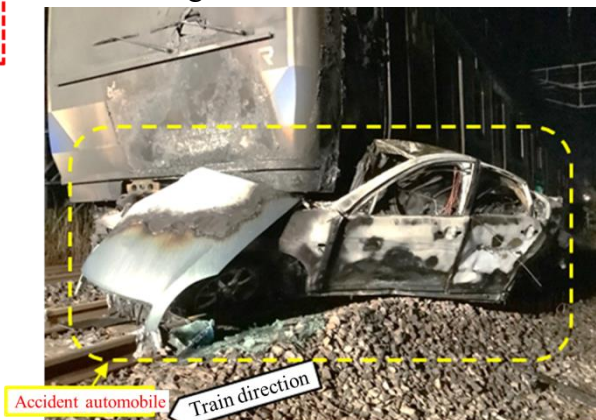
Damaged status of the automobile

It is probable that the standard motor vehicle had been invaded into the railway track because the standard motor vehicle broke through the net fence and invaded into the railway track and became as could not be moved, because the driver of the standard motor vehicle mistook the handling operation in the situation that the driver could not drive calmly in order to escape from the pursuit by the police.

It is desirable for the road administrator to take measures such as to install the rumble strips to let known by sound and vibration, the rivets on the road surface, etc., or the guiding eye signs clearly indicated the road shapes, etc., for the place where the driver of automobile should pay attention as to enable the safe driving, in order to prevent accident from happening, because this accident was caused by that the standard motor vehicle broke through the net fence and invaded into the railway track. Furthermore, it is desirable to take measures to install the protection fences stronger than the net fences, i.e., the guard rail, etc., for the place where invasion of automobile into track was feared.

In addition, it is desirable for the railway operator to confirm the status of the facilities, implement discussions with the road administrators depending on the necessity, and apply to install the devices to prevent invasion of automobiles into the railway track.
