# **RAILWAY SERIOUS INCIDENT INVESTIGATION REPORT**

## **Overrun on main track**

# Railway Serious Incident Investigation Report

Railway operator	WILLER TRAINS Inc.
Serious incident type	Overrun on main track, railway serious incident related with "the situation that the train or the vehicle overrun on the main track between stations" stipulated in Article 4, paragraph (1), item (iv) of the Ordinance on Report on Railway Accidents
Date and time	About 21:04, October 4, 2020
Location	Around 18,500 m from Nishimaizuru station, between Tangoyura station and Kunda station, Miyazu Line, Miyazu City, Kyoto Prefecture

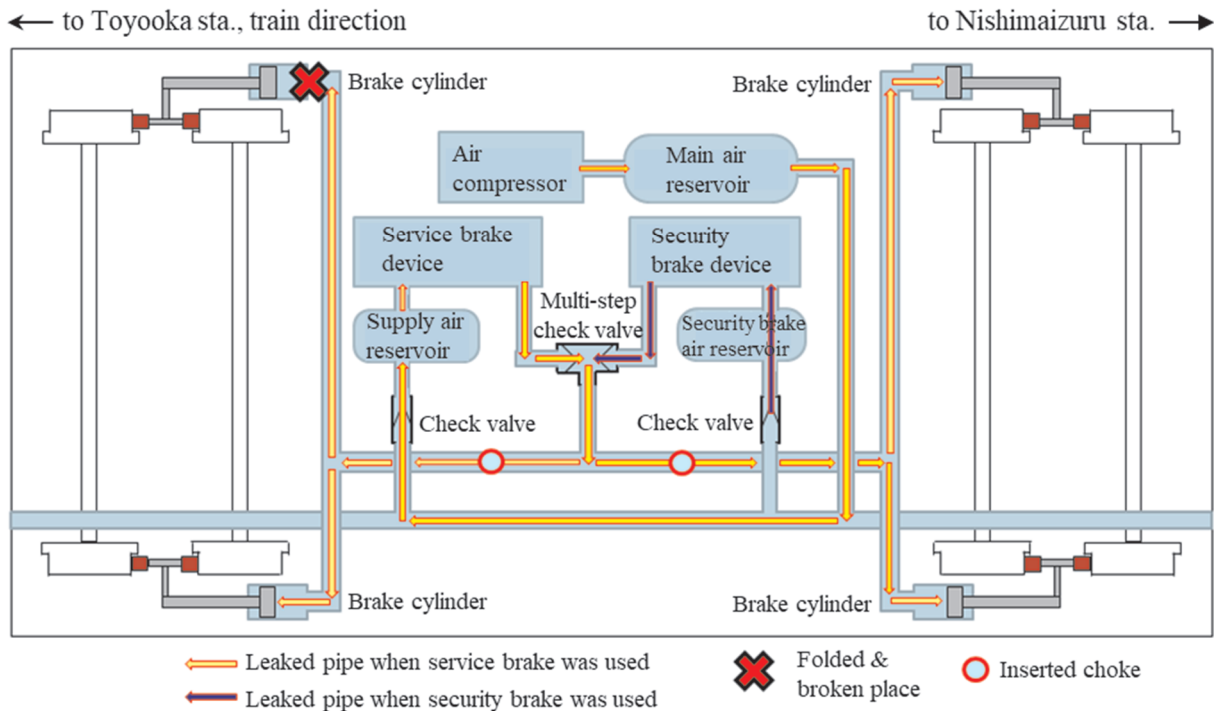
Figure 2. Service brake system and security brake system of the Train

When the service brake was operated in the Train, in the situation as the pipe connected to the brake cylinder had been folded and broken, the compressed air between the main air reservoir and the brake cylinder via the supply air reservoir, the service brake device and the multi-step check valve, was leaked completely, and the compressed air stored in the main air reservoir and the supply air reservoir was lost. Furthermore, because the pipes from the multi-step check valve to the brake cylinder was commonly used in the service brake and the security brake, the compressed air from the security brake air reservoir to the multi-step check valve via the security brake device was leaked completely when the security brake was operated, and the compressed air stored in the security brake air reservoir was also lost. Although the air compressor, which was driven by the power of the engine, continued to produce the compressed air, the service brake and the security brake became not to function because all brake shoes pushing each wheel were released because the volume of the leaked air was larger than the produced compressed air. Additionally, the improving maintenance of the brake device described in 2.9 (2) (vi) (b) had been implemented and the choke has been inserted in around the BC cock<sup>\*9</sup> of the pipe connected to the bogie, in the Train.

As described in 2.4.1, when the pipe connected to the brake cylinder was folded and damaged in the Train, the operation of the service brake causes the complete leakage of the compressed air in the range from the main air reservoir to the brake cylinder via the supply air reservoir, the service brake device, and the multi-step check valve, and the compressed air stored in the main air reservoir and the supply air reservoir were lost. Furthermore, because the pipe from the multi-step check valve to the brake cylinder was commonly used in the service brake and the security brake, when the security brake was operated, the compressed air from the security brake air reservoir to the multi-step check valve via the security brake device was leaked completely, and the compressed air stored in the security brake air reservoir was also lost. It is highly probable that the service brake and the security brake became not to function, because all brake shoes pushing each wheel were released as the volume of the leaked air was larger than the produced compressed air, although the air compressor continued to produce the compressed air. Therefore, it is probable that the study should be implemented on the replacement of the vehicles equipped with the brake system which adopted the fault tolerant design<sup>\*11</sup>, *i.e.*, the design that can secure the security brake function even when the pipe of the service brake had folded and damaged, such as to consider the

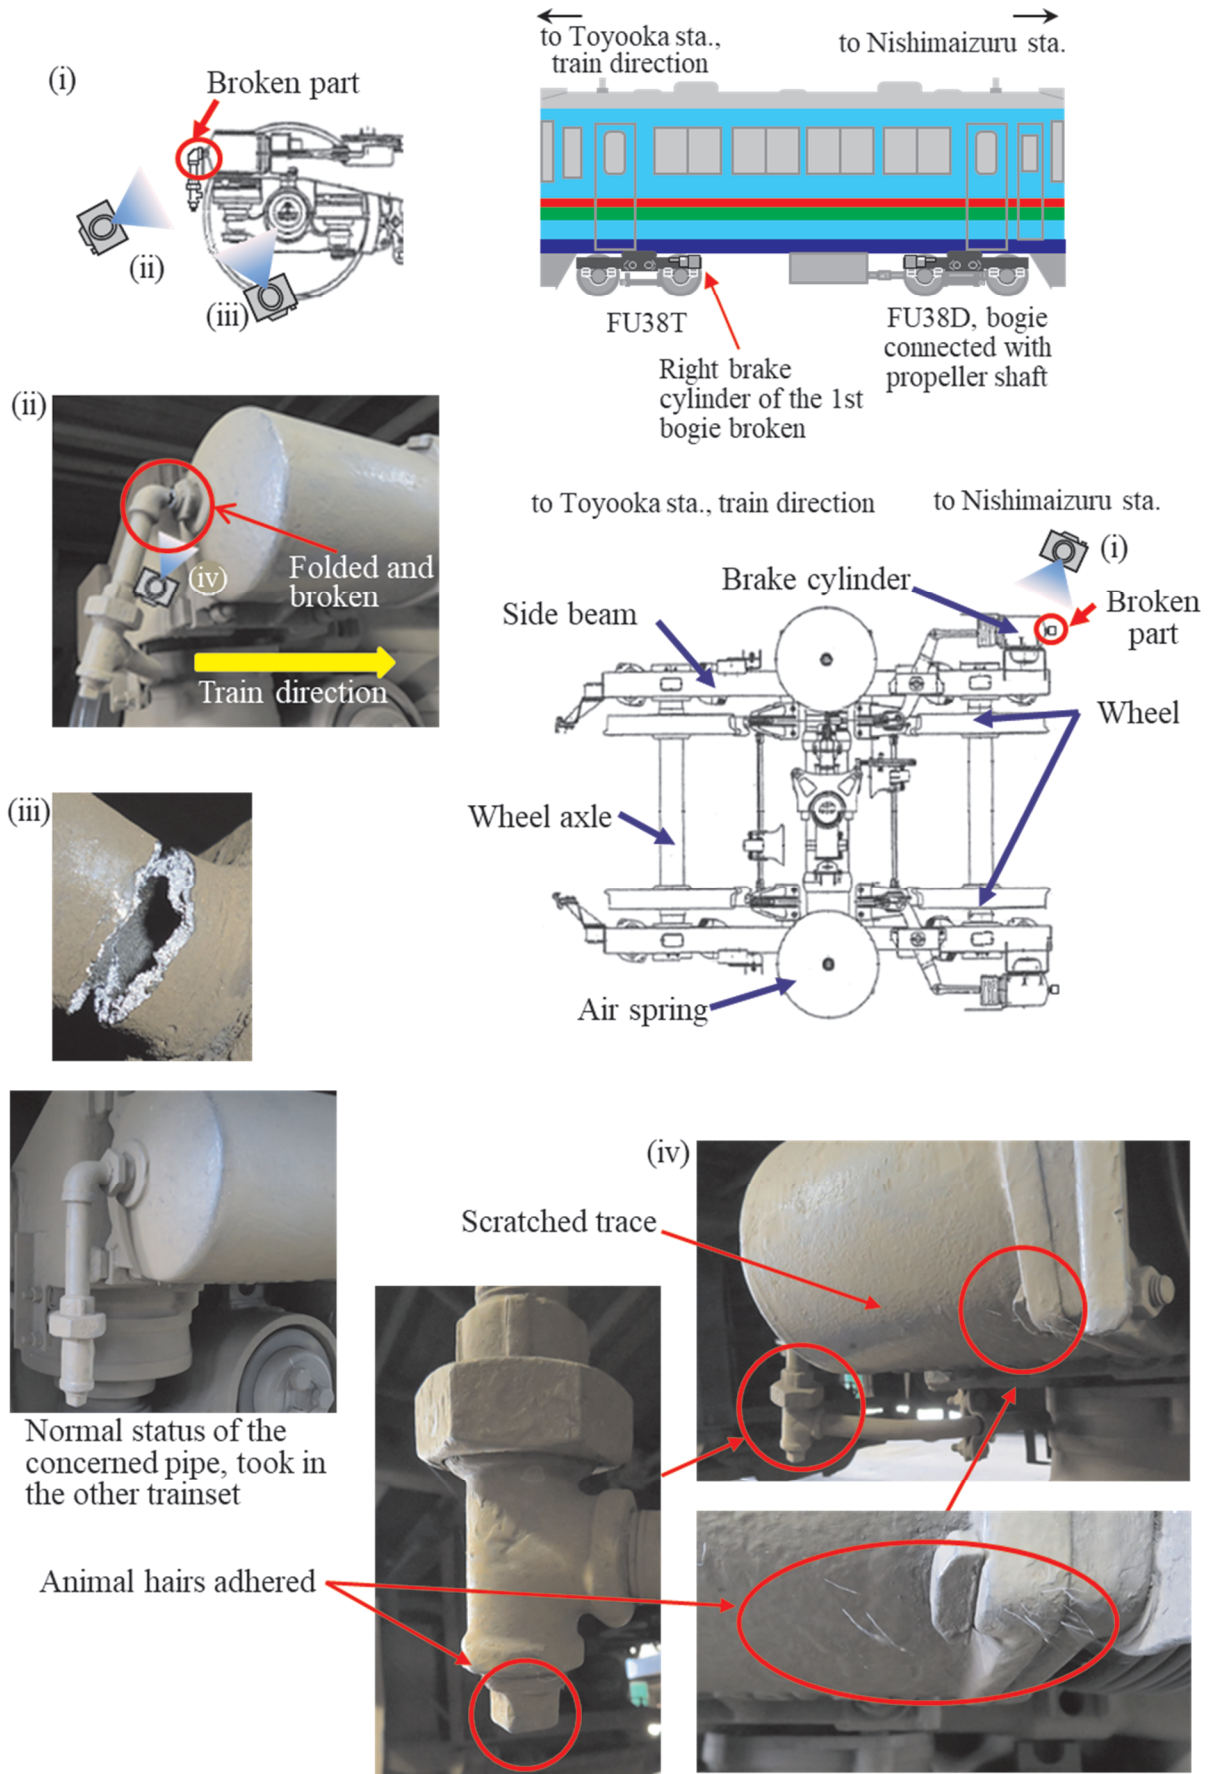
Attached Figure 3. Damaged Status of the Train

The concerned vehicle was investigated and it was found that the pipe, *hereinafter referred to as "the Pipe"*, connected to right brake cylinder of the 1st bogie was folded and broken at the root part which had been bent in the direction opposite to the direction of travel. , *following the bogie, etc., was counted from the outbound direction of the track route of the Company and the words "left" and "right" are based on the running direction of the outbound train.* Furthermore, animal hair was adhered to the joint part of the Pipe and the bottom of the brake cylinder, and the scratched trace was found in the bottom of the brake cylinder.

The brake cylinder of the Train was laid in outside of the side beam of the bogie and the Pipe was in the position close to the side surface of the vehicle body. Furthermore, the Pipe had been overhung in lower part of the brake cylinder.

Additionally, it is probable that the Pipe was folded and damaged due to collided with the animal invaded in forward of the rear axle of the front bogie from right side of the Train because the hair of animal had been adhered to the joint part of the Pipe and the bottom of the brake cylinder. However, it could not be cleared the precise situation because there was no dead body of animal, etc.

It is probable that the pipe connected to the brake cylinder had folded and broken which had been bent around the root part in the direction opposite to the direction of travel, because the pipe had been overhung in lower side of the brake cylinder in the near place to side surface of the vehicle body and could not prevent the collision with the animal invaded to front part of the rear axle of the front bogie from right side of the track.
