**Railway Accident Investigation Report
(Excerpt)**

Train Derailment Accident between Tsukaguchi and Amagasaki Stations of the
Fukuchiyama Line of the West Japan Railway Company

June 28, 2007

Aircraft and Railway Accidents Investigation Commission

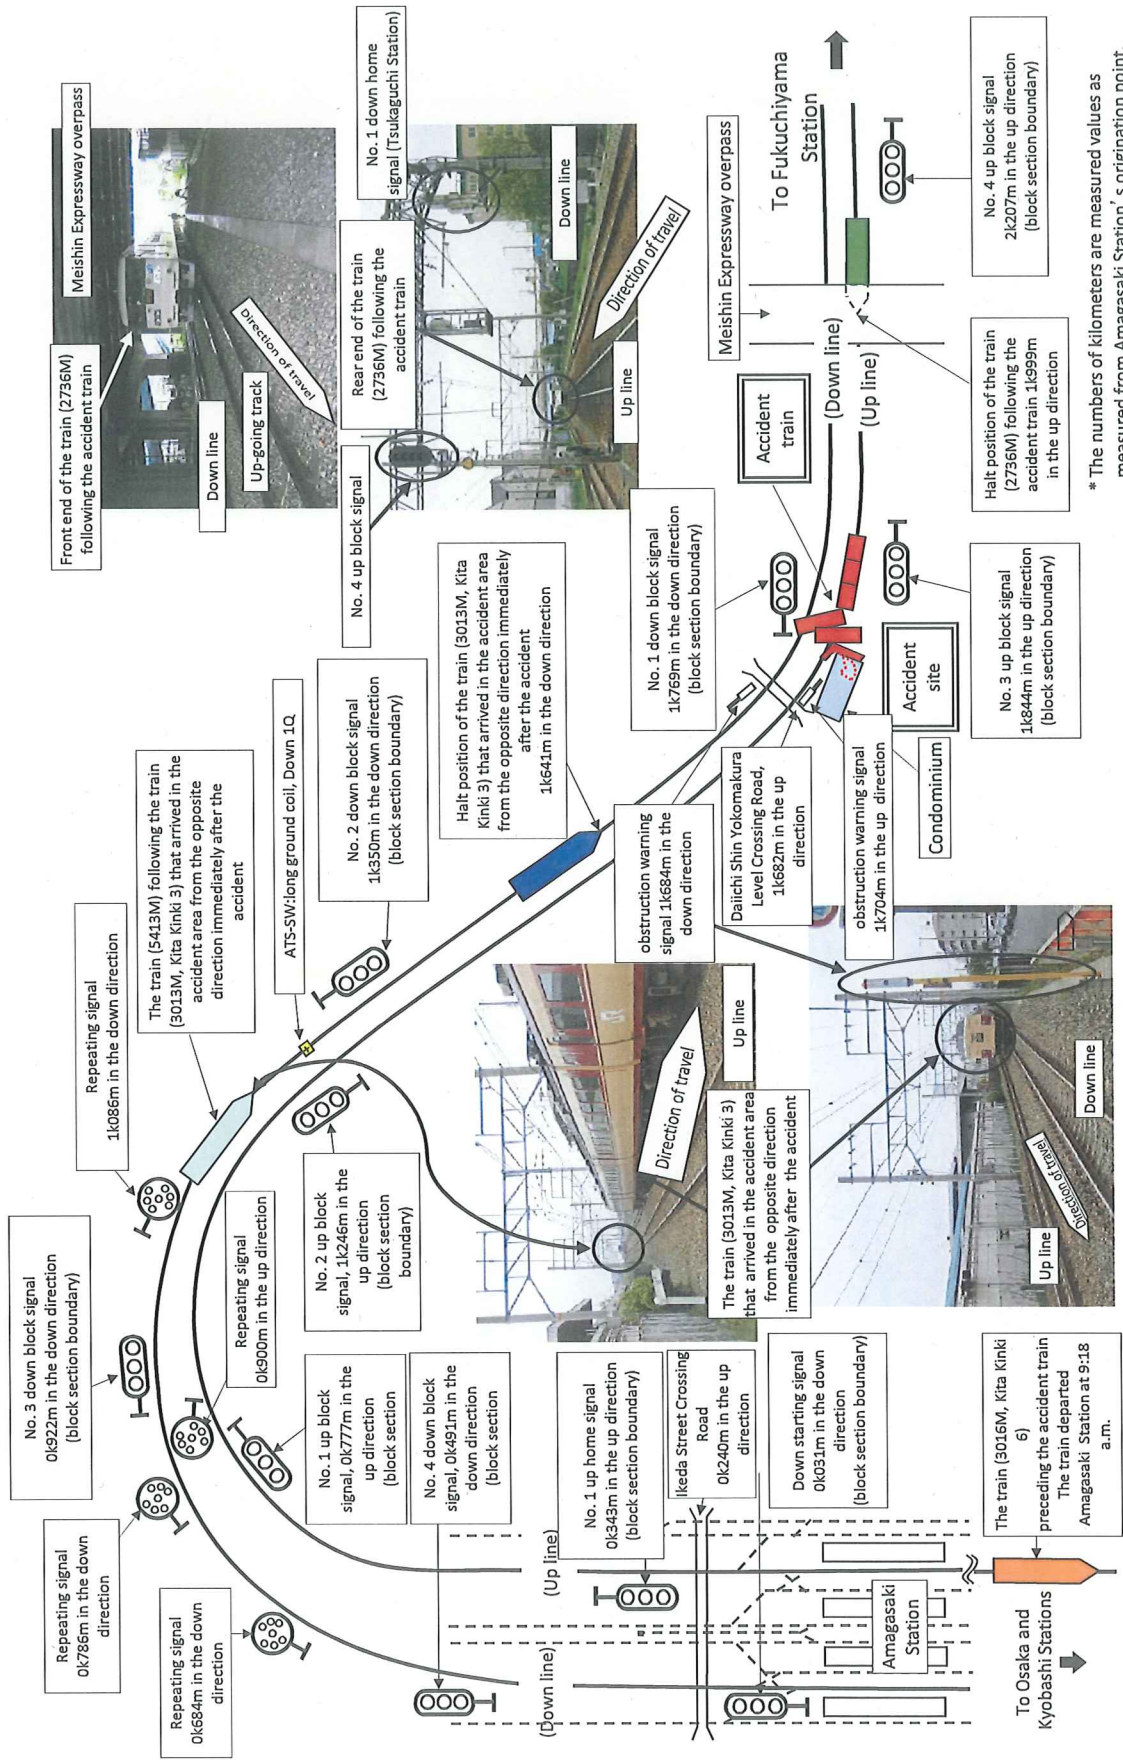
Figure 7 - States of Damage to Railway Facilities etc. (1)

Concerning the up track near the accident site, there were many vestiges on the left side of the left rail from the No. 107 to No. 146 sleepers, seemingly left by running of wheel flanges, etc. Of them, intermittent linear vestiges (to be referred to as "vestige lines") were found on the No. 107 (up track 1k818m) to No. 113, No. 116 (up track 1k812m) to No. 124, No. 128 (up track 1k805m) to No. 134, and No. 137 (up track 1k799m) to No. 146 sleepers, respectively. These four vestige lines seem to have been left by running of the left wheel of the first or second axle of the different single bogies, respectively.

Intermittent curved scratches were found within the gauge from the No. 161 to No. 180 sleeper, and there was lateral displacement of the track to the left in that section.

Furthermore, there was damage on the right side of the right rail from the No. 198 to No. 201 sleeper and lateral displacement of the track to the left in that section, respectively.

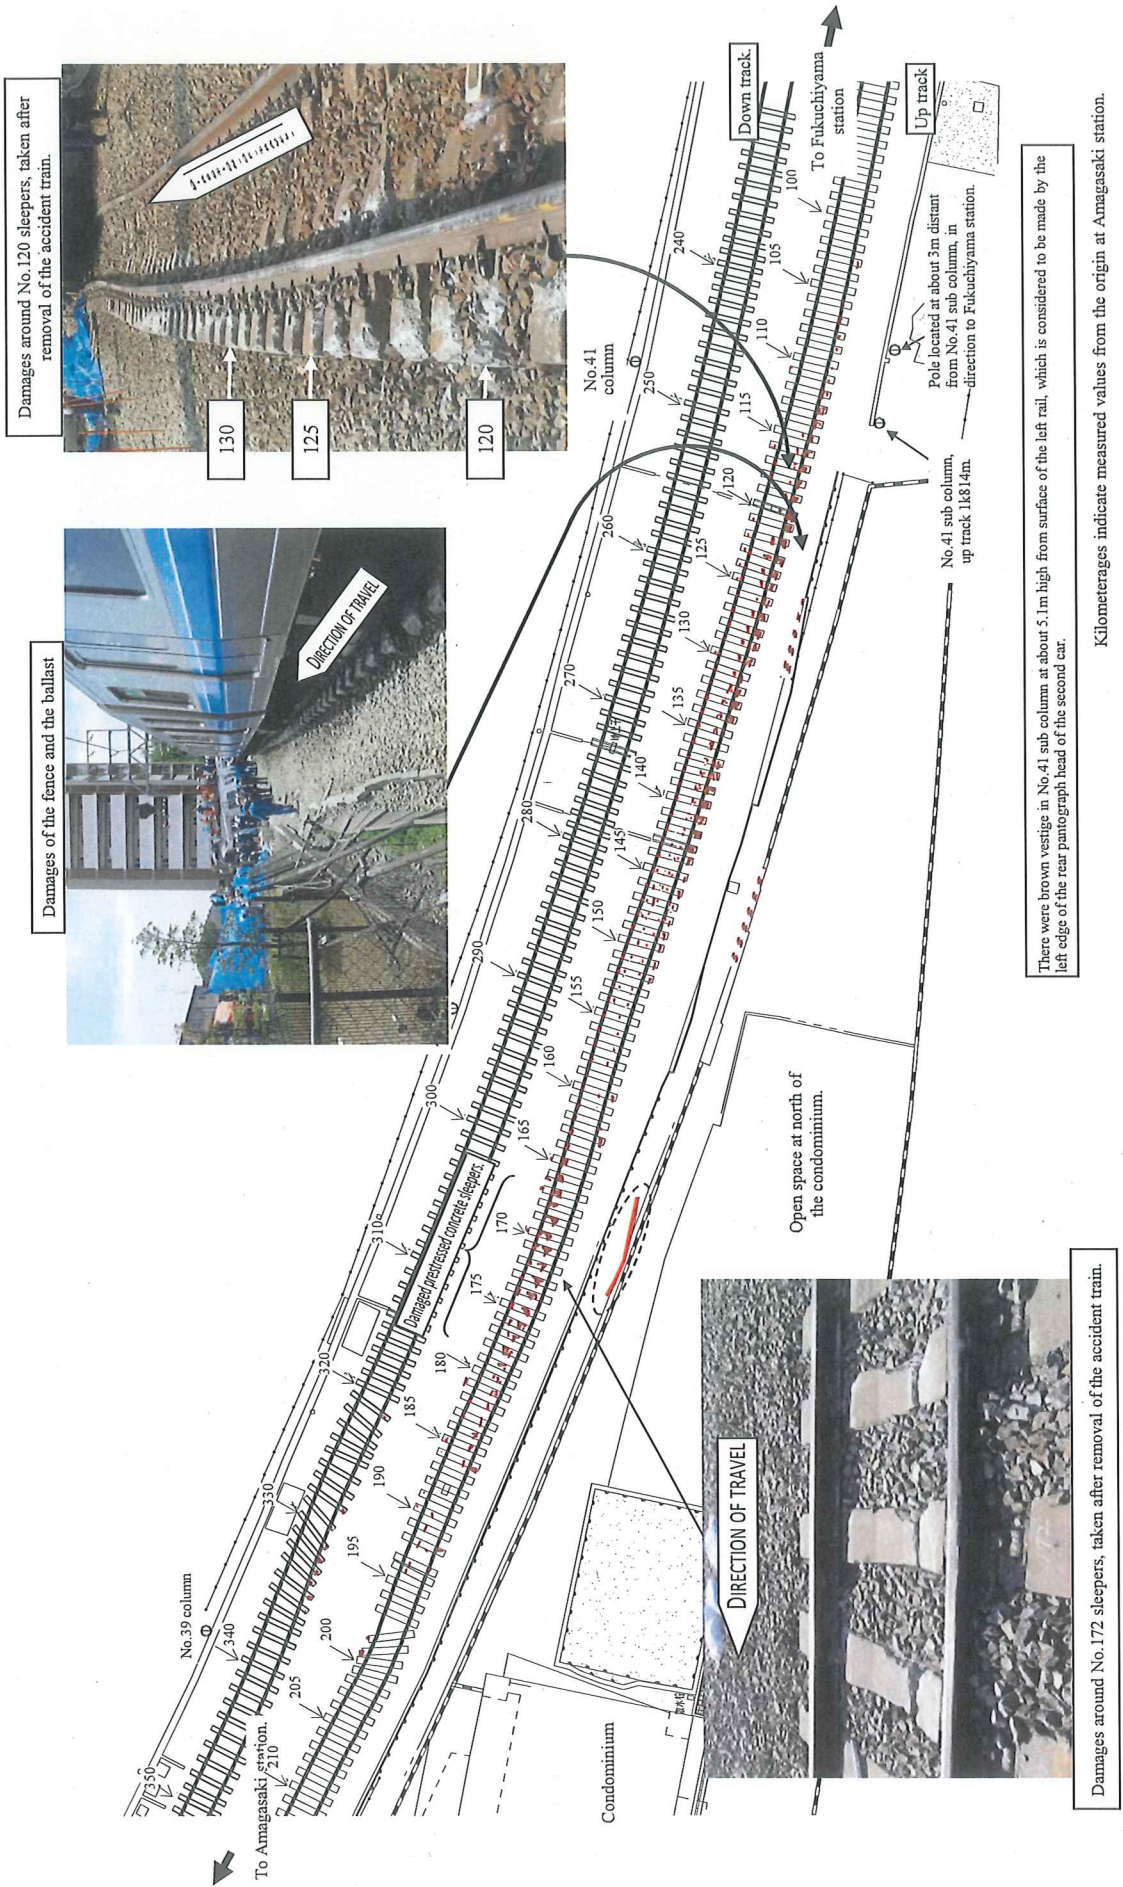
Figure 7 - States of Damage to Railway Facilities etc. (3)

There were brown vestige in No.41 sub column at about 5.1m high from surface of the left rail, which is considered to be made by the left edge of the rear pantograph head of the second car.

Damages around No.172 sleepers, taken after removal of the accident train.

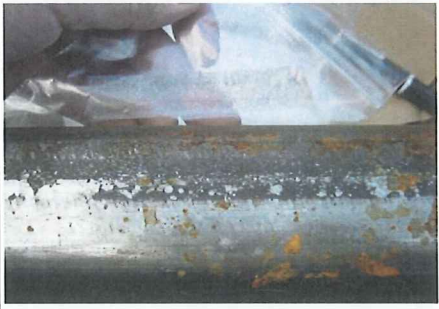
2	Scratched pole.	No.41 sub column, up track 1k814m.	Stuck by scratching.	Fe Cr Si Ca Al Ni	Stainless steel.	150

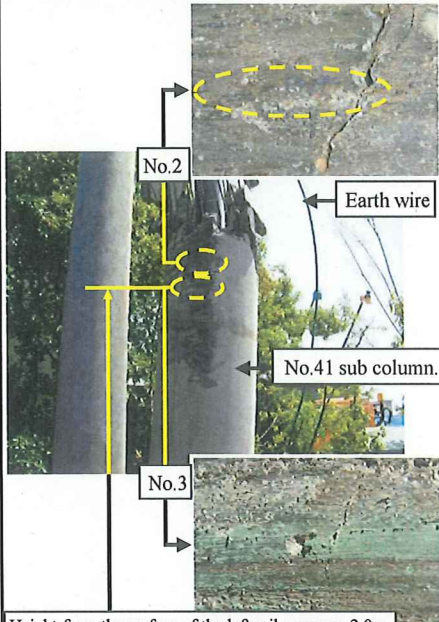
3	Materials scratched and stuck to a pole.	No.41 sub column, up track 1k814m.	Green adhesive material stuck to a pole.	Homogeneous spectrum with the vinyl tube covering earth wire installed in No.41 sub column.	—	Vinyl tube covering earth wire installed in No.41 sub column

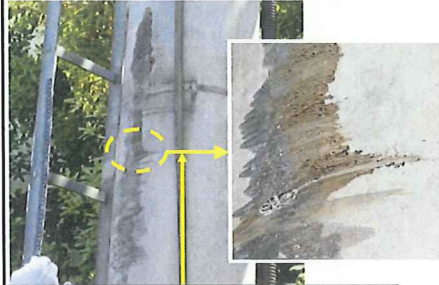
Height from the surface of the left rail : approx. 2.0m.
4	Materials scratched and stuck to a pole.	Pole located at about 3m distant from No.41 sub column, in direction to Fukuchiyama station.	Brown adhesive material stuck to a pole.	Homogeneous spectrum with roof sheet of a car.	—	Roof sheet.

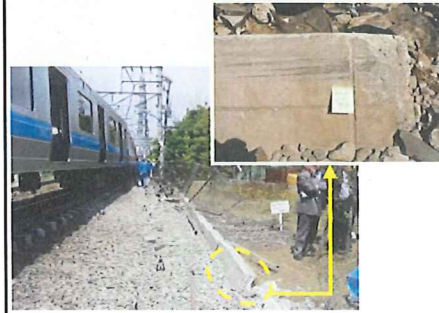
5	Materials scratched and stuck to fence.	fence near the No.156 sleeper.	Black or bronze colored glossy stuck materials in flaky shape.	Fe O Cr Si Al Ni Ca C	Stainless steel.	Car body.

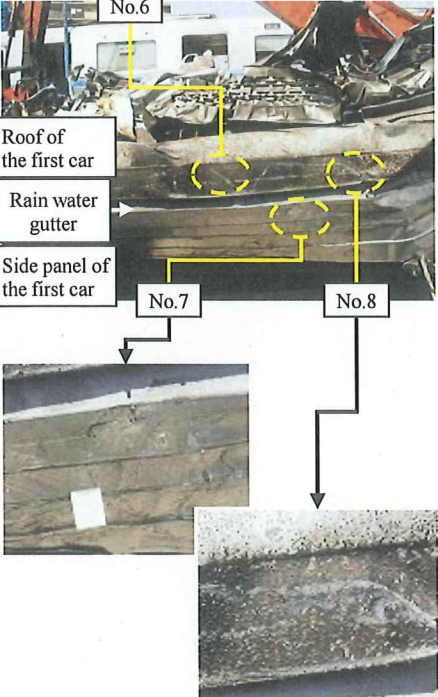
7	Materials stuck to the first car.	Upper part of the rain water gutter at upper rear of the left side third door of the first car.	Green stuck material.	Homogeneous spectrum with the vinyl tube covering earth wire installed in No.41 sub column.	—	Vinyl tube covering earth wire installed in No.41 sub column.

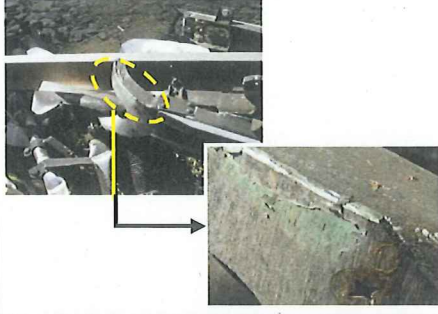
9	Materials stuck to the pantograph.	Rear pantograph on the second car fallen near the No.41 sub column.	Green stuck material in filmy shape.	Homogeneous spectrum with the vinyl tube covering earth wire installed in No.41 sub column.	—	Vinyl tube covering earth wire installed in No.41 sub column.
