Marine Accident Inquiry Agency MAIA DIGEST

Marine Accidents in Naka Suido (Channel) and Nishi Suido (Channel) of the Kurushima Kaikyo (Strait)

- ◆ Traffic Rules of the Kurushima Kaikyo (Strait) 1 ~ 2
- ◆ Typical Marine Accidents in Naka Suido (Channel) and Nishi Suido (Channel) 3
- ◆ Case Studies (Collision and Grounding) 4 ~ 8

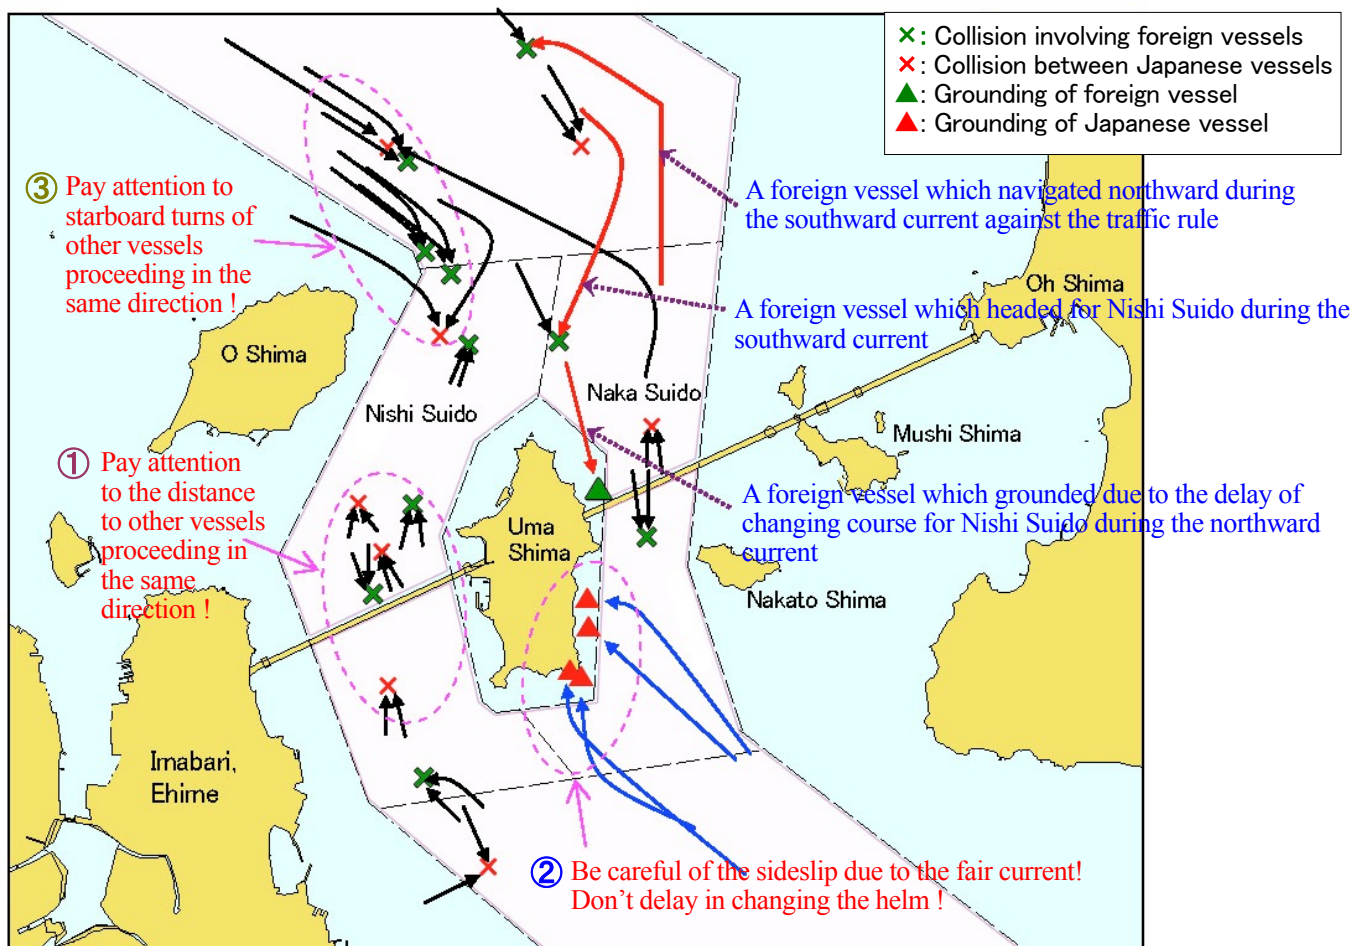
Point of Collisions or Groundings in the Last Decade (1996~Aug., 2006)

① Collisions while overtaking other ships in the center of Nishi Suido during the southward current (Case 1 (page 4) and Case 2 (page 6))

② Groundings on the south-east side of Uma Shima in the south entrance of Naka Suido during the northward current (Case 3 (page 7))

③ Collisions at the north entrance of Nishi Suido during the northward current

While entering Nishi Suido from the west entrance of the Kurushima Kaikyo Traffic Route, and turning starboard at the north-east corner of O Shima, many ships have collided with others proceeding in the same direction. **These collisions are attributed to lack of proper lookout for the ships on the starboard (Shikoku) side and also to making starboard turns.** Operators should keep proper lookout on the movements of other vessels proceeding in the same direction while turning starboard.

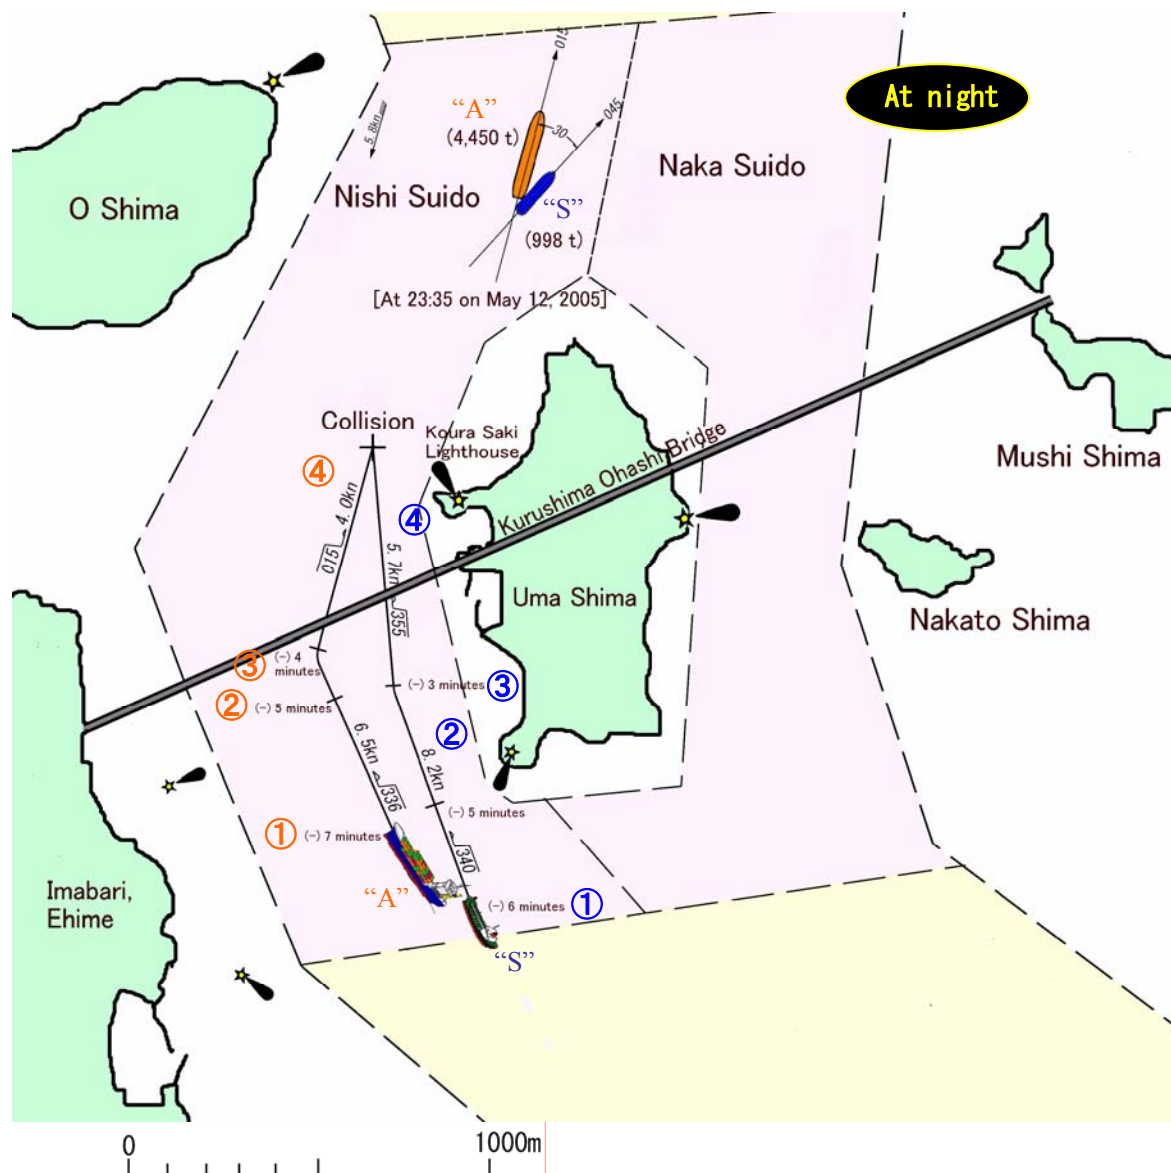
Case 1: While four vessels proceeded northbound, a vessel overtaking another near Uma Shima collided

Four vessels were proceeding northbound in line in the Kurushima Kaikyo Nishi Suido at night. The 4th vessel "S", after overtaking the 3rd vessel decided to overtake the 2nd vessel "A" by "A" 's starboard side, and changed the direction to starboard with reduced speed. Then "S" turned port slightly to avoid Uma Shima, and resulting in a close-quarters situation with the stern of "A".

On the other hand, "A" was proceeding with reduced speed to keep distance from the preceding vessel, while keeping a look on the movement of "S" approaching from her starboard aft. Although "A" tried to attract the attention of "S" with the use of light signals, "A" eventually collided with "S". "A" could not make port turn because of the preceding vessel close to her port fore.

④ Just before the collision: “S” got even closer. **Being unable to turn port because of the preceding vessel near on her port bow, “A” steered hard-a-starboard.**

③ (-) 4 minutes: “A” **changed course to 015°**. “A” **reduced her speed to 4.0 knots** to keep distance from the preceding vessel 280m forward. As “S” **got closer to 370m, 63° on her starboard quarter**, “A” **gave the warning of “No overtake, dangerous” using VHF ch16, but received no response.** “A” also gave blinking light signals to attract “S”’s attention, but gave no sound signals so as not to confuse the other vessels.

② (-) 5 minutes: “A” **sighted the lights of “S” 420m, 19° on her starboard quarter.**

④ Because “S”’s master had no experience to sail near Uma Shima, he could not reduce the speed for fear of sideslip. He **turned port to avoid Koura Saki**. The master noticed soon that the vessel got closer to the stern of “A” and ordered boatswain to give sound signals, but he failed because he did not know where the whistle button was. The vessel steered starboard 20° just before the collision.

③ (-) 3 minutes: After overtaking another vessel, which was following “A”, “S” **changed course to 355° and halved her speed.** “S” **sighted “A” 270m, 34° on her port bow**, but continued overtaking.

② (-) 4 minutes: “S” **heard through VHF ch16 that Kurushima Martis (VTS) was making a warning, “Watch the movement of “A”. She is reducing her speed.”** But “S” continued overtaking, judging “A” was safely away from “S”.

① (-) 6 minutes: “S” set course on 340° and proceeded with full speed northbound near Uma shima. **The master ordered boatswain to report the distance from “A”. The master could not see the radar because he was engaged in hand steering.**

The master of “S” engaged himself in steering by hand, so he could not leave the steering stand.

No.2 Radar with ARPA was installed away from the steering stand.

○ The master further ordered the boatswain to take the steering stand and to operate following his instruction, but the boatswain did not follow it. So, the master had no other choice but to engage himself in steering by hand. Consequently, the master could not monitor the movement of other ships directly on radar.

The boatswain had been temporarily on board “S” for 2 months. But he was unable to steer by hand in the Kurushima Kaikyo and did not know where the whistle button was.

Crew must be trained and educated appropriately for specific voyages.

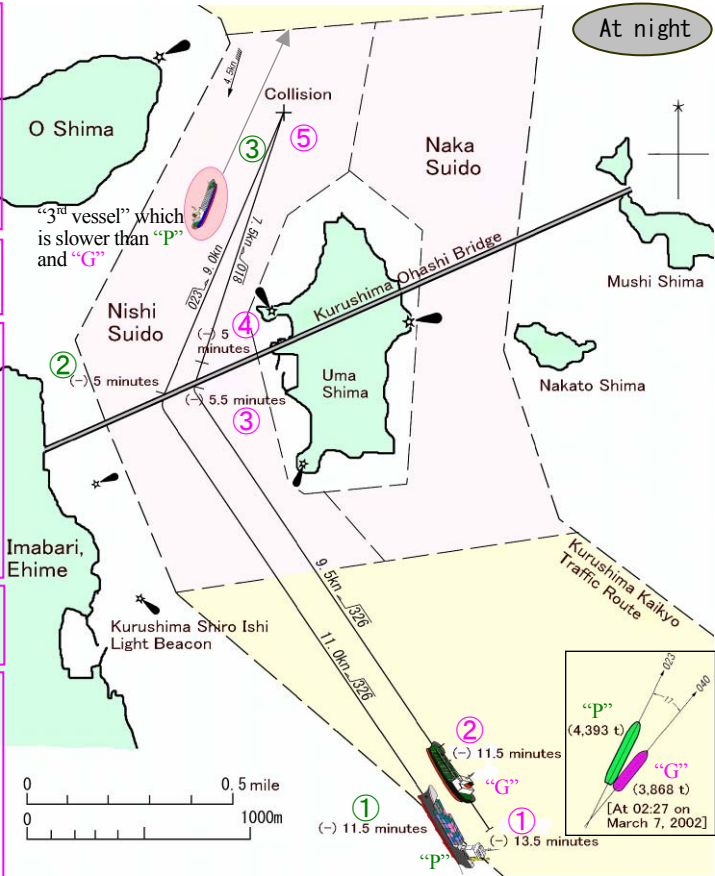
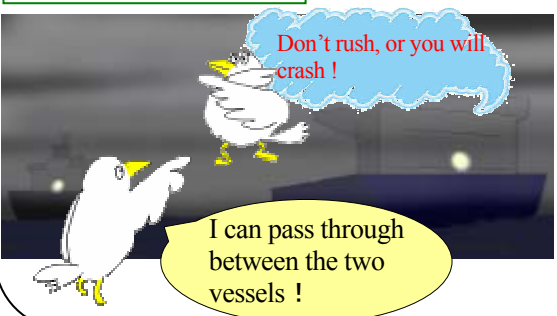
Case2: Collision in Nishi Suido while trying to pass through between two preceding vessels

"P" intended to pass through between two vessels while proceeding northward in the Kurushima Kaikyo Nishi Suido at night. "G" was on "P" 's starboard bow, and another vessel on "P" 's port bow was slow. "P" paid most attention to the slow vessel on the port side, and did not notice that the courses of "P" and "G" were in crossing position. Although "G" sighted "P" approaching from stern, "G" assumed that "P" would overtake "G" safely on her port side, and proceeded without giving warning signals. As a result, the two vessels collided.

③ (-) about 1 minute before collision
 Having her attention caught by the port side vessel, "P" **did not notice that the courses of "P" and "G" were in crossing position.** "P" was informed of the risk of collision through VHF from Kurushima Martis (VTS). Shortly before the collision, "P" gave a prolonged blast and steered hard-a-port.

⑤ (-) about 1 minute before collision
 Although "G" heard herself addressed by Kurushima Martis (VTS) on VHF, "G" was too busy to reply with maneuvering the vessel. Shortly before the collision, "G" steered hard-a-starboard.

④ (-) 5 minutes
"G" did not notice the change of course and the approach of "P" because she was paying attention only to the vessel on her port bow. Continued proceeding without giving warning signals.

② (-) 5 minutes
"P" changed course to 023° to pass through between the two vessels. Sighted "G", 240m and 23° on her starboard bow.

② (-) 11.5 minutes
"G" recognized "P", 460 m and 17° on her port quarter by radar (1.5 miles range scale). Sighted "P" proceeding northward on the port side. "G" assumed that "P" would overtake "G" safely and watched only ahead of her.

① (-) 11.5 minutes
 "P" sighted the stern light of "G", 460m and 17° on her starboard bow. Assuming that "P" would overtake "G" near the north exit of Nishi Suido, "P" did not reduce the speed.

Keep listening to VHF ch16 !
 Turn on VHF ch16 at all times to obtain information from Vessel Traffic Service (VTS) and to communicate with other vessels.

Keep an ample distance from other vessels in Nishi Suido !
 Even when the radar vision is readily available, operators tend to rely on the actual sight of stern lights of preceding vessels to judge their movement. But **it is very hard to measure the distance and predict the course precisely with the eye** especially at night. In addition, the fast-flowing current against the ship in the narrow passage makes it tremendously difficult to maneuver the ship.
You should never try unnecessary overtaking in Nishi Suido !
Keeping ample distance is imperative here !

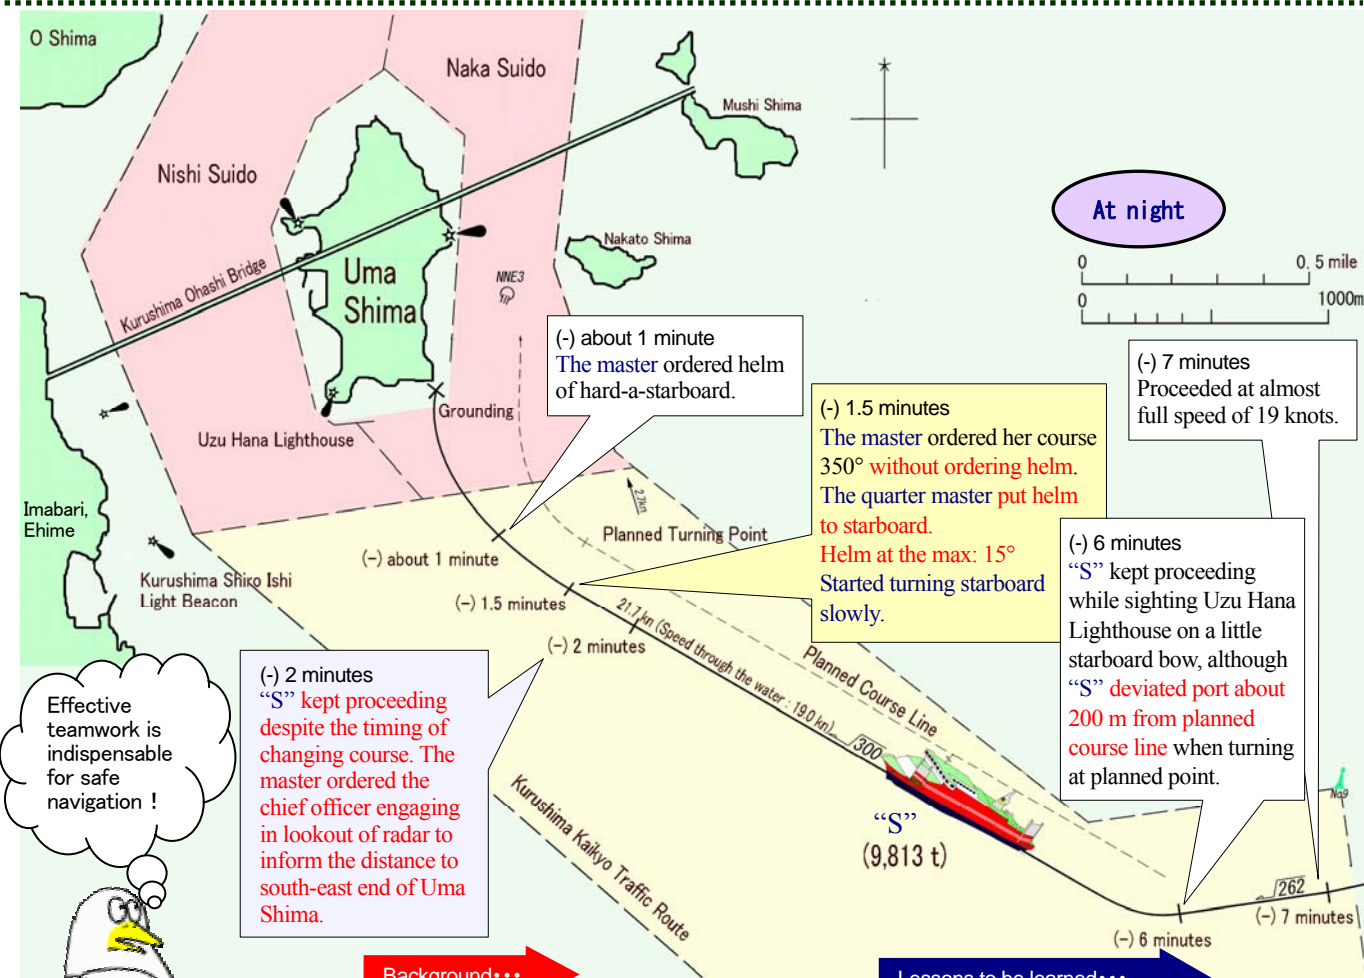
Case3: Grounding off the south-east coast of Uma Shima due to delay of changing course while proceeding northward for Naka Suido at 19 knots

En route from Osaka Port to Naha Port, "S" intended to anchor for sheltering from a typhoon off Yashiro Shima, Yamaguchi, under the condition that typhoon No.23 was approaching the south coast of Shikoku. The vessel proceeded westward in the Seto Naikai (the Inland Sea) and reached the Kurushima Kaikyo. Receiving NNE wind on her starboard bow, "S" was proceeding with the fair current at almost full speed of 19.0 knots at the south entrance of Naka Suido, when the ship ran aground on shallows off the south-east coast of Uma Shima due to the delay of changing course.

| Master | <ol style="list-style-type: none"> The master lacked self-assurance, as it was his first navigation through the Kurushima Kaikyo. He was unfamiliar with the vessel, as he had been on board "S" for 8 days. He had previously been working on board a ferry boat which was smaller (4,000 t) and had better maneuvering ability. He kept the speed of 19.0 knots because the departure had been delayed, and he needed to reach the sheltering spot promptly as the typhoon was approaching. |
| C/O | In response to the master's request, the C/O answered only the distance to Uma Shima. |
| Q/M | The Q/M followed the master's instruction to turn starboard, but the helm, no more than 15°, was not enough to take the course of 350°. |

| Master | <ol style="list-style-type: none"> He should have prepared and navigated more carefully as it was an inexperienced trip at night. He should have notified in advance other bridge members of the planned course line and the planned turning point. He should have ordered concretely the proper helm to take in the narrow channel. |
| C/O | He should have given the master more detailed information obtained from the radar image, such as the deviation from the planned course line and the distance to the planned turning point. |
| Q/M | Being instructed to take "the course to 350°", he should have asked how far he should turn the helm or notified the helm he took and the consequent change of the course. |

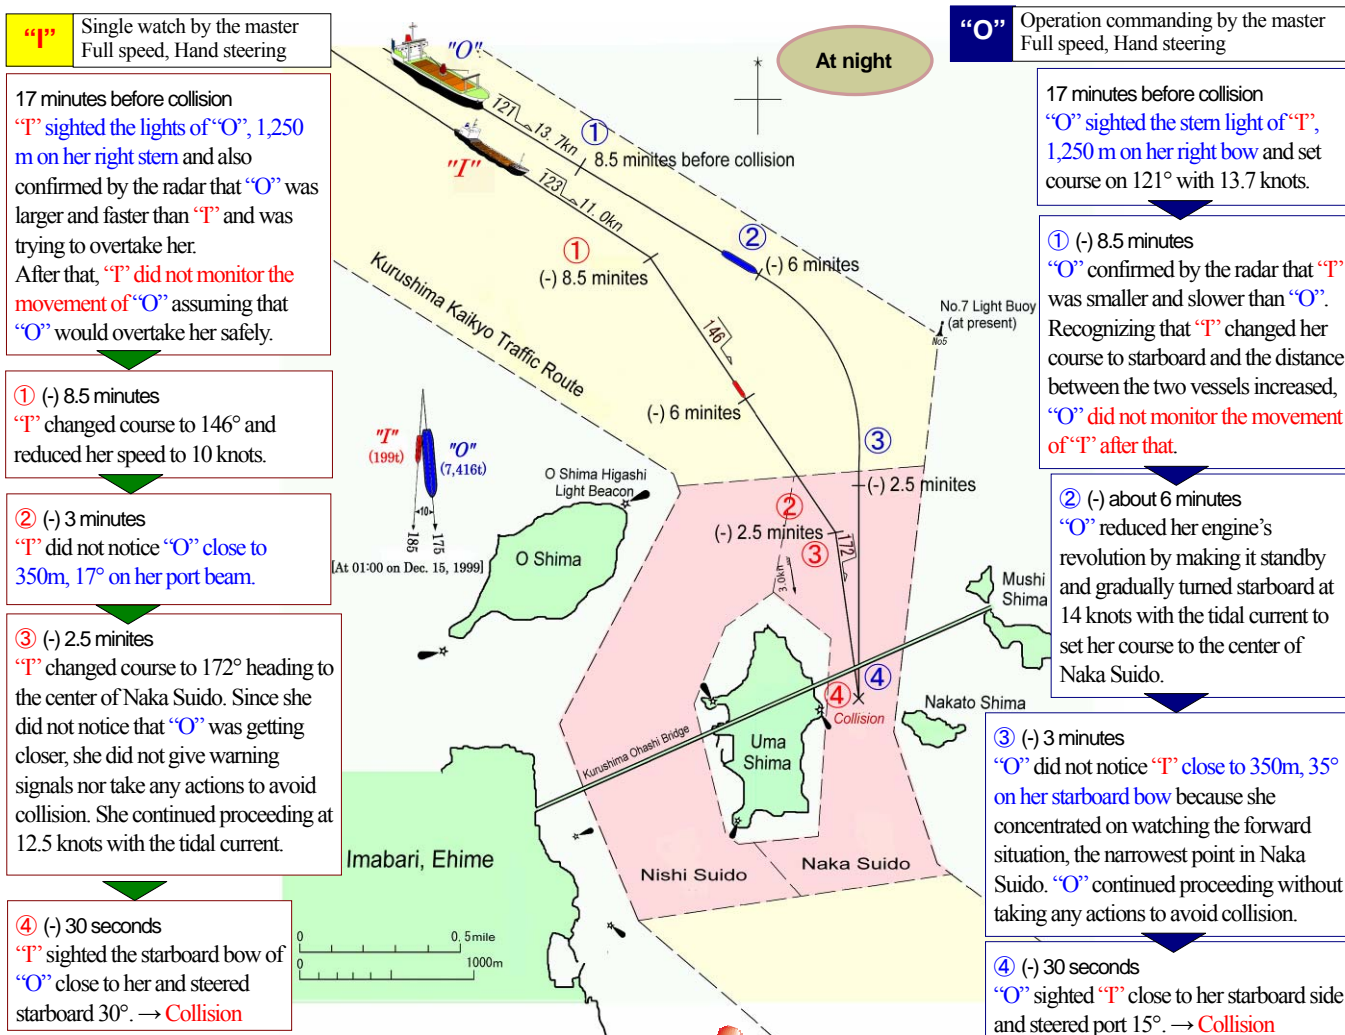
Case4: While proceeding southward in Naka Suido, an overtaking at the narrowest spot caused a collision

The two vessels, "I" and "O", had recognized each other's size, speed and course beforehand. However, after entering Naka Suido, while concentrating on maneuvering the vessel in the narrow route, the existence of each other had slipped from their minds until they collided.

The Kurushima Kaikyo is congested with heavy traffic around midnight. Crew members are obliged to concentrate their attention on maneuvering the vessel in the narrow and winding routes. Therefore, **they sometimes lack enough attention to recognize the movement of overtaking vessels.**

Should you need to overtake other vessels, **you must give the overtaking signal in order to notify them of your intention. The flashing light signal is also effective at night.**

On the other hand, if you do not want other vessels to overtake you, you should give more than five short blasts to warn them.
