Marine Accident Inquiry Agency

MAIA DIGEST

Message for the Prevention of Marine Accidents in Fog

“Why Did the Ship Make a Port Turn ? ”
- clearing the mystery of accidents in fog -

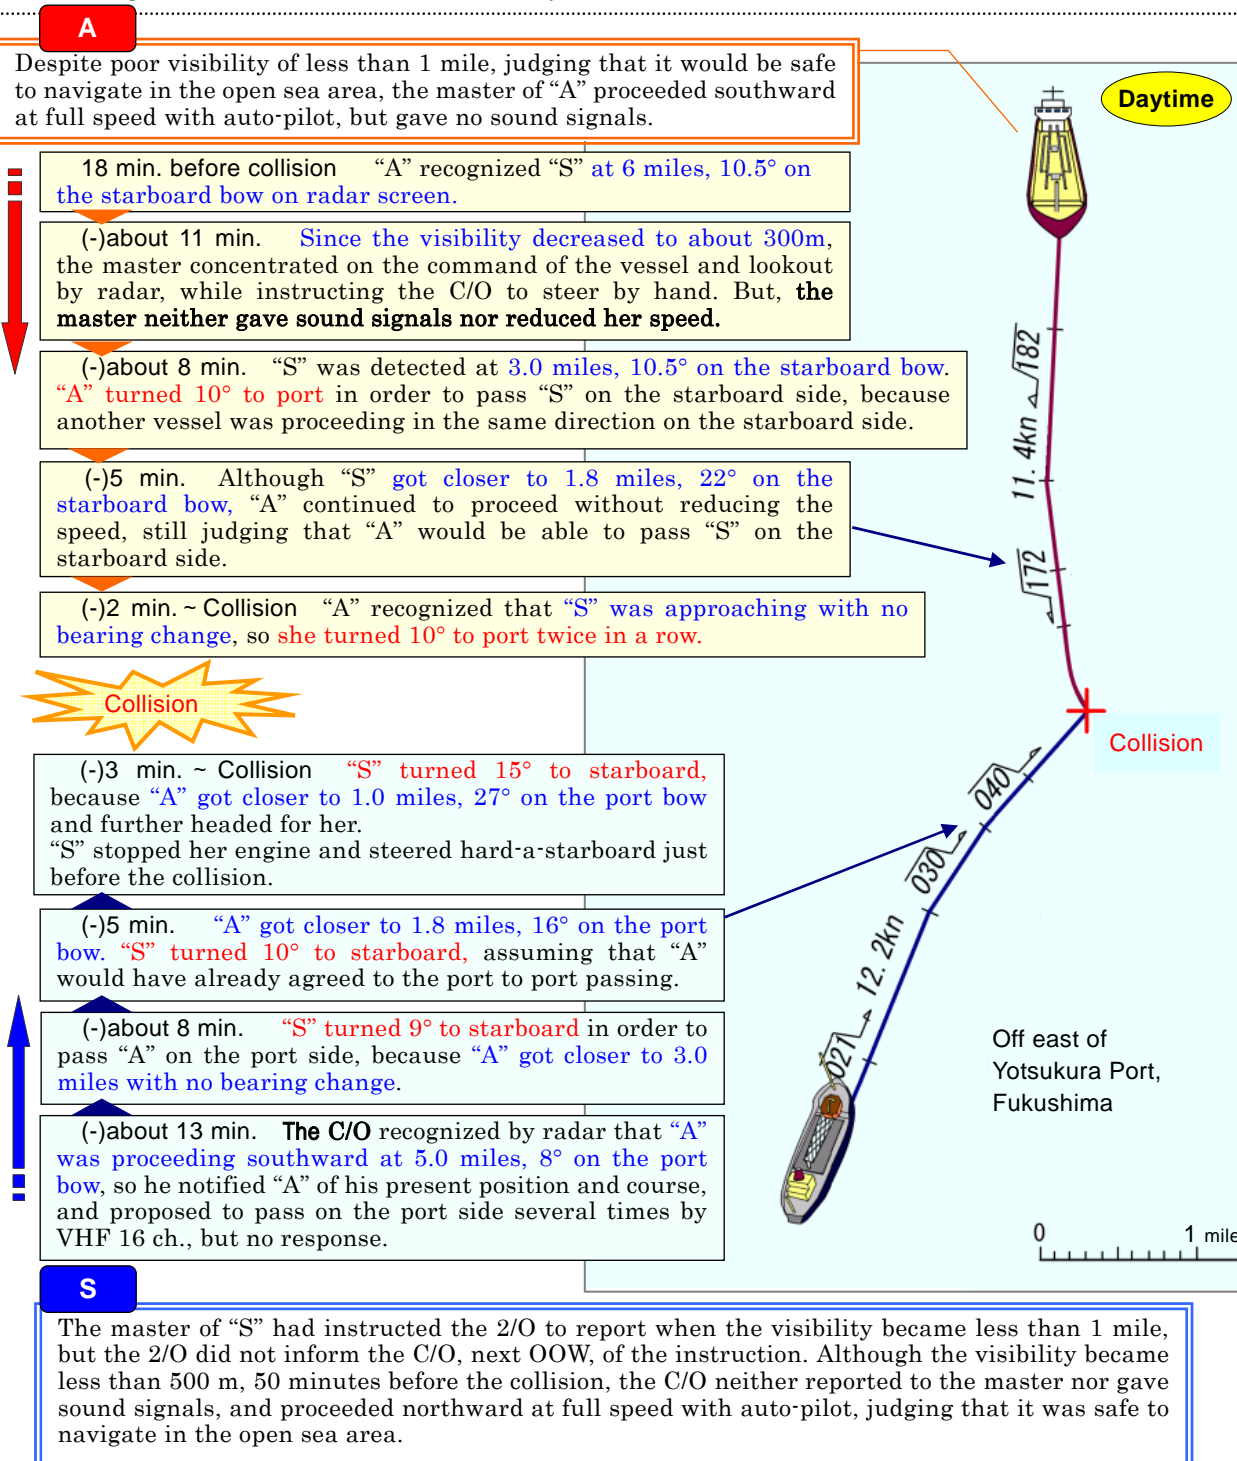
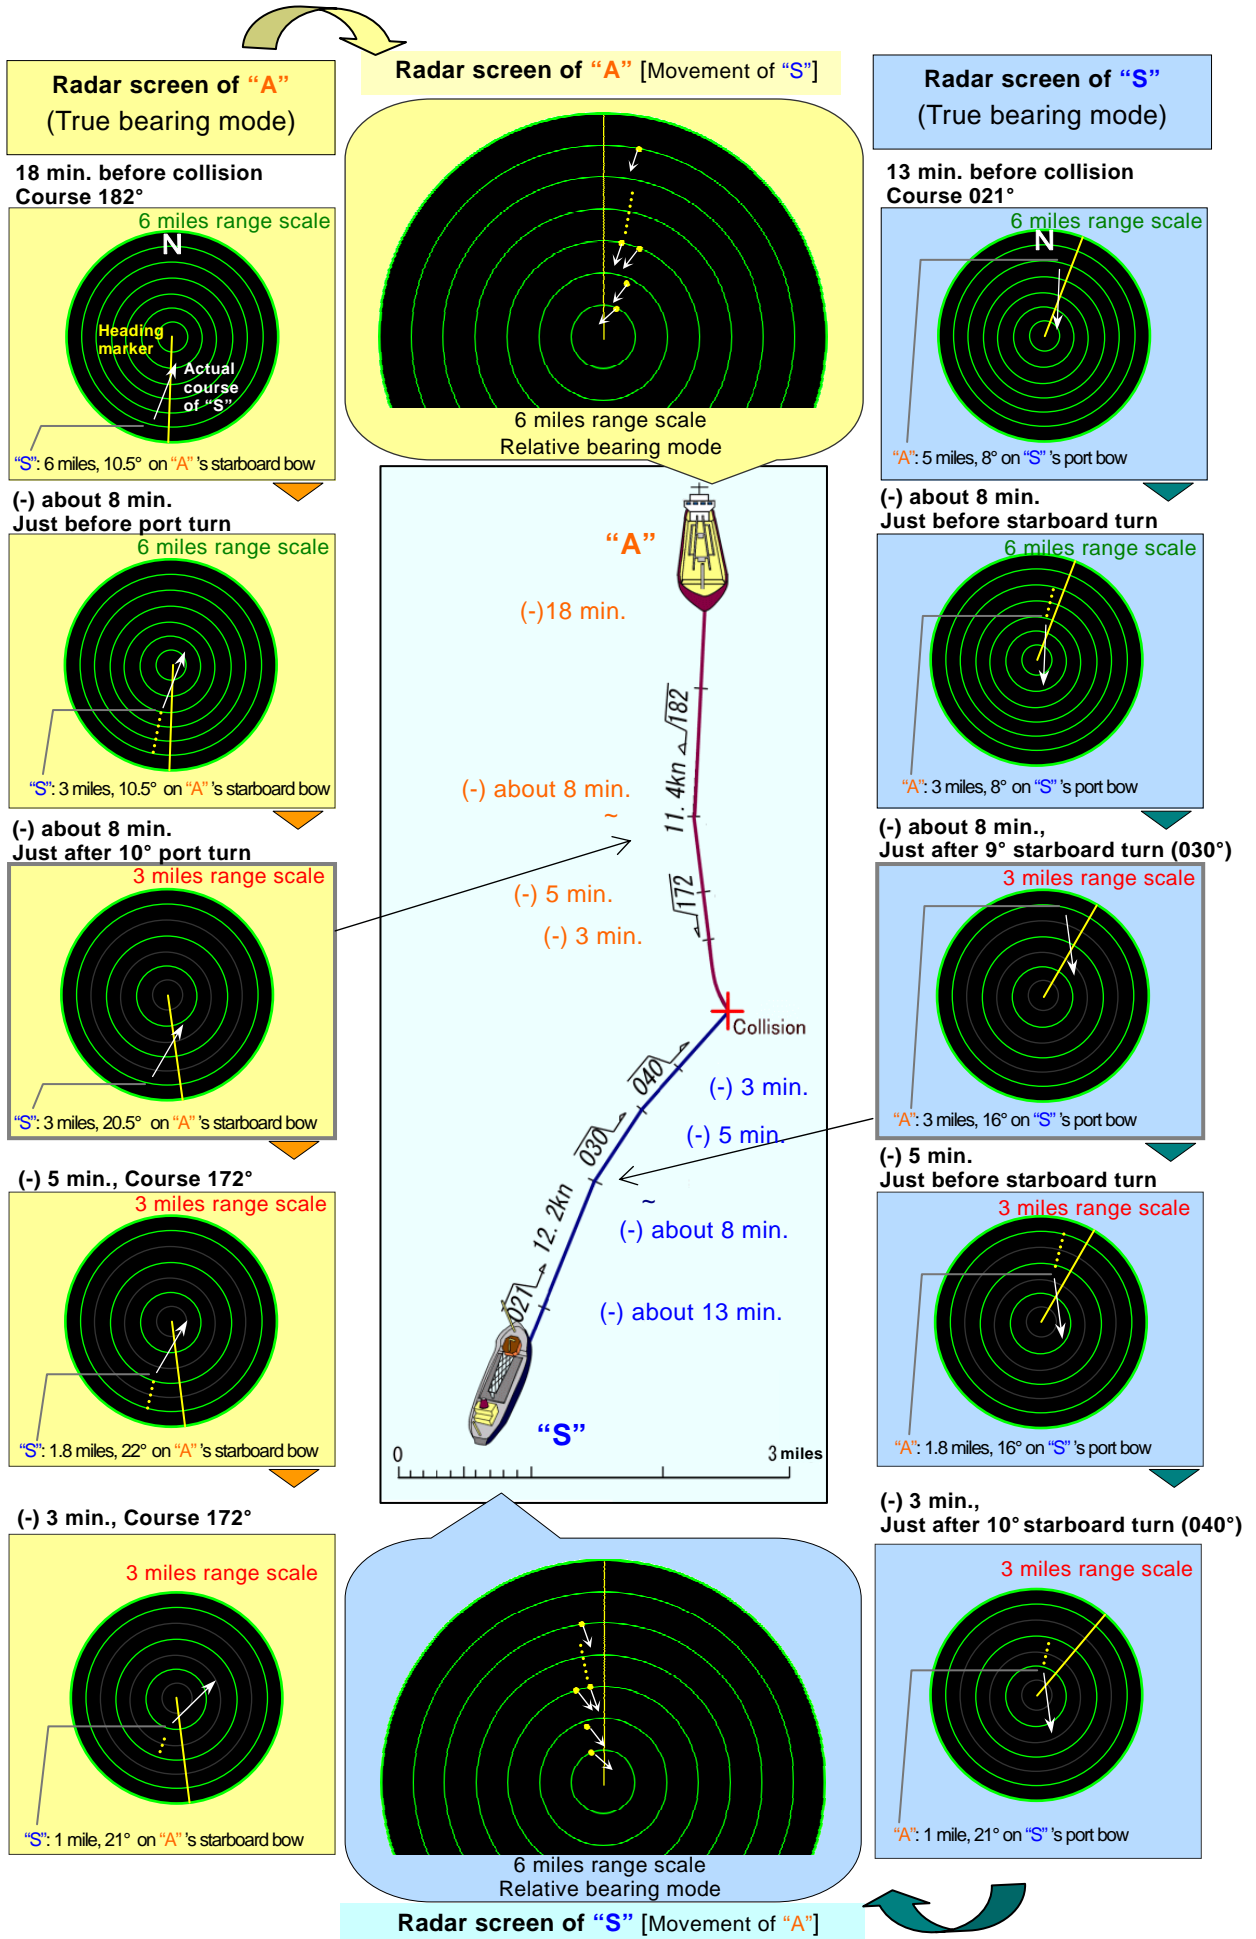
Case 1

Collision between Cargo vessel "S" and Oil tanker "A"

Off east of Yotsukura Port, Fukushima Pref.
Under visibility of about 120m

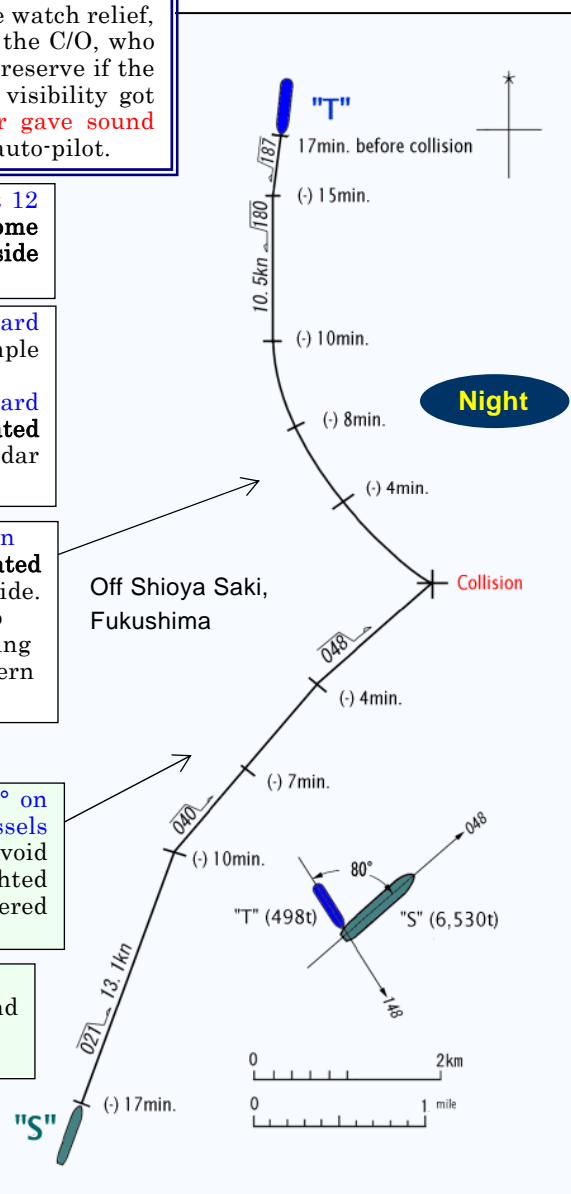
Case 2

Collision between Cargo vessel "T" and Cargo vessel "S"

Off NE of Shioya Saki, Fukushima Pref.
Under visibility of about 100m

Under the visibility of about 2 miles, at the watch relief, the master left the bridge after giving instruction to the C/O, who had a long experience as a master, to report without reserve if the visibility decreased extremely. But, even after the visibility got worse, the C/O **neither reported to the master nor gave sound signals**, and proceeded southward at full speed with auto-pilot.

33 min. before collision The C/O **recognized "S" at 12 miles, 7° on the starboard bow** on radar screen. **Some northbound vessels were also displayed on the west side of "S" on her radar.**

(-)15 min. "S" was at **5.0 miles, 4.5° on the starboard bow**. "A" turned 7° to port in order to ensure ample passing distance on the starboard side.

(-)10 min. "S" was at **3.1 miles, 11° on the starboard bow**. "A" proceeded without slow-down **with repeated small port turns**, so that the echo of "S" on the radar screen came to starboard side from heading marker.

The master did not give OOW the concrete instruction to report decreased visibility.

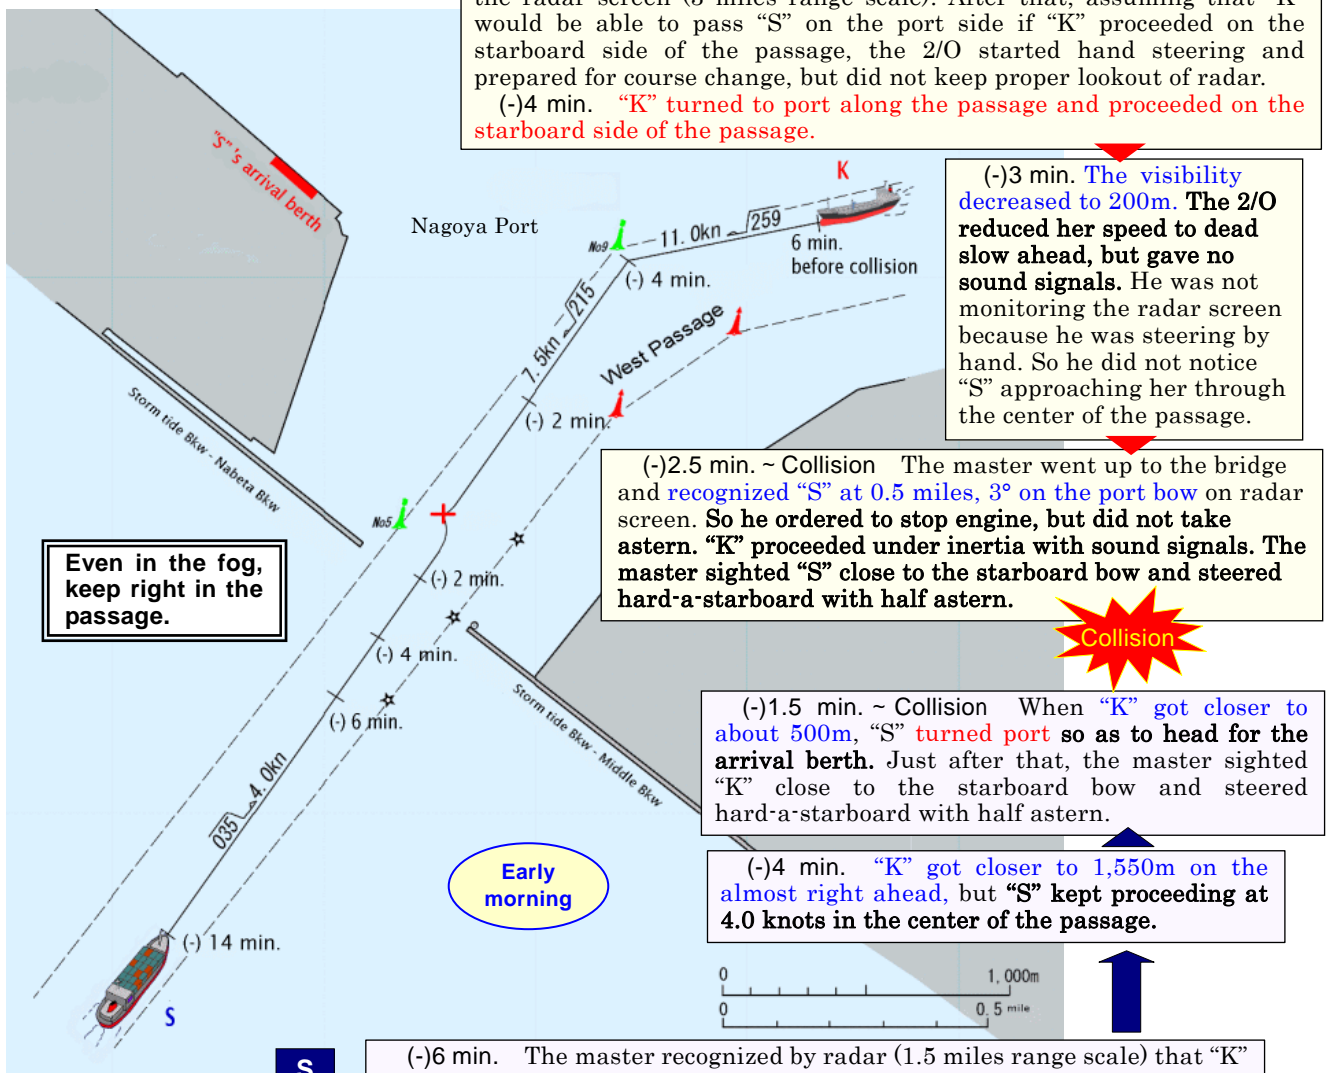
Case 3

Collision between Oil tanker "K" and Cargo vessel "S"

West Passage, Nagoya Port
Under visibility of about 200m

K 13 min. before collision Although the master of "K" knew dense-fog warning was issued after leaving berth, he expected that the situation would not be very serious because the visibility was about 2 miles at that time. He left the bridge for breakfast assigning the 2/O to operate the vessel. After that, despite deterioration of the visibility, the 2/O neither reported to the master nor gave sound signals, and proceeded at full speed with auto-pilot on the starboard side of the West Passage.

(-4 min. "K" turned to port along the passage and proceeded on the starboard side of the passage.

S (-6 min. The master recognized by radar (1.5 miles range scale) that "K" was at 1.3 miles, 11° on the starboard bow and was leaving the port.

14 min. before collision The master assigned the 3/O to lookout and an able seaman to hand steering respectively and proceeded at dead slow ahead toward the center, not along the starboard side of the passage, with sound signals.

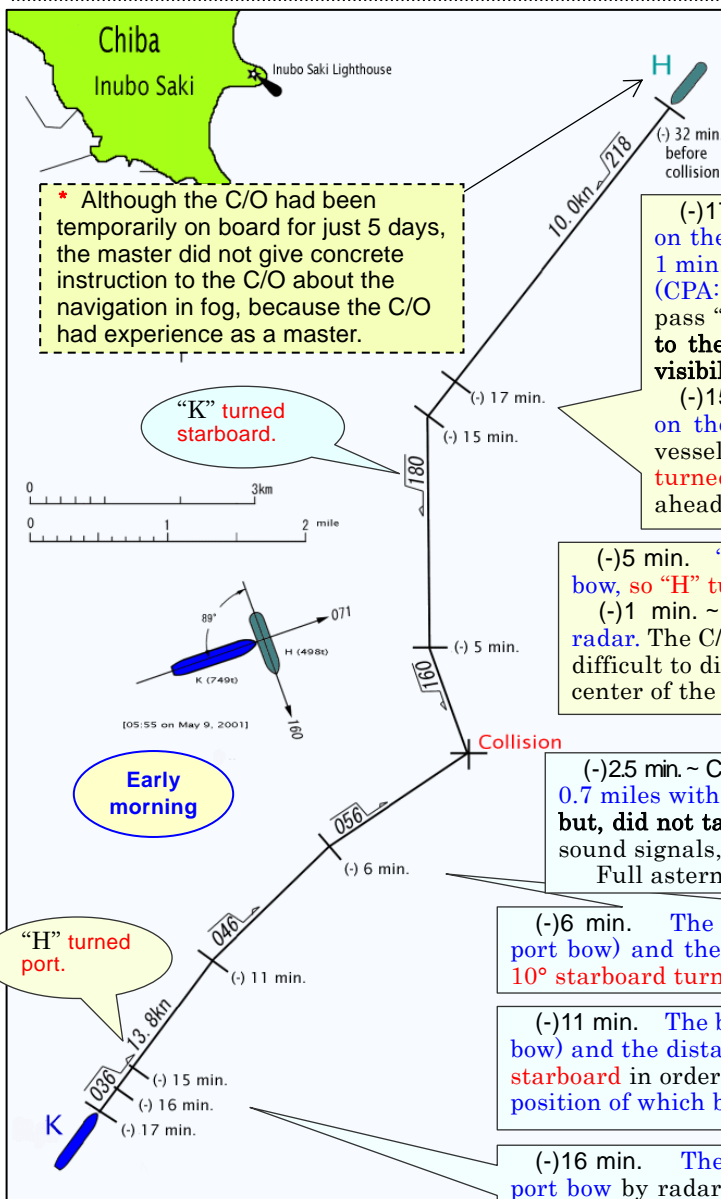
Case 4

Collision between Chemical tanker "K" and Cargo vessel "H"

(-)17 min. The C/O recognized "K" at 6 miles, 12° on the port bow by radar (6 miles range scale). After 1 min., "K" got closer to 5.6 miles, 13° on the port bow (CPA: 1.1 miles) and the C/O judged that "H" would pass "K" on the port side safely. So he did not report to the master in spite of rapid deterioration of the visibility.

(-)about 25 min. Despite rapid deterioration of the visibility, judging easily that the fog would clear away soon, The C/O of "K" neither reported to the master nor gave sound signals, and continued to proceed at full speed with auto-pilot.

* The master of "K" had repeatedly reminded the crew at meetings of the importance of reporting poor visibility and other actions on board.

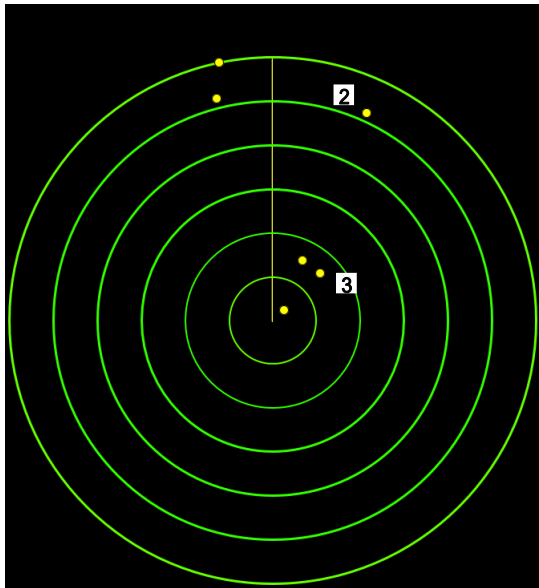
Radar screen of "H"

(-) 1 min.: "K" was at 0.3 miles on the starboard bow. (The echo of "K" was too close to the center of the radar to be distinguished from it.)

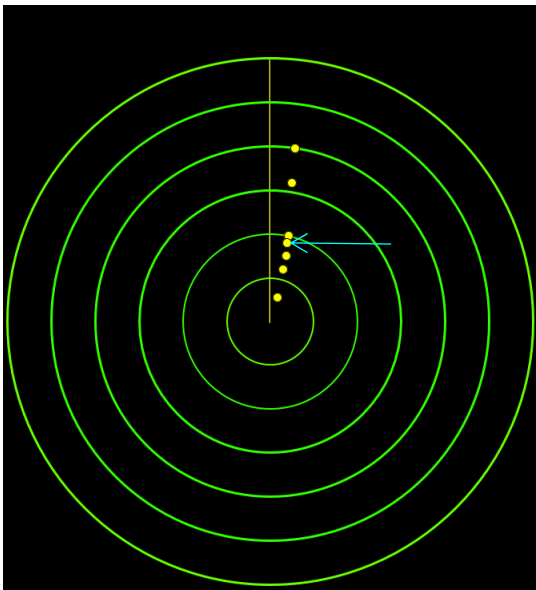
Radar screen of "T"

- (-)12 min.: "T" recognized "K" at 4.0 miles, 8° on the starboard bow.
- (-)10 min.: "T" recognized "K" at 3.2 miles, 9° on the starboard bow. ((-)8 min.: "K" altered 5° to starboard.)
- (-)6.5 min.: "T" recognized "K" at 2.0 miles, 11° on the starboard bow. CPA was 0.12 miles.
- ("T" judged that "T" would be able to pass "K" on the starboard side because "K" was in the starboard side of heading marker.)
- (-)6 min.: "T" recognized "K" at 1.8 miles, 11° on the starboard bow. ("K" altered 5° to starboard.)
- (-)5 min.: "T" recognized "K" at 1.5 miles, 13° on the starboard bow.
- ("T" reduced her speed to half ahead of 9.6 knots.)
- (-)4 min.: "T" recognized "K" at 1.2 miles, 13° on the starboard bow. ("K" altered 5° to starboard.)
- (-)2 min.: "T" recognized "K" at 1,050m, 13° on the starboard bow. ("K" altered 5° to starboard.)

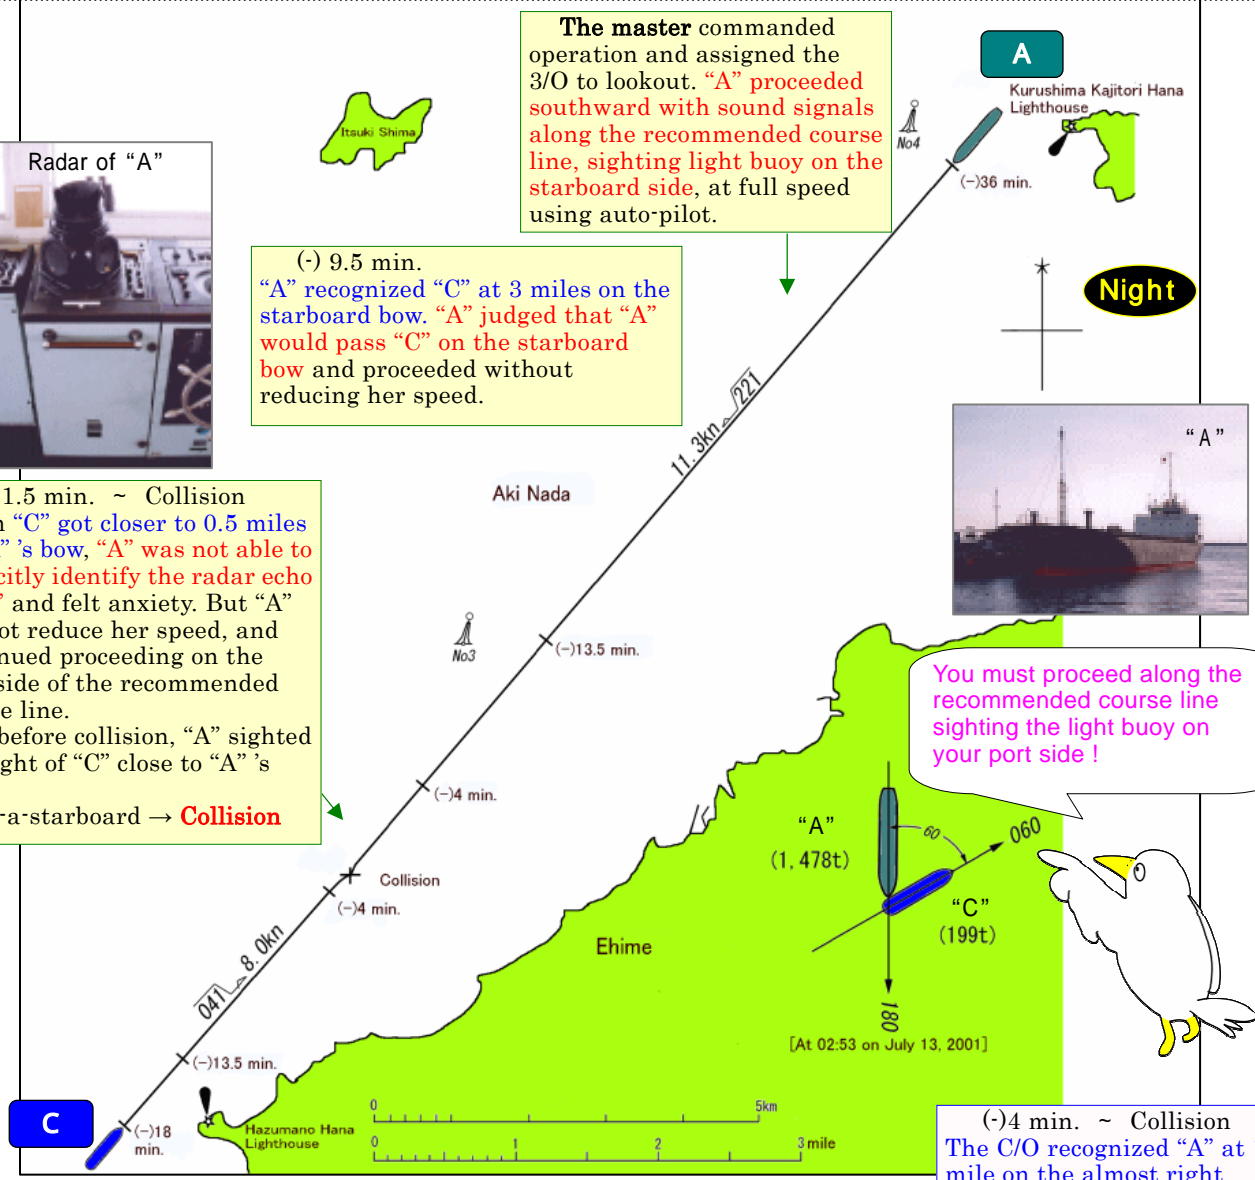
The master commanded operation and assigned the 3/O to lookout. "A" proceeded southward with sound signals along the recommended course line, sighting light buoy on the starboard side, at full speed using auto-pilot.

(-)1.5 min. ~ Collision
 When "C" got closer to 0.5 miles on "A" 's bow, "A" was not able to explicitly identify the radar echo of "C" and felt anxiety. But "A" did not reduce her speed, and continued proceeding on the port side of the recommended course line.
 Just before collision, "A" sighted the light of "C" close to "A" 's bow.
 Hard-a-starboard → **Collision**

(-)1.5 hours
 The master of "C" went up to bridge after hearing sound signals, but the master continued to have the C/O to watch, and the master himself did not command the operation. He looked into the radar screen or engaged in lookout in port wing from time to time.

(-)18 min.
 Visibility: 100m
 The C/O of "C" set her course on the south (starboard) side of the recommended course line and proceeded using auto-pilot with sound signals manually.
 (-) 13.5 min.
 The C/O recognized "A" at 4 miles on her bow on radar screen.

(-)9.5 min.
 The C/O recognized "A" at 3 miles on her bow on radar screen.
 The C/O worried that "A" was proceeding southward on the port side of recommended course line. But, "C" assumed that "A" would turn starboard, and continued proceeding without reducing her speed.

You must proceed along the recommended course line sighting the light buoy on your port side !
