Marine Accident Inquiry Agency

MAIA DIGEST

Message for the prevention of marine accidents due to typhoons

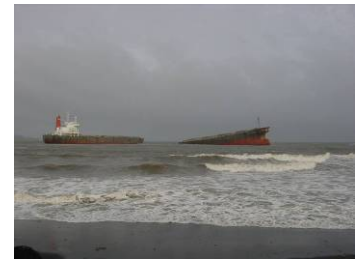
- 21:15 The ship ran aground in depth of 10m.**

The ship broke in two from midship and all crew took to a life boat with helmets and life jackets. The life boat was damaged when it hit the ship hull hard due to the wave while lowering. All crew evacuated from the life boat. 15 crew members reached the shore but 4 were drowned.

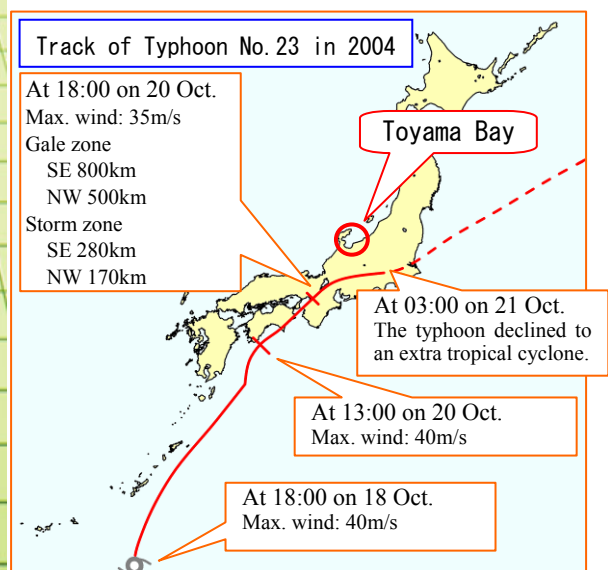
While anchoring in Toyama Bay under the condition that Typhoon No.23 was approaching, "K" dragged her anchor due to NE wind and high swell, ran aground to shallow waters and was pushed to breakwater despite the use of the engine.

21:00 Swell reached 6m, and she continued drifting despite full ahead and approached outer breakwater from near quarantine anchorage.
22:25 Touched sea ground after being severely shaken.

22:30 Engine stopped and "K" started flooding from engine room in the bottom, and the master ordered all crew to wear life jackets and asked JCG for help by VHF.

22:47 Ran aground on wave absorbing block in the base of outer breakwater.

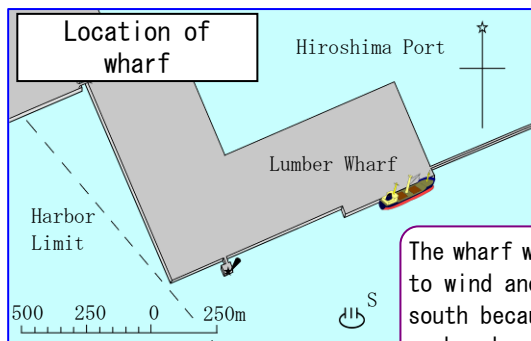
The wharf was vulnerable to wind and wave from south because there was no breakwater.
