四国航空株式会社所属ヘリコプター JA6522火災事故調査の進捗状況

1. 事故の概要

型式； ユーロコプター式AS350B3型

登録番号； JA6522

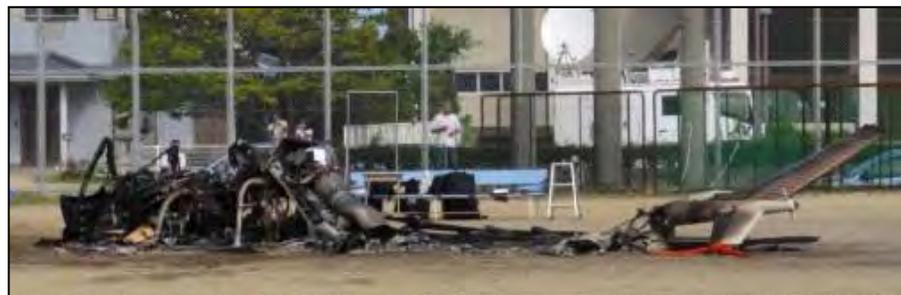
写真2 同機の残骸

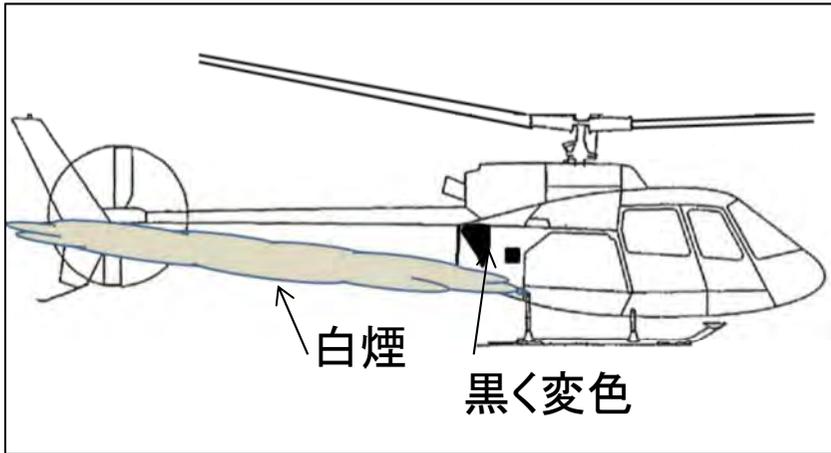
付図3 事故機の見撃情報(飛行中)

- ・後部荷物室の床付近から白煙
- ・後部荷物室外板が黒く変色

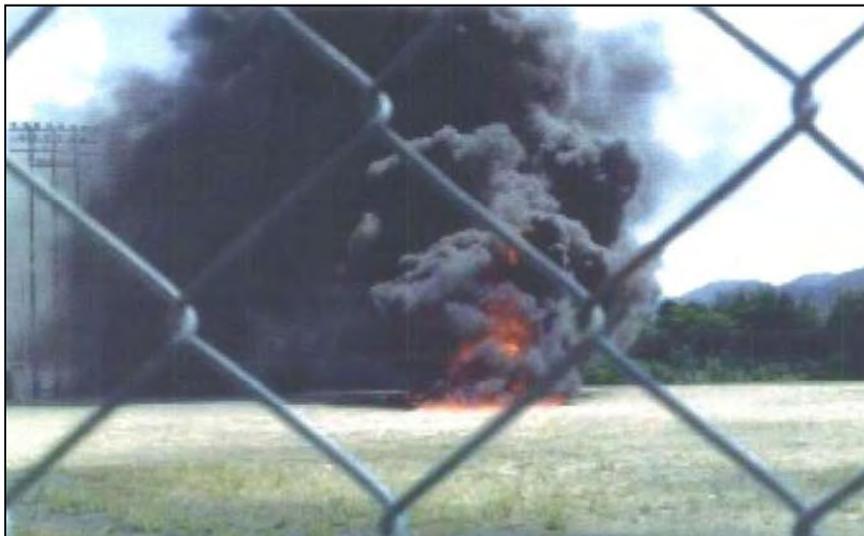
写真5 着陸後(10:23ごろ)

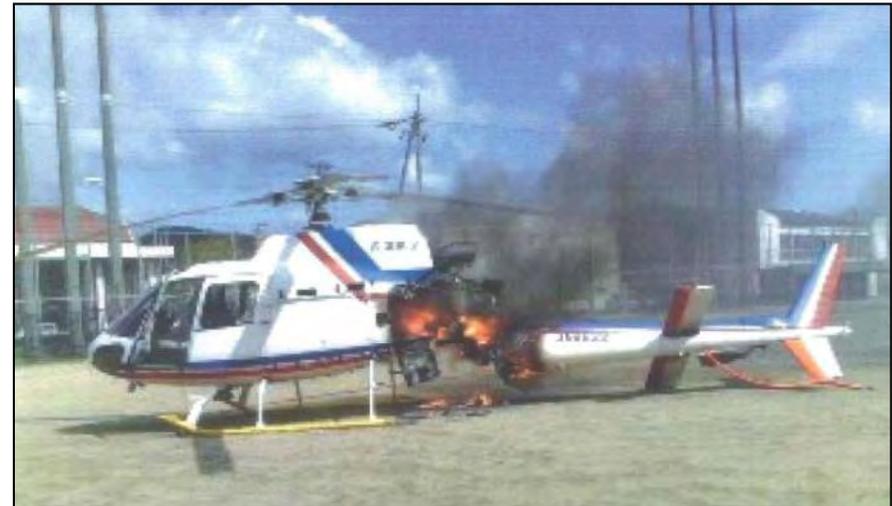
写真3 着陸後(10:13ごろ)

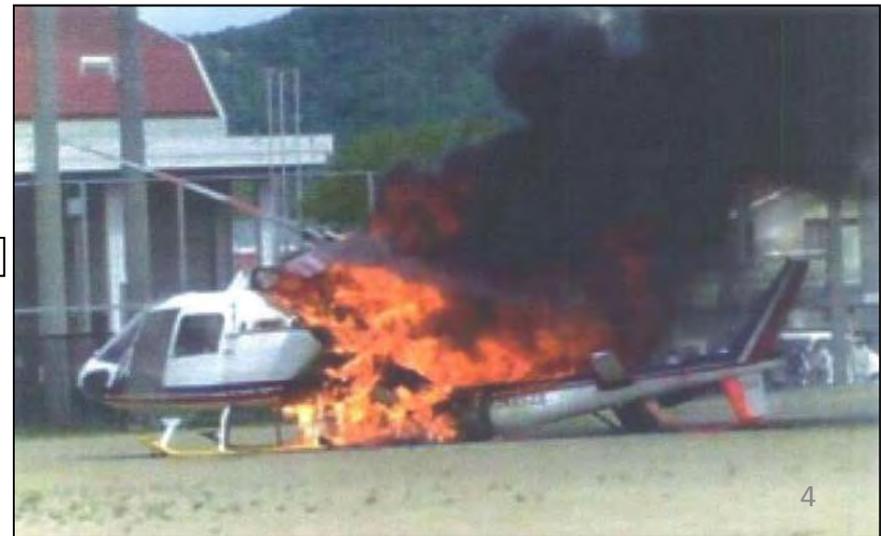
写真4 着陸後(10:19ごろ)

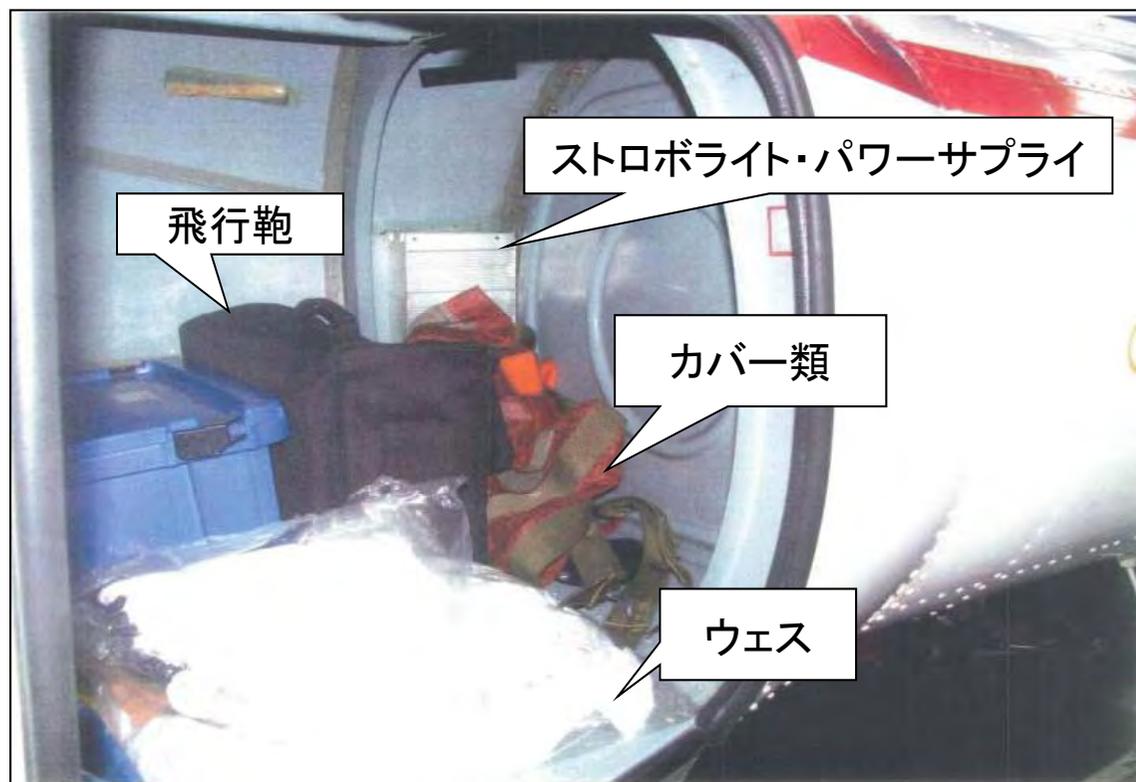
写真6 同型機の後部荷物室内(事故機と同じ積載状況)

※ 後部荷物室付近にはいくつかの電気装備品があり、後部荷物室には多数の可燃物が積載されていた。

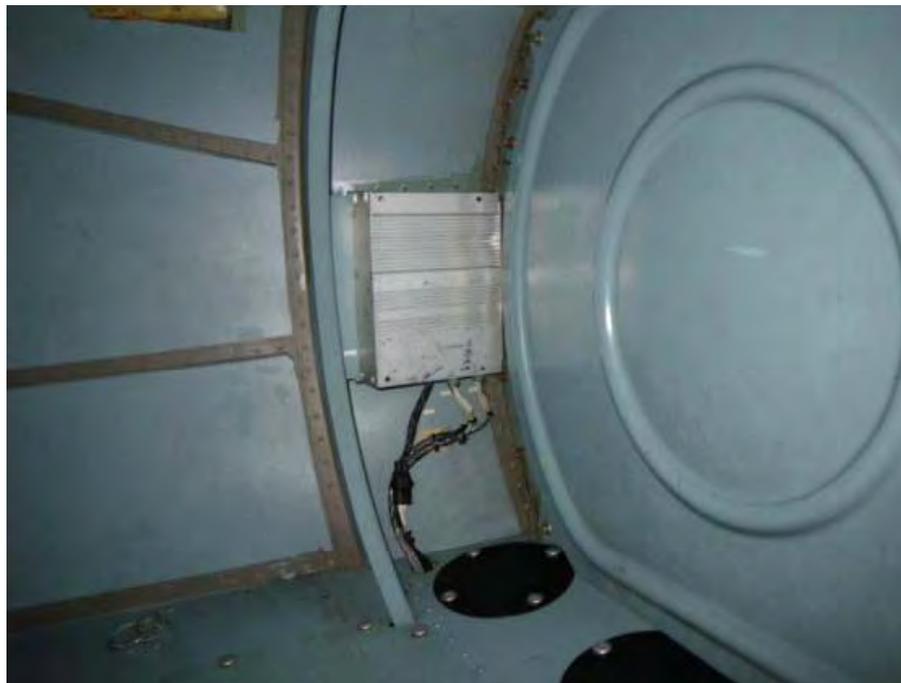
本体には、入力28VDC、出力400VDCの配線が接続している。出力側には保護装置(ヒューズ等)がない。

写真7 装備状況(同型機)

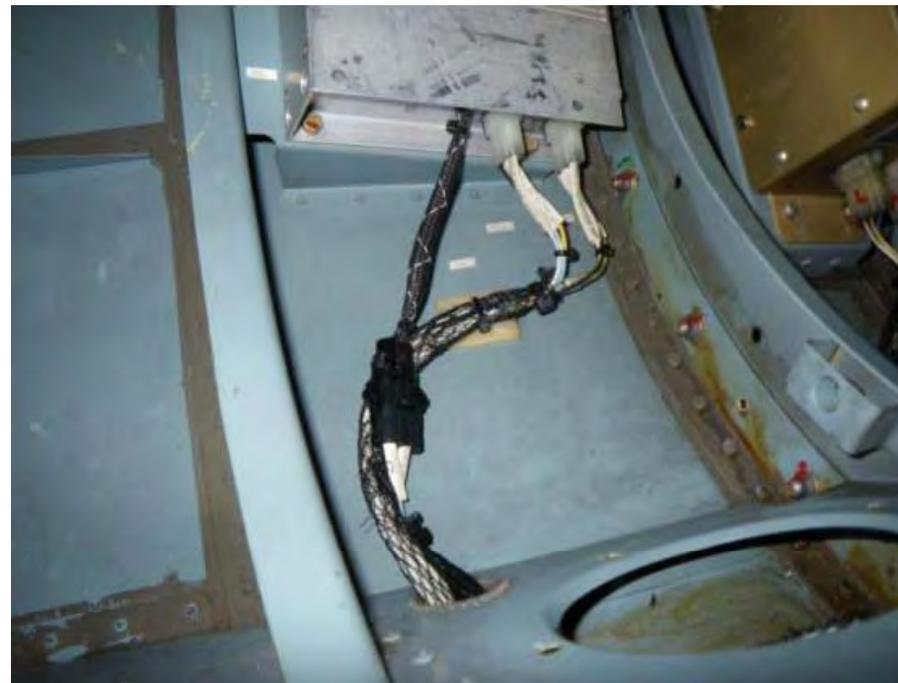
電気装備品名	特徴
ストロボライト・パワーサプライ	後部荷物室内右後方の壁面に取り付けてあり、床下に入出力の配線が伸びている。配線はほとんど保護されておらず、荷物の移動で損傷する可能性が十分考えられる。配線付近にカバー類を積載していた。
衝突防止灯パワーサプライ	後部荷物室と金属製隔壁で隔てられた後方の区画に装備されており、荷物の移動による影響はなく、発火しても後部荷物室に延焼する可能性は低い。
ELT (航空機用救命無線機)	後部荷物室内前方の壁面に取り付けてあり、荷物の移動による影響は少ない。また、電池は内蔵されているが、通常は作動していない。
FADEC (燃料コントロール)	後部荷物室内前方の壁面に取り付けてあり、配線の被覆が厚く荷物の移動による影響は少ない。配線の短絡が生じた場合は何らかのエンジン又は計器表示に異常が出るはずであるがそれはなかった。
マスターボックス (配電盤)	後部荷物室床下に取り付けてあり、荷物の移動による影響はなく、発火しても後部荷物室に延焼する可能性は低い。配線の短絡が生じた場合は何らかの計器表示が出るはずであるが、それはなかった。

写真8 配線の状況(同型機)

本事故を受け、当委員会に確認後、先月22日、EASA（欧州航空安全局）からEAD(Emergency Airworthiness Directive)、同日、製造者からASB(Alert Service Bulletin)、同26日、航空局からTCDが発出された。EADには、「本ADは、設計変更を行うまでの暫定的措置であり、更なるADの発行もあり得る。」との記載がある。EAD及びASBは、ストロボライトを使用停止するか、または使用する場合は繰返し点検を実施すること等を指示している。
