# 全日本空輸株式会社所属ボーイング式787-8型JA804A航空重大インシデントに係る安全勧告に基づき講じた措置について(通知)

## 【重大インシデントの概要】

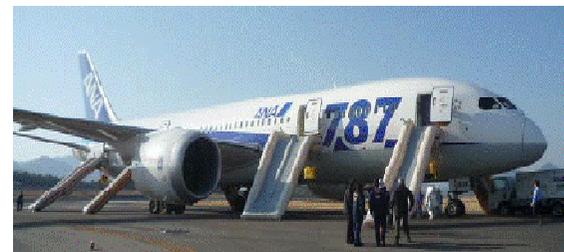
全日本空輸株式会社所属ボーイング式787-8型JA804Aは、平成25年1月16日(水)、東京国際空港に向けて山口宇部空港を離陸し、四国上空を上昇中、メインバッテリーの不具合を示す計器表示とともに、操縦室内で異臭が発生したため、目的地を高松空港に変更し、高松空港に着陸した。

同機のメインバッテリーが損傷したが、火災は発生しなかった。
