エアーニッポン株式会社所属ボーイング式737-700型JA16AN航空重大インシデントに係る安全勧告に基づき講じた措置について(通知)

SPECIAL AIRWORTHINESS INFORMATION BULLETIN

SUBJ: Flight Controls

SAIB: NM-15-03

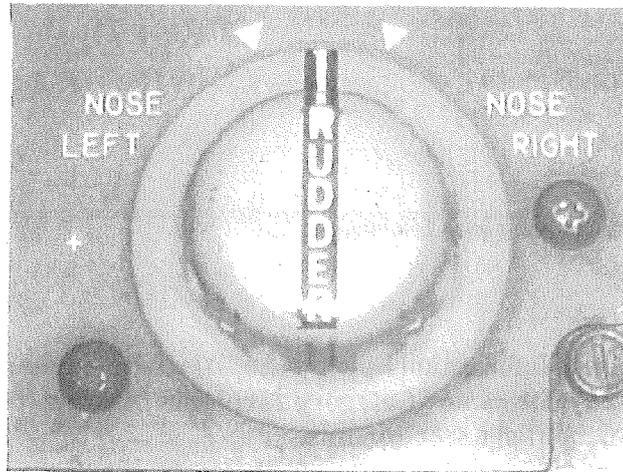
Figure 1 – Rudder Trim Switch

During the investigation of this incident, numerous aisle stand configurations were identified due to the multitude of supplemental type certificate installations and significant variability in the Boeing-delivered configurations. On the incident airplane (Model 737-700), the rudder trim switch is in approximately the same location as the flight deck door control switch on the operator's Model 737-500 airplane. This creates a potential for confusion when pilots transition between aircraft. Positive training on one model can become negative when the pilot transfers to a different model. Although the rudder trim switch (Figure 1) and flight deck door control switch (Figure 2) are different in size and shape (cylindrical vs. blade shaped), and the flight deck door unlock side of the switch must be depressed before turning, the general feel (spring force) to actuate the switches is similar; both are spring loaded to the center position. In this incident, the negative transfer error allowed the pilot to think he had operated the correct control, and the similarity of the control's operation exacerbated the situation.

Having a consistent position for the rudder trim switch is paramount because it provides a direct input to the aircraft rudder and can induce both yaw and roll into the aircraft flight attitude. Because both the rudder trim switch and the flight deck door control switch have a similar feel and action (turn and hold), a standard location and sufficient separation between these controls is recommended. Placing the controls in the recommended locations is consistent with most Boeing-delivered airplanes and creates a distinctive reach posture, provides sufficient separation in relation to reach direction from both seats, and provides adjacent tactile landmarks. This includes the railing in the corner of the aisle stand and the guarded stabilizer trim switch located between the rudder trim switch and the flight

1. Place the rudder trim switch in the center column as far aft as possible.
2. Place the flight deck door control switch in the far right column (first officer side) aft position.
3. Do not place the flight deck door control switch in the center column.

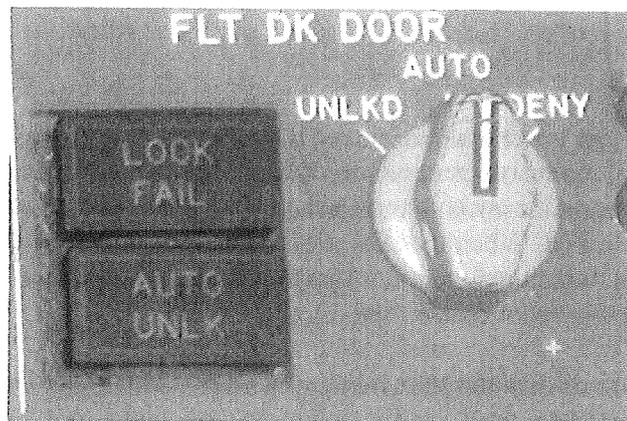
Figure 2 – Flight Deck Door Control Switch

In response to this incident, Boeing analyzed modifying the shape of the flight deck door control switch; however, they determined the position of the switch is more important than the shape of the switch from a human factors perspective. Position of a switch that affects pilot reach/posture provides better feedback to the pilot than the shape of the switch that the pilot feels. Boeing determined the most important factor to minimize inadvertent activation of the control switches is aisle stand configuration consistency within an operator's fleet.
