# (4) Emergency evacuation was conducted, based on a warning indicating the presence of smoke in the cargo compartment(s)

Summary: On August 21, 2005, an Airbus Industrie A330-303, operated by Airline D, took off at Narita International Airport heading for Perth International Airport. During the flight, a warning was displayed on the electronic centralized aircraft monitor (ECAM) indicating the presence of smoke in the cargo compartment(s). The crew made the decision to change their destination to Kansai International Airport and the aircraft landed at the airport.

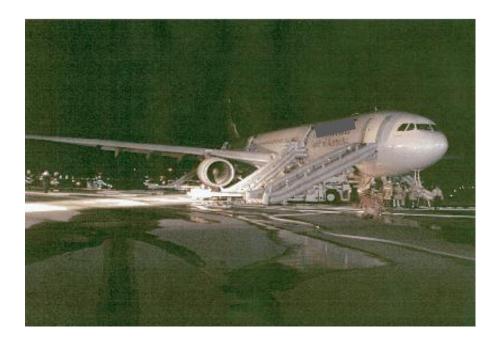
On the lower portion of an evacuation slide, the passenger, who was until then held by her parent from behind, slid out of her parent's arms and struck her lower back against the ground.

Eight passengers sustained minor injuries due to bruises or abrasions.

- o Some passengers were carrying hand baggage or carry-on suitcases as they evacuated.
- The number of evacuation slides used was 7 out of 8. At one slide, the door did not
- o Firefighters provided assistance at the bottom of three slides. At the slide where the serious injury occurred, there was no one assisting people.
- o The cabin attendants did not ask passengers that slid down to the ground first to assist the subsequent passengers.
