This column presents a case where Iwate Galaxy Railway Co., Ltd. took the measures using the “Support for project cost for general safety measures for railway facilities” to respond to heavy rains that have become more frequent and severer in recent years. The company has installed new riverbed protection blocks and new scouring detectors as the measures against scouring of bridges with the aim of improving the safety of railway passengers and preventing bridges from being washed out or inclined by heavy rains. We interviewed with Iwate Galaxy Railway Co., Ltd. about the details of this project and the procedures for the subsidy.

【Interview with Iwate Galaxy Railway Co., Ltd.】

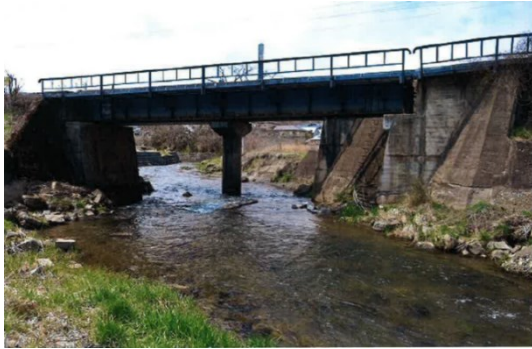
In the upstream and downstream sides of No.4 Kitakami River bridge, the river width was widened by the river improvement works carried out in the past. However, the river width was reduced near the concerned bridge compared to the upstream and downstream sides, because the position of the bridge abutment has not been changed. Therefore, the flow velocity near the bridge accelerates when the water level rises, and the riverbed has lowered. As a result of conducting the overall and individual inspections of the concerned bridge, the riverbed lowering near the bridge pier as well as partial scouring of the bridge abutment were observed. It was found out that reinforcement works are necessary.

Figure 17: No.4 Kitakami River Bridge
(Full view from the upstream side)

Construction work to install new riverbed protection blocks at No.4 Kitakami River bridge

When selecting a construction technique, riverbed protection blocks were selected taking into account the nearby environment, because the work can be done in a narrow space, these blocks can prevent bridge piers and abutments from being washed out and the riverbed from being lowered, and the company has an experience in this construction technique. Since the bridge piers and newly-installed concrete riverbed protection blocks have been connected, a possibility of wash-out decreases significantly. In addition, the scouring and riverbed lowering are prevented by covering the entire river width with these new blocks.

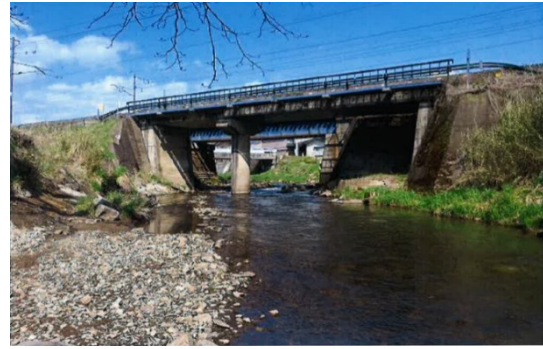
Figure 18: No.4 Kitakami River Bridge
(Full view from the downstream side)

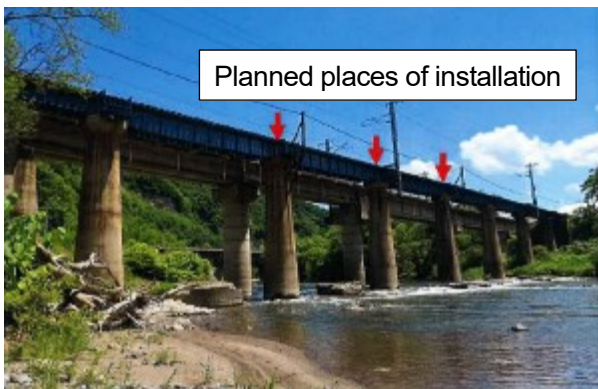
Moreover, the riverbed has lowered at No.8 and No.10 Mabechi River bridges from the time when they were constructed. Therefore, riverbed protection blocks were newly installed at No.8 Mabechi River bridge (FY2013) and at No.10 Mabechi River bridge (FY2016) to control the riverbed lowering. Since then, as a result of conducting the overall and individual inspections of both bridges, it was confirmed that there is no problem in their soundness. However, there was a risk that the bridge piers are washed out or inclined due to insufficient embedment caused by the riverbed lowering when the river level rises. Therefore, it was necessary to examine a possibility of introducing inclination detection devices (See Figure 25).

Figure 19: No.8 Mabechi River Bridge (Full view from the downstream side)

Installation of new scouring detection devices at No.8 and No.10 Mabechi River bridges

Since the devices capable of automatically transmitting observational data from inclinometers on-line have been installed, it is now possible to check data on a real-time basis and efficiently control operations. Moreover, it is now possible to check the stability of bridge piers with the inclinometers when resuming the train operation after it has been restricted (stopped) due to the rise in water levels. In addition, it is possible to view data on restrictions and disasters in the past.

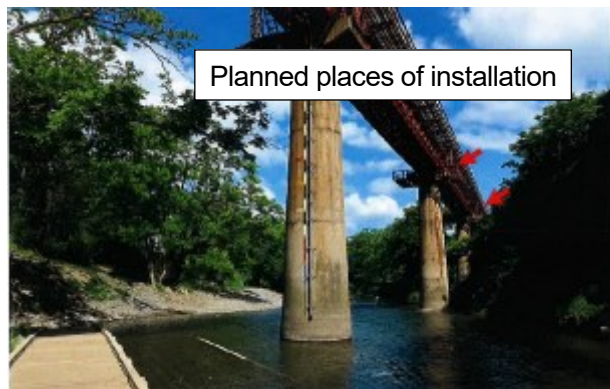
Figure 20: No.10 Mabechi River Bridge
(Full view from the downstream side)

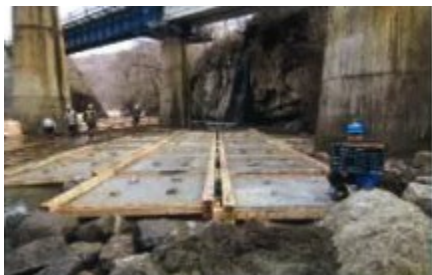
Figure 21: Installation of new riverbed protection blocks (completion of concrete placement)

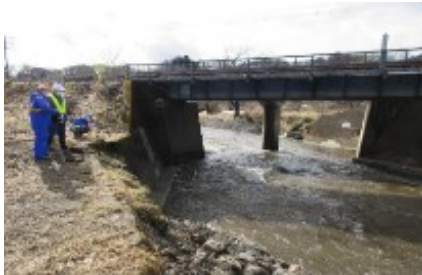
Figure 22: Completion of work (Full view)

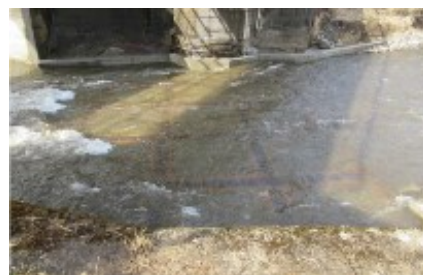
Figure 23: Completion of work (riverbed bottom)

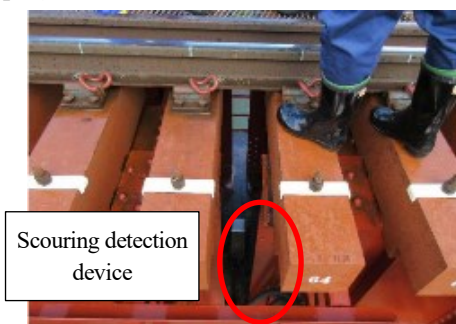
Figure 24: No.10 Mabechi River bridge (work completed)

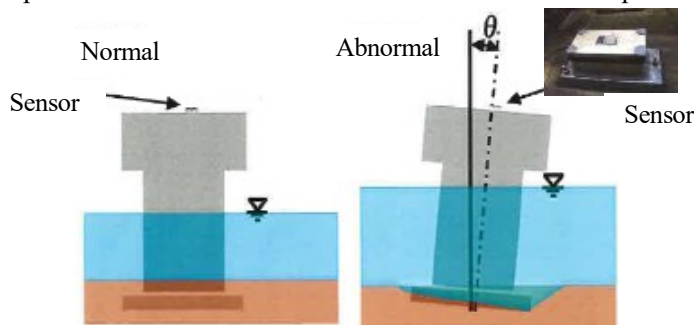
Figure 25: System to detect a bridge pier inclination with a scouring detection device
