Case 3

The aircraft bounced during the landing at the airport, which led to the damage of propellers and fuselage structure.

Summary: On March 24, 2011, a Cessna 172S operated by Company A took off from Kumamoto Airport for a solo training flight. The aircraft was damaged when it bounced during the landing at the airport. A student pilot on board the aircraft suffered no injury.

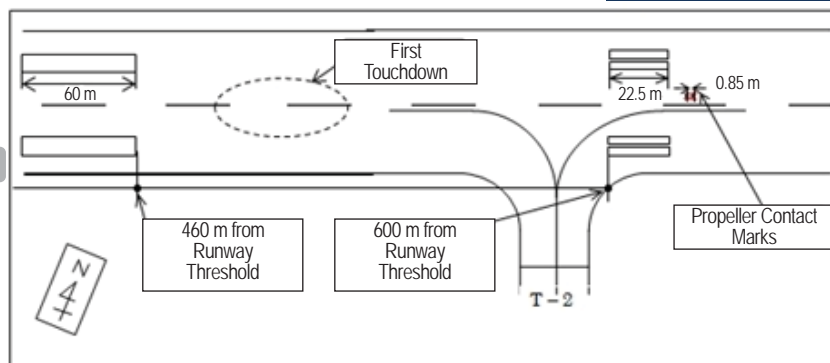
Estimated Flight Route

The student pilot took off from Kumamoto Airport for solo training flight for air maneuvers at 12:24, he entered the base leg (*) for runway 07 south traffic pattern.

He set the flaps at FULL DOWN on the mid-final at about 75 kt. The runway threshold airspeed was about 71 kt.

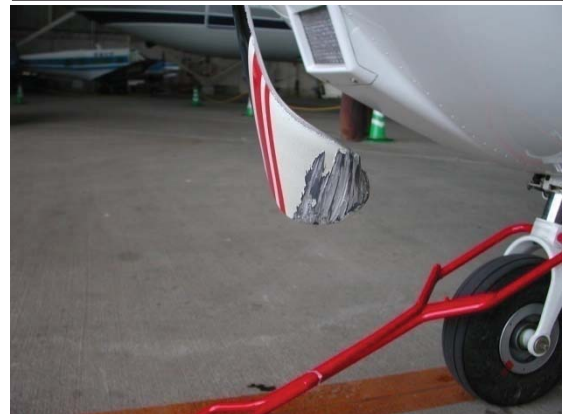
It is very likely that the aircraft bounced upon landing, followed by a nose-low hard contact with the runway, resulting in damage of propeller blades and fuselage structure.

He had possibly pushed the control wheel or failed to apply back elevator pressure to hold the pitch down attitude, resulting in the nose-low contact with the runway. It is highly probable that hard strikes of propeller blades very likely lead to the damage of fuselage structure.

Damage of the propeller blades

- It is necessary to develop teaching techniques to have student pilots acquire proper flare height and touch-down attitude, and share them among instructors.
- As it is possible that student pilots in early phase may not have sufficient landing techniques, granting them solo flight needs to be done with further caution considering weather conditions and their preparedness.
- Appropriate training including in-flight training should be given to student pilots so that they could execute a go-around without hesitation in order to address the unexpected sink after passing over the runway threshold or bouncing after the touchdown.
