Investigated accident case 4

Grounding, in Hayatomo Seto, Kanmon Passage, of a cargo vessel which was proceeding northeastward in restricted visibility because of thick fog, when she tried to avoid a vessel sailing ahead of her

Outline: Manned by a master and six crew members, Cargo Vessel A, which was sailing northeastward through the Kanmon Passage, Kanmon Port, for Tsukumi Port, Oita Prefecture, grounded on the west side of Moji Saki about 23 seconds past 0643 hours on December 10, 2008. Vessel A suffered dent damage to the shell plating but no fatalities nor personal injuries.

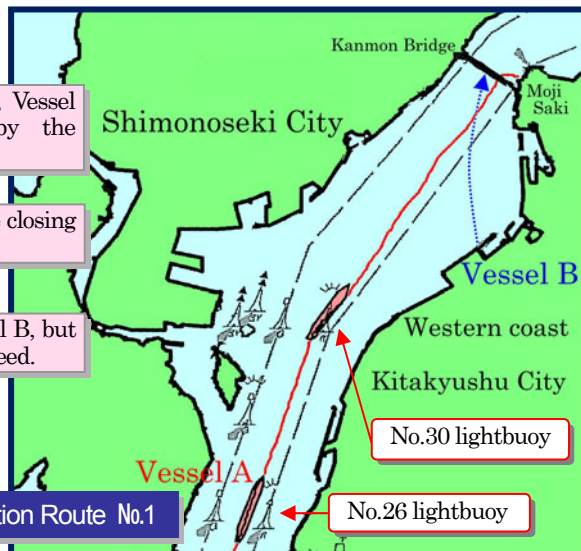
On the radar screen, Vessel B was obscured by the Kanmon Bridge.

She was sailing while closing to Vessel B.

He lost track of Vessel B, but did not slacken his speed.

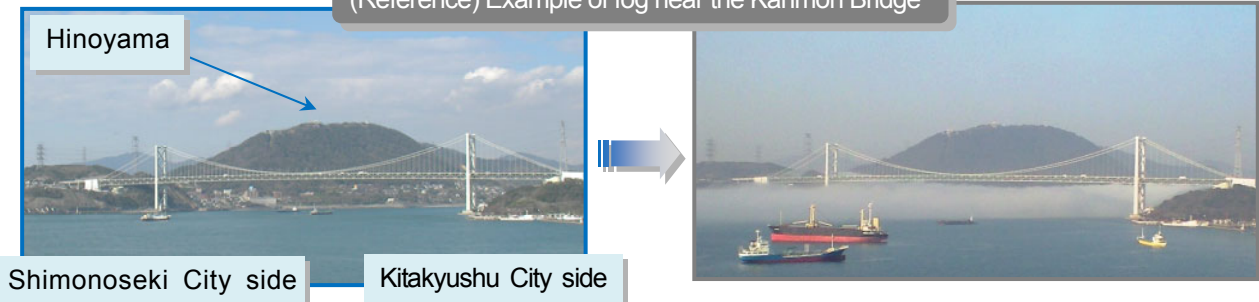
(Reference) Example of fog near the Kanmon Bridge
