**AIRCRAFT SERIOUS INCIDENT
INVESTIGATION REPORT**

**A SITUATION WHERE A PILOT IN COMMAND OF AN AIRCRAFT
RECOGNIZED A RISK OF COLLISION OR CONTACT
WITH ANY OTHER AIRCRAFT**

1. PRIVATELY OWNED BEECHCRAFT A36, JA3815

AIRBUS A320-214, B-9940

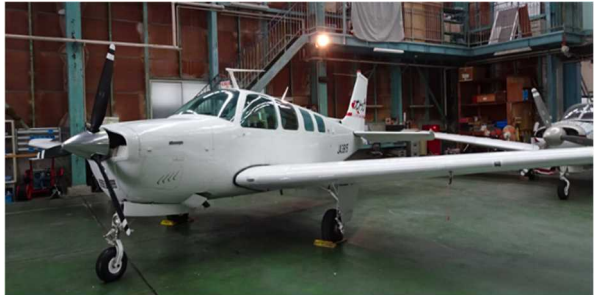
<p>Figure 1: Aircraft A</p>

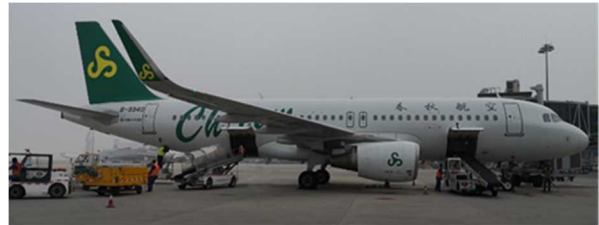
Figure 2 Aircraft B
