MA2019-2

**MARINE ACCIDENT
INVESTIGATION REPORT**

Vessel type and name: Training ship NIPPONMARU
Vessel number: 128115
IMO number: 8211502
Gross tonnage: 2,570 tons

Accident type: Fatality of a cadet
Date and time: Around 14:25, April 2, 2018 (local time, UTC +9 hours)
Location: Keihin port, Tokyo district 3, No. 10-1 Multi-purpose Terminal M-P
Around 294° true bearing, 1.2 nautical miles from Tokyo Mokuzai Anchorage Breakwater West Lighthouse
(approximately 35°37.5'N, 139°47.7'E)

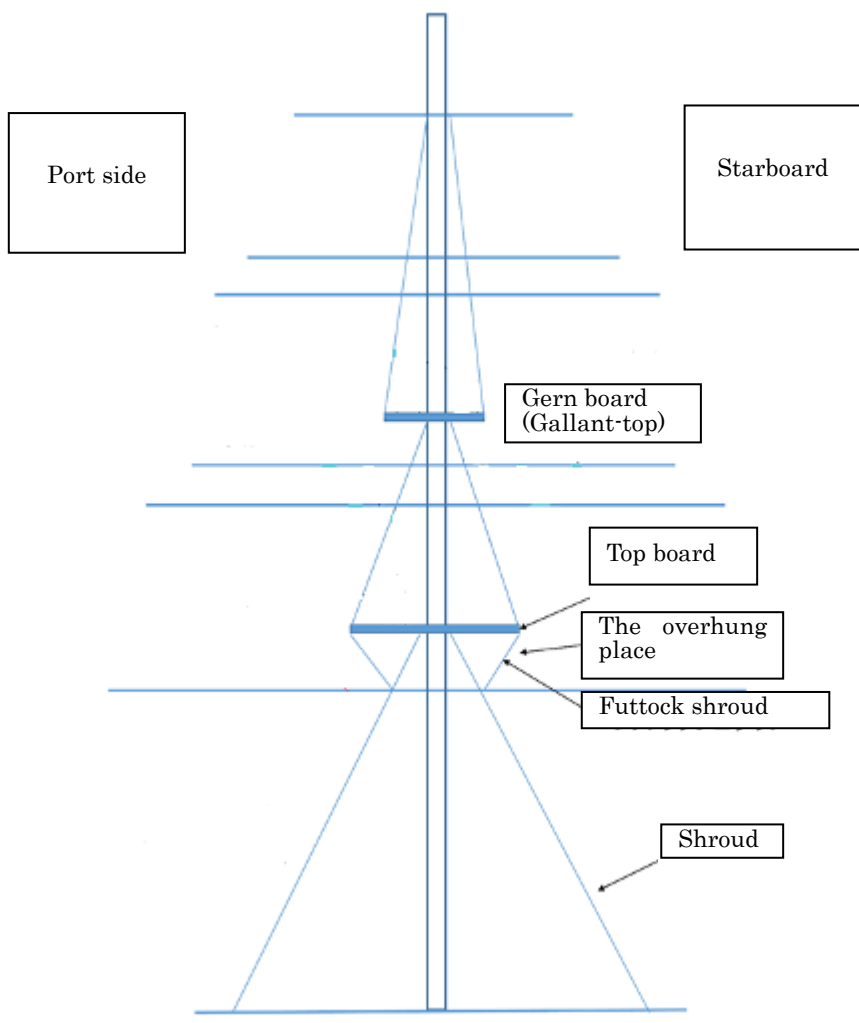
Figure 2.5-3 Overhung futtock shroud

⁶ “Futtock shrouds” are overhung (tilting outside) structurally in order to support a top board, made of reticulum rounded steel wires which construct a ladder to climb a mast with ratlines by passing through vertically.

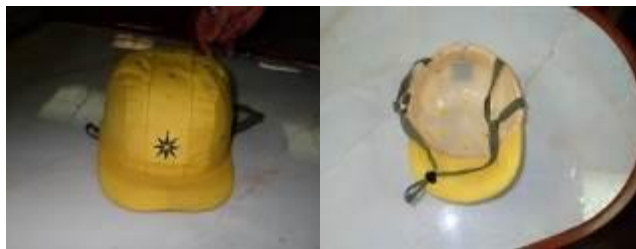
Picture 2.8-1 Working caps for high places

There are work caps for works in high places made of cloth and rigid polyethylene with an inner package that covers the inside entirely.

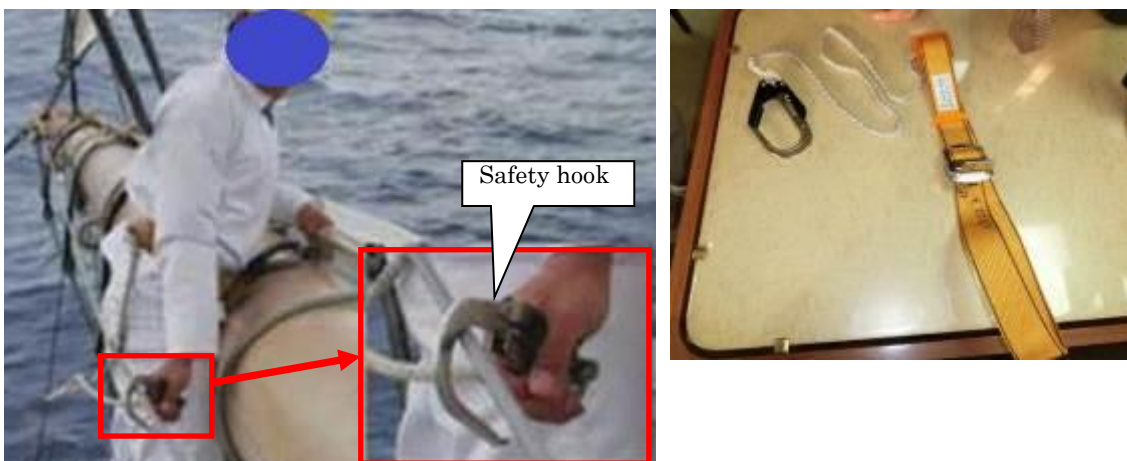
The use of safety belts for the prevention of falling when working in high places, a belt with safety hook was worn at the waist. The safety hook was not used at the time of up and down the masts due to danger from the time of put on/off the hook by one hand, so it was used only when waiting at the top board and the ratlines. (See Figure 2.8-2)

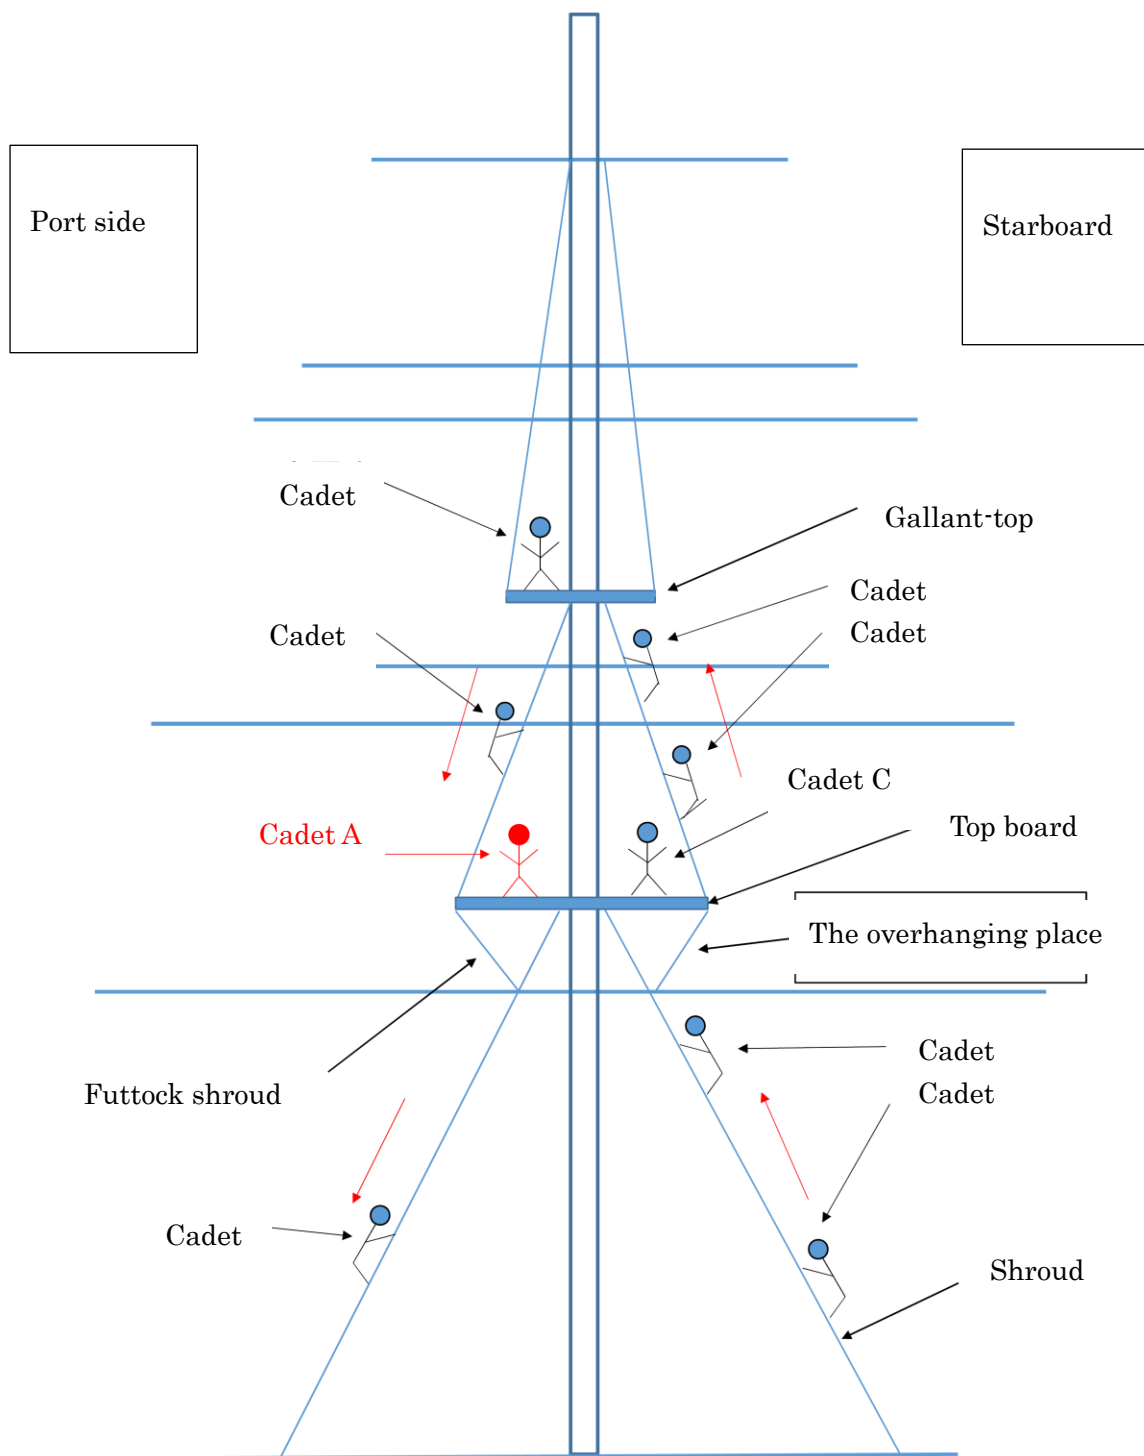
Attached Figure 2 The situation of the foremast before the accident occurrence

Cadet A returned to the top board around 14:20 and stayed there.

Around 14:20, Cadet A was taking a rest at the top board

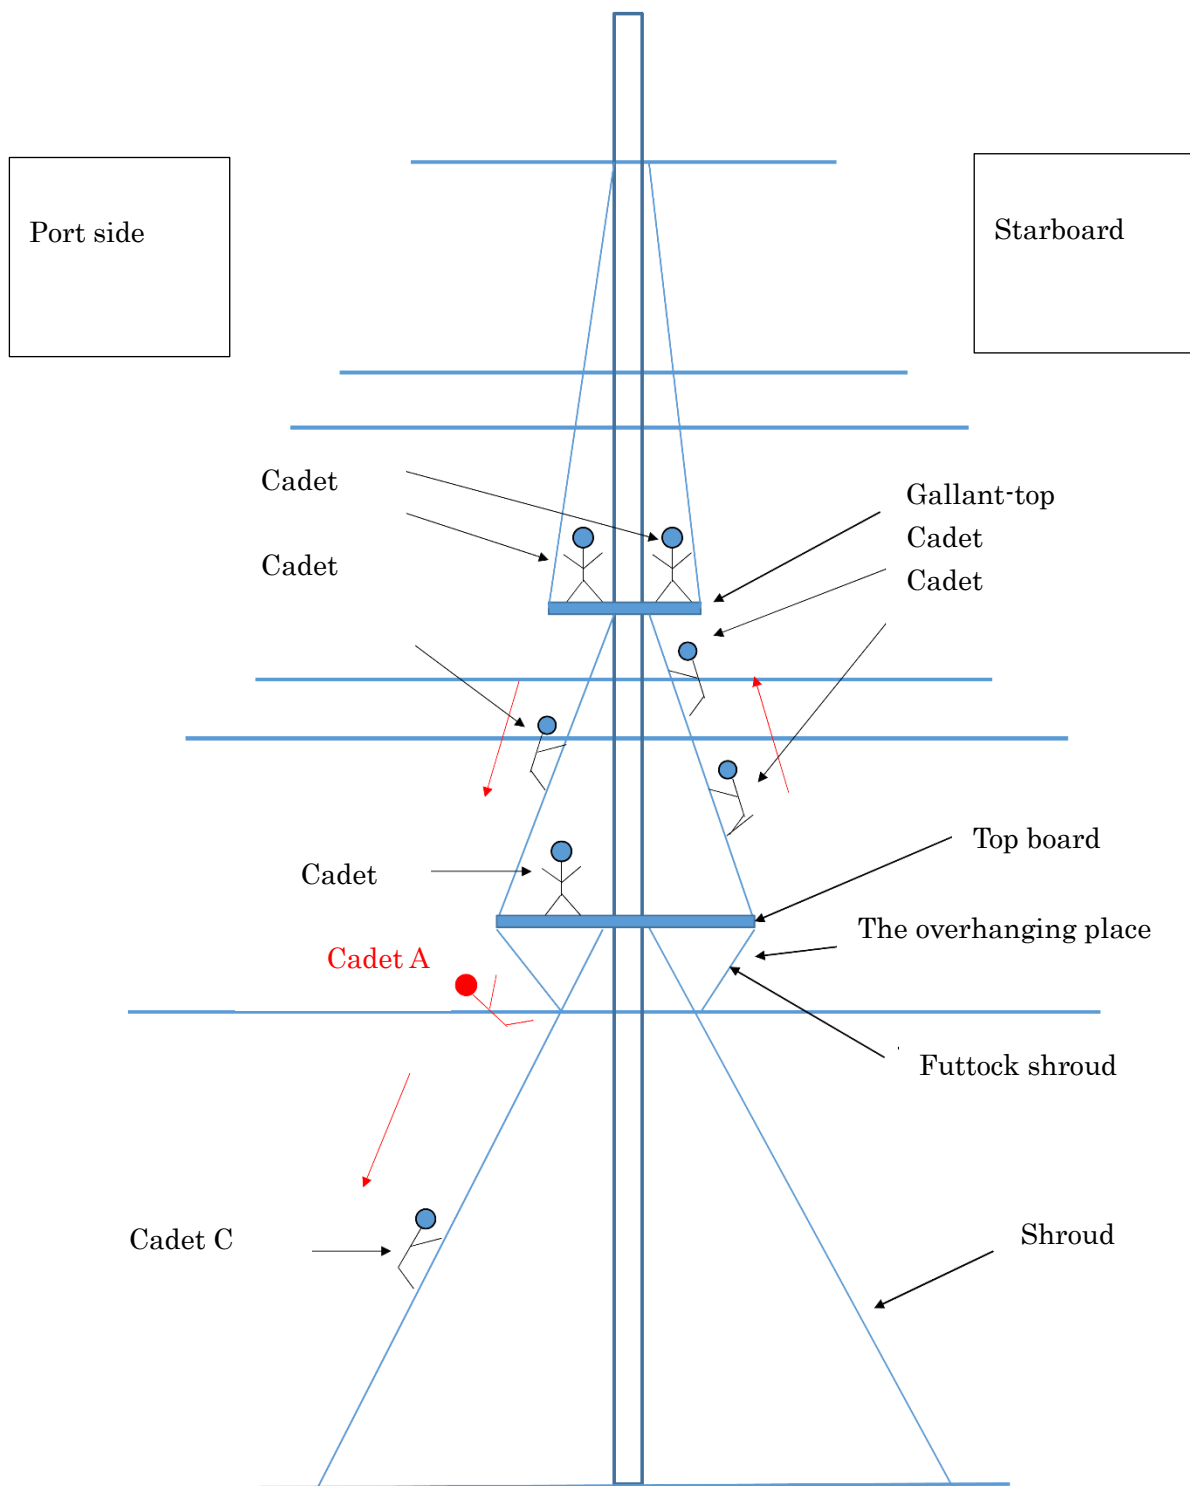
Attached Figure 3 The situation of the foremast at the time of the accident occurrence

Around 14:25, while Cadet A put both legs on the ratline a few steps down from the top board (the height from the deck was approximately 11 meters), his both hands left the futtock shroud⁶, he fell backward to the port side saying, “Oh!”

Around 14:25, at the time the apprentice A fell down

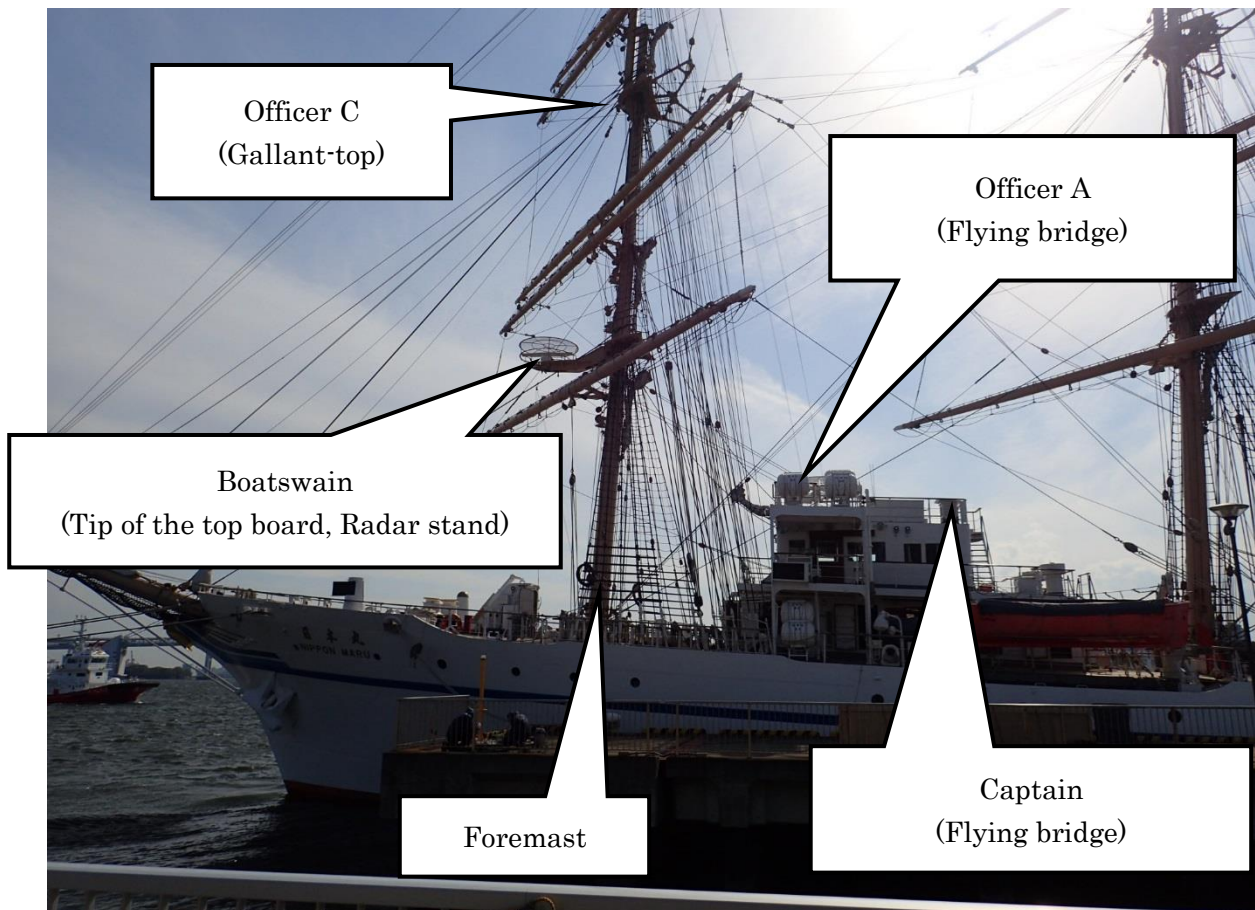
Picture 2 The deployment of the crews at the time of the accident occurrence

For the lay aloft training up to the gallant-top, Officer A at the flying bridge, Officer C on the gallant-top, the boatswain at the radar stand near the top board, they took charge of training on the foremast respectively.
