"The accident with human death caused by the collision of the train and the passerby, occurred in the class 4 level crossing"

Railway operator : East Japan Railway Company
 Accident type : Level crossing accident
 Date and time : About 17:47, March 21, 2019
 Location : Yamanone level crossing, the class 4 level crossing without crossing gate nor road warning device, in the premises of Zushi station, Yokosuka Line, Zushi City, Kanagawa Prefecture

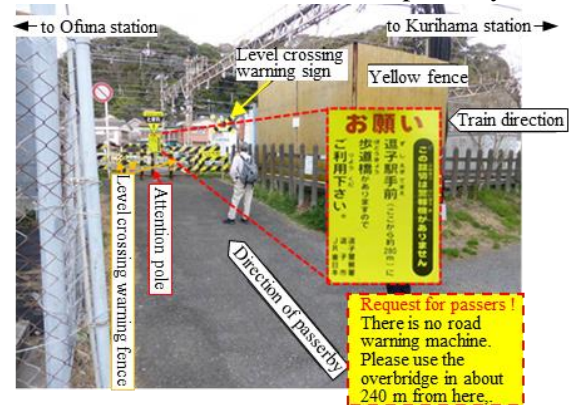
<Status of Yamanone level crossing viewed from the entered side of the concerned passerby>

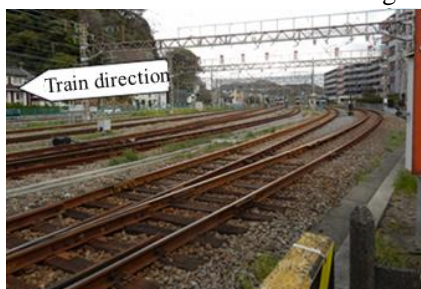
<Perspective of the direction to Kurihama station from Yamanone level crossing>

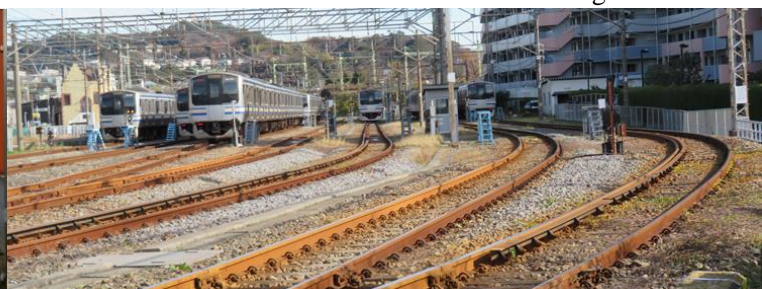
<Perspective of the parking tracks viewed from southward of Yamanone level crossing>
